MEMORANDUM

DATE: 6/10/2020

SUBJECT: Marine Drive – Old Marine Dr to Wynn Rd, including Bridge #172 over BNSF Track

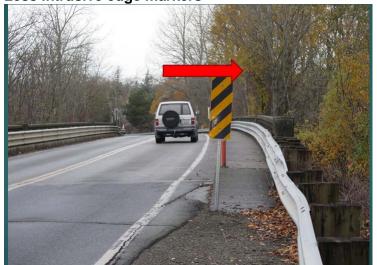
3. Less intrusive edge markers

a. Following site meeting with Jim Karcher on June 4th, and review of the Manual on Uniform Traffic Control Devices (MUTCD), the relocation of the Type 3 Object Markers will be considered. Currently Traffic Engineering is following up with Maintenance and Operations and Bridge and Hydraulic Engineering on this.
