**Lake Samish
Proposal to Change
Ordinance 2019-046
August 2019**

ALLEGED DOCK DAMAGE

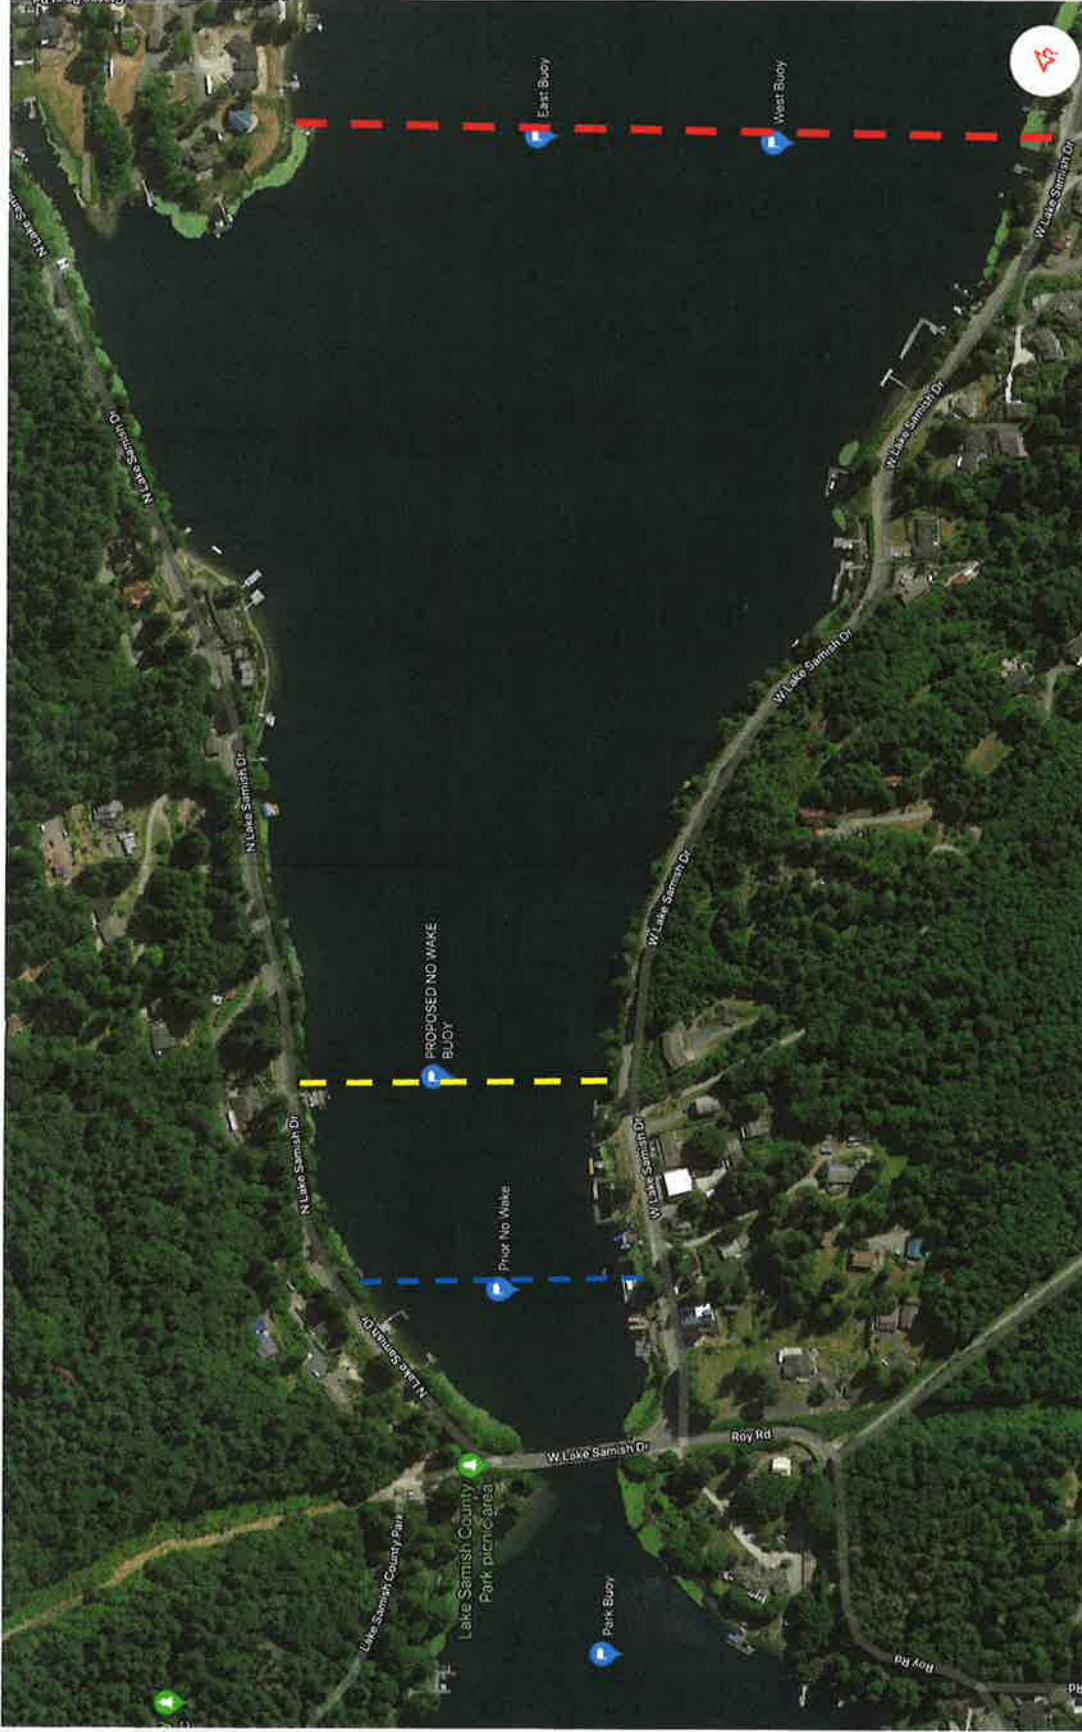
NO-WAKE MAP

Blue Line – Original buoy location approximately 300 to 350 feet from bridge

Yellow Line – Proposed buoy location approximately 800 feet from bridge

Red Line – Post Ordinance 2019-046 buoy location >2,700 feet from bridge

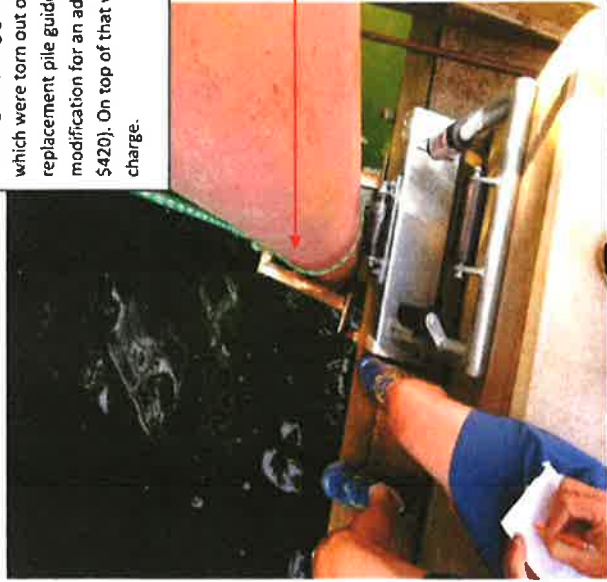
The original piling guide was attached with six inch lag bolts which were torn out of the dock by wake action. The replacement pile guide cost \$160 x2 then required modification for an additional \$100 to fit the piling (total \$420). On top of that would have been an installation charge.

Note: Rusted U-shaped bracket at base of dock that is past it's useful life. The bracket appears to be nearly rusted through at one joint. Additionally the bracket is not robust enough to adequately support a long heavy cement dock attached to steel pilings. The support was old and was in fact replaced by the owner with a new more robust bracket with multiple fastening points to the dock. The bracket did not employ a system to reduce friction between the support and the steel piling, resulting in significant stress to the U-shaped support bracket. The owner in this case was doing normal preventative dock maintenance with a reported cost of \$420. This is an expected ongoing support expense associated with owning a large cement dock, that according to the owner weighs a staggering 33,000 pounds, and is not attributable to wake damage. The U-shaped support is nearly rusted through due to extended length of service or the part was not properly designed (not designed with rustproof materials). Rust failure of the support clearly is not from boat wakes.

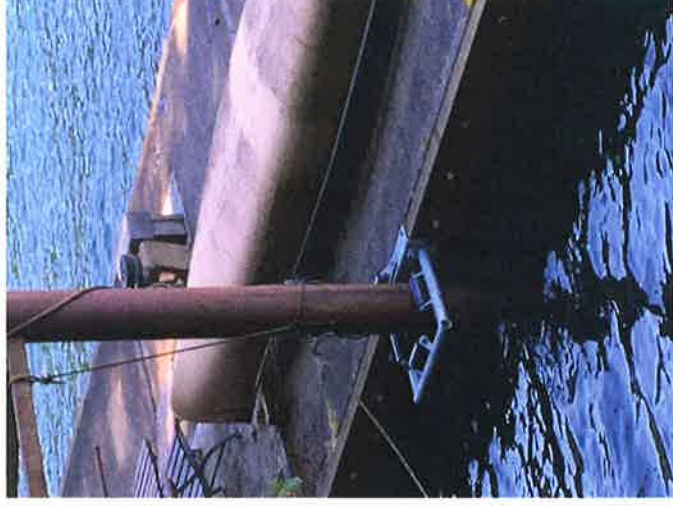
Note: Same dock, picture taken July 27, 2019. New support bracket installed. Support is significantly more robust than prior. It attaches to the top and side of dock for greater strength. It employs a roller system to allow dock to slide up and down the support piling with less drag, this will decrease stress on the dock and support. Remember the owner of this dock stated that it weighs 33,000 thousands pounds, which will exert significant stress on the support bracket. (photo taken from public road July 27, 2019)

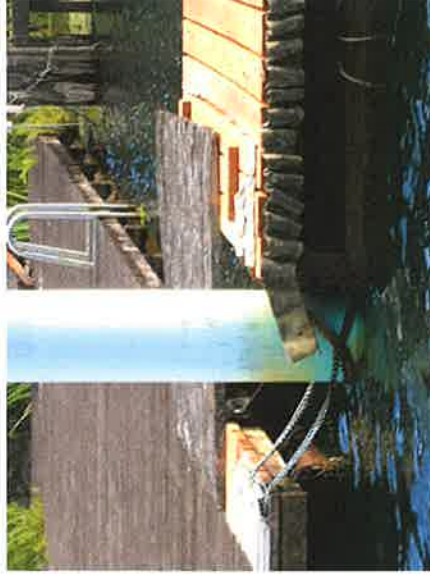
Note: Upper right picture – two separate floats are connected by wood that is severely decayed and is not structurally sound to bridge two floats. The float on the left side of the picture has top boards that are badly worn. Top boards on left dock have been replaced which is good. (photo taken from public waterway, July 27, 2019)

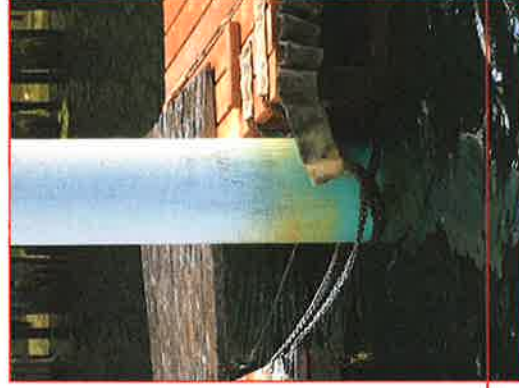
Note: Center picture – closeup of installation where two floats are joined. No residential or commercial dock installer would design or build a dock to the specifications displayed in this photo. There will be predictable performance issues with this dock that are unrelated to wake waves. Dock owners have an obligation to properly maintain their dock and this dock is clearly not well maintained. (photo taken from public waterway, July 27, 2019)

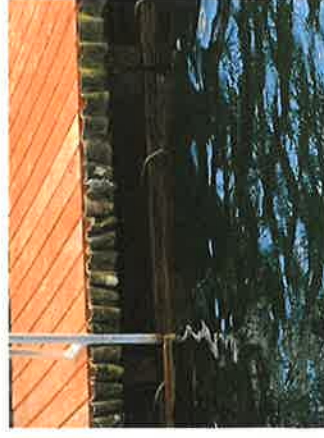
Note: Far right picture – structural support beams at the waterline are held together with rope. No bonded dock installer would build a dock to these specifications. The construction will lead to ongoing issues as it is not properly designed or installed. (photo taken from public waterway July 27, 2019)

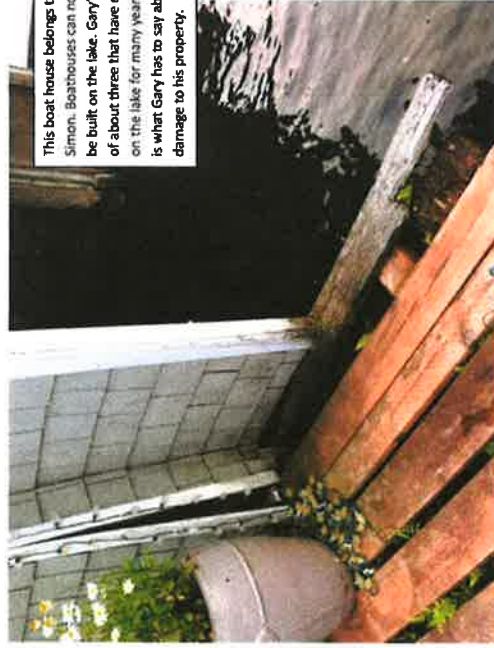
Note: Upper picture – This is the original picture in the Document. Wood is rotten and no longer structurally sound. This boat house has not been kept in good repair by the owner.

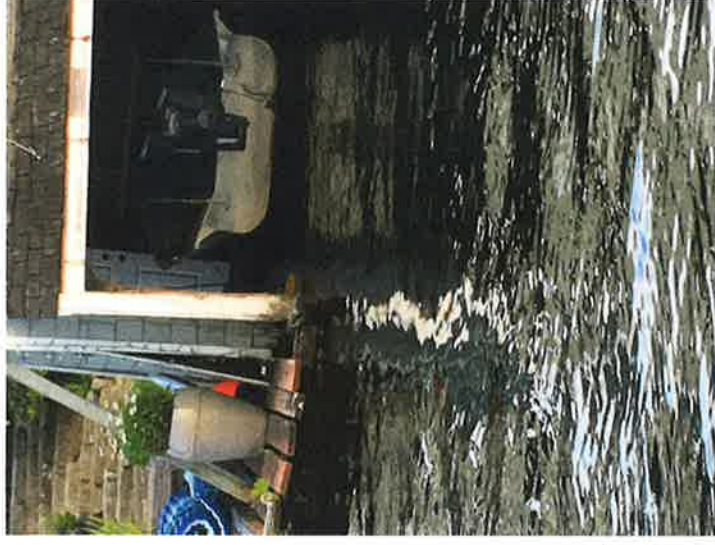
Note: Right picture – Boat house appears to have been in consistent decline for an extended number of years. Note the rotted wood on left side of boat house along waterline. Homeowners have an accountability to maintain docks and boat houses in good working condition. Without ongoing preventative maintenance the structural integrity of docks and boat houses will decline as evidenced in these photos. (picture taken from public waterway July 27, 2019)

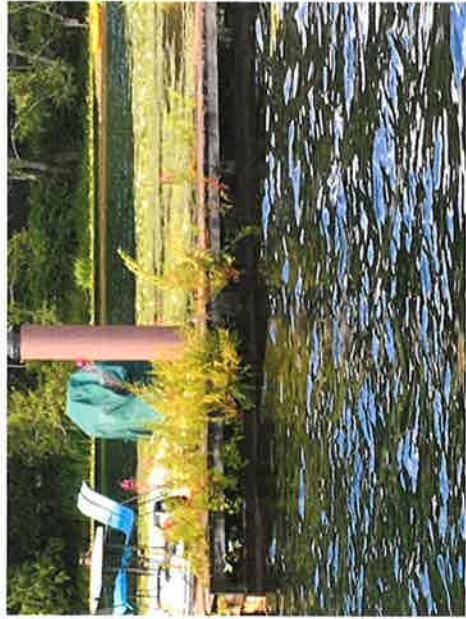
Note: Upper left picture – Wide view of dock showing extensive plant growth in dock. This will weaken dock and is a sign of failing wood. As stated by owner, note the reinforced piling sleeves which will help extend the useful life of the dock. The cost however associated with this type of repair is in fact a predictable event for old wood pilings, which often give out at the waterline. Looking at the condition of the float it is easy to extrapolate that pilings were in the same state of disrepair, prior to repair. (photo taken from public waterway July 27, 2019)

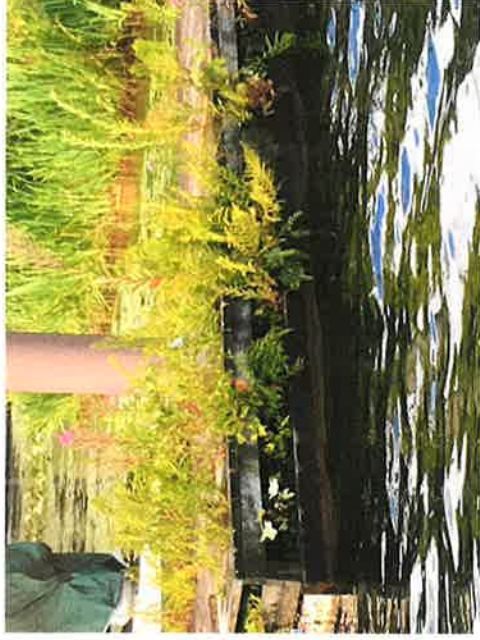
Note: Upper right picture – Closer view of same dock where there is apparent wood decay, which will significantly weaken the structural integrity of the dock. (photo taken from public waterway July 27, 2019)

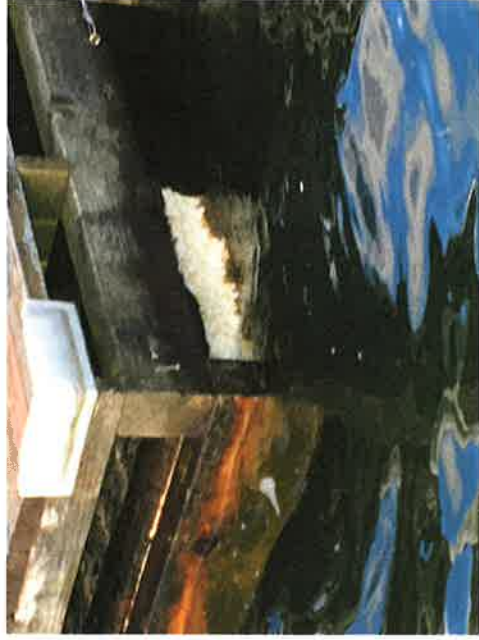
Note: Lower right picture – Dock float is supported by old technology white styrofoam. This styrofoam will eventually become water logged and provide less buoyancy pulling the float deeper into the water. (photo taken from public waterway July 27, 2019)
