**Lake Samish
Proposal to Change
Ordinance 2019-046**

August 2019

ALLEGED DOCK DAMAGE

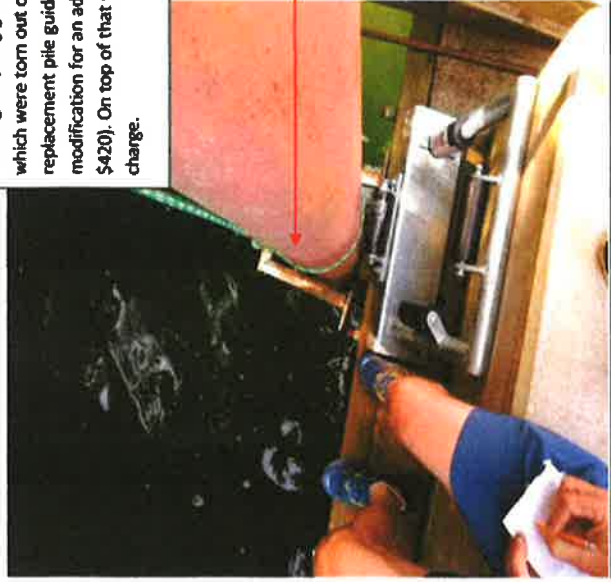
The original piling guide was attached with six inch lag bolts which were torn out of the dock by wake action. The replacement pile guide cost \$160 x2 then required modification for an additional \$100 to fit the piling (total \$420). On top of that would have been an installation charge.

Note: Rusted U-shaped bracket at base of dock that is past it's useful life. The bracket appears to be nearly rusted through at one joint. Additionally the bracket is not robust enough to adequately support a long heavy cement dock attached to steel pilings. The support was old and was in fact replaced by the owner with a new more robust bracket with multiple fastening points to the dock. The bracket did not employ a system to reduce friction between the support and the steel piling, resulting in significant stress to the U-shaped support bracket. The owner in this case was doing normal preventative dock maintenance with a reported cost of \$420. This is an expected ongoing support expense associated with owning a large cement dock, that according to the owner weighs a staggering 33,000 pounds, and is not attributable to wake damage. The U-shaped support is nearly rusted through due to extended length of service or the part was not properly designed (not designed with rustproof materials). Rust failure of the support clearly is not from boat wakes.

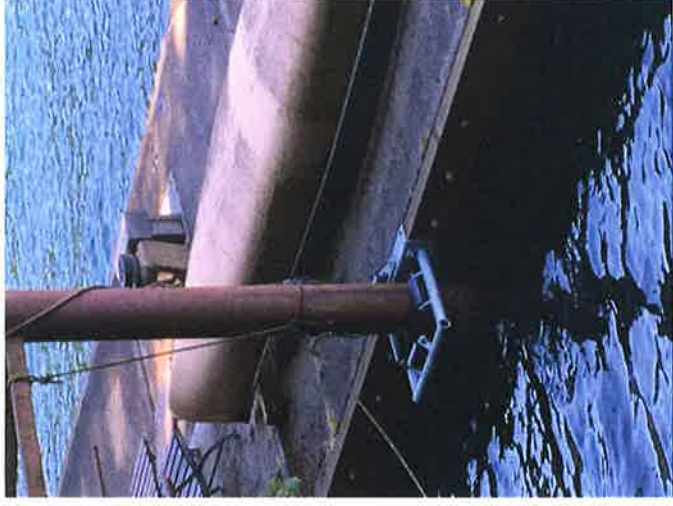
Note: Same dock, picture taken July 27, 2019. New support bracket installed. Support is significantly more robust than prior. It attaches to the top and side of dock for greater strength. It employs a roller system to allow dock to slide up and down the support piling with less drag, this will decrease stress on the dock and support. Remember the owner of this dock stated that it weighs 33,000 thousands pounds, which will exert significant stress on the support bracket. (photo taken from public road July 27, 2019)

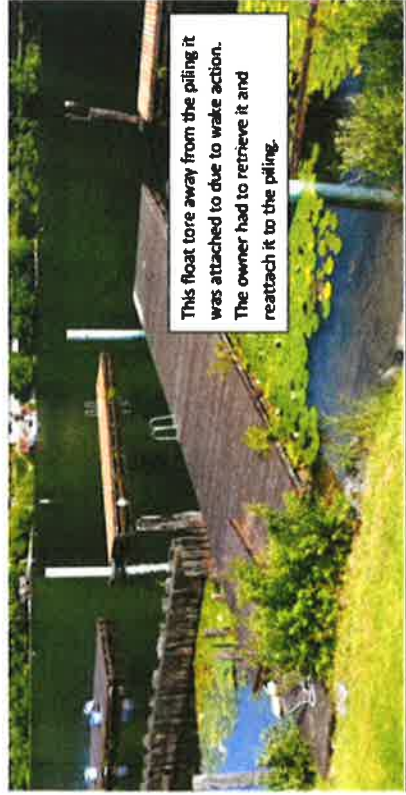
This float tore away from the piling it was attached to due to wake action. The owner had to retrieve it and reattach it to the piling.

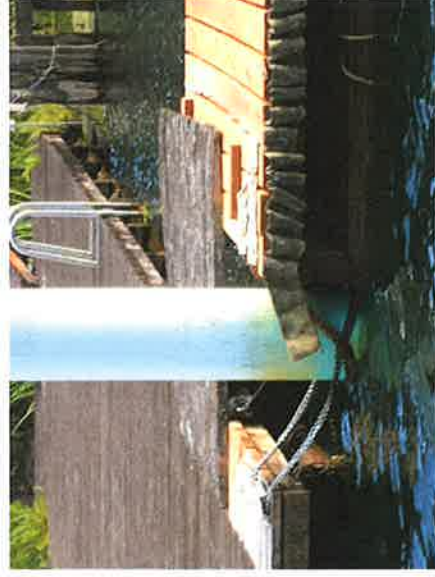
Note: Upper right picture – two separate floats are connected by wood that is severely decayed and is not structurally sound to bridge two floats. The float on the left side of the picture has top boards that are badly worn. Top boards on left dock have been replaced which is good. (photo taken from public waterway, July 27, 2019)

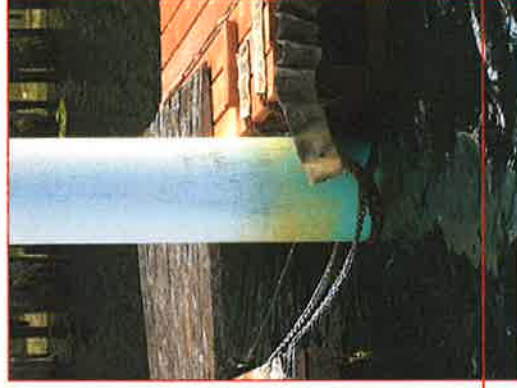
Note: Center picture – closeup of installation where two floats are joined. No residential or commercial dock installer would design or build a dock to the specifications displayed in this photo. There will be predictable performance issues with this dock that are unrelated to wake waves. Dock owners have an obligation to properly maintain their dock and this dock is clearly not well maintained. (photo taken from public waterway, July 27, 2019)

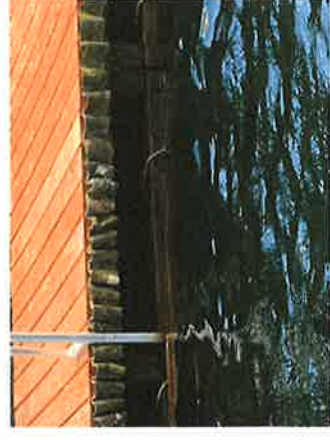
Note: Far right picture – structural support beams at the waterline are held together with rope. No bonded dock installer would build a dock to these specifications. The construction will lead to ongoing issues as it is not properly designed or installed. (photo taken from public waterway July 27, 2019)

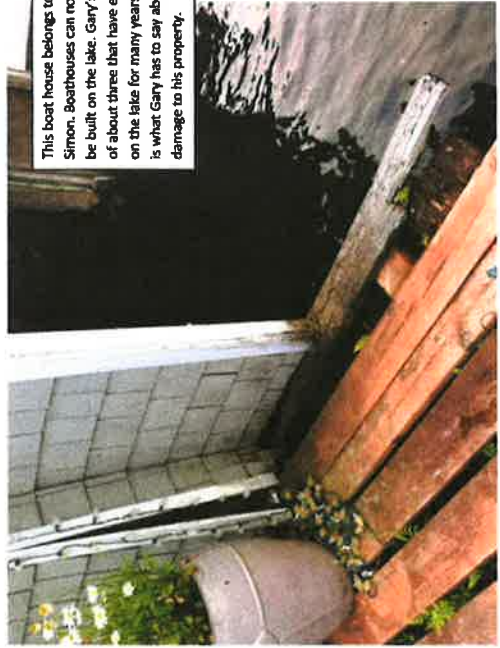
Note: Upper picture – This is the original picture in the Document. Wood is rotten and no longer structurally sound. This boat house has not been kept in good repair by the owner.

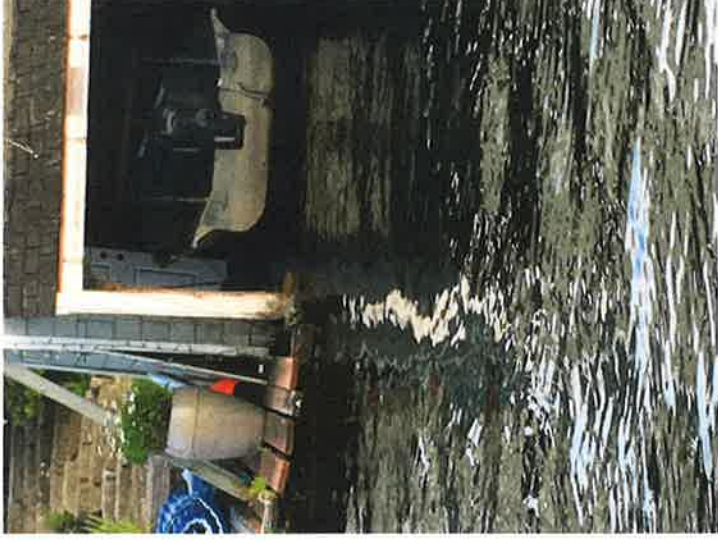
Note: Right picture – Boathouse appears to have been in consistent decline for an extended number of years. Note the rotted wood on left side of boat house along waterline. Homeowners have an accountability to maintain docks and boat houses in good working condition. Without ongoing preventative maintenance the structural integrity of docks and boat houses will decline as evidenced in these photos. (picture taken from public waterway July 27, 2019)

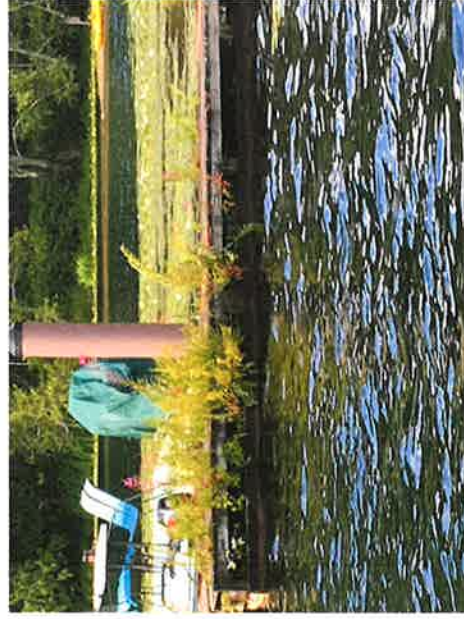
Note: Upper left picture – Wide view of dock showing extensive plant growth in dock. This will weaken dock and is a sign of failing wood. As stated by owner, note the reinforced piling sleeves which will help extend the useful life of the dock. The cost however associated with this type of repair is in fact a predictable event for old wood pilings, which often give out at the waterline. Looking at the condition of the float it is easy to extrapolate that pilings were in the same state of disrepair, prior to repair. (photo taken from public waterway July 27, 2019)

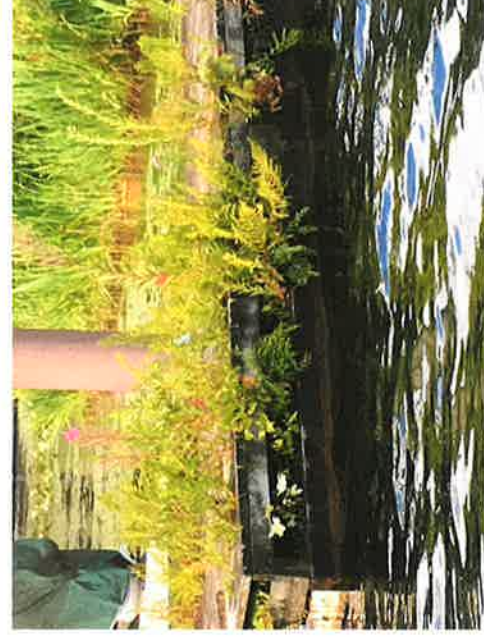
Note: Upper right picture – Closer view of same dock where there is apparent wood decay, which will significantly weaken the structural integrity of the dock. (photo taken from public waterway July 27, 2019)

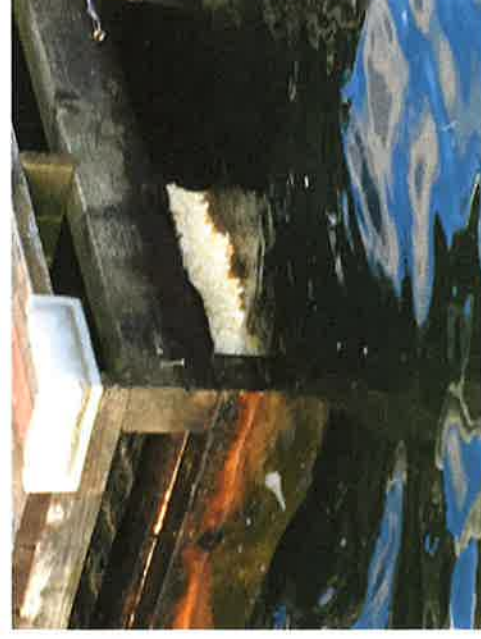
Note: Lower right picture – Dock float is supported by old technology white styrofoam. This styrofoam will eventually become water logged and provide less buoyancy pulling the float deeper into the water. (photo taken from public waterway July 27, 2019)
