Bay Rd Intersection Traffic Study –Valley View Rd

10/11/2022

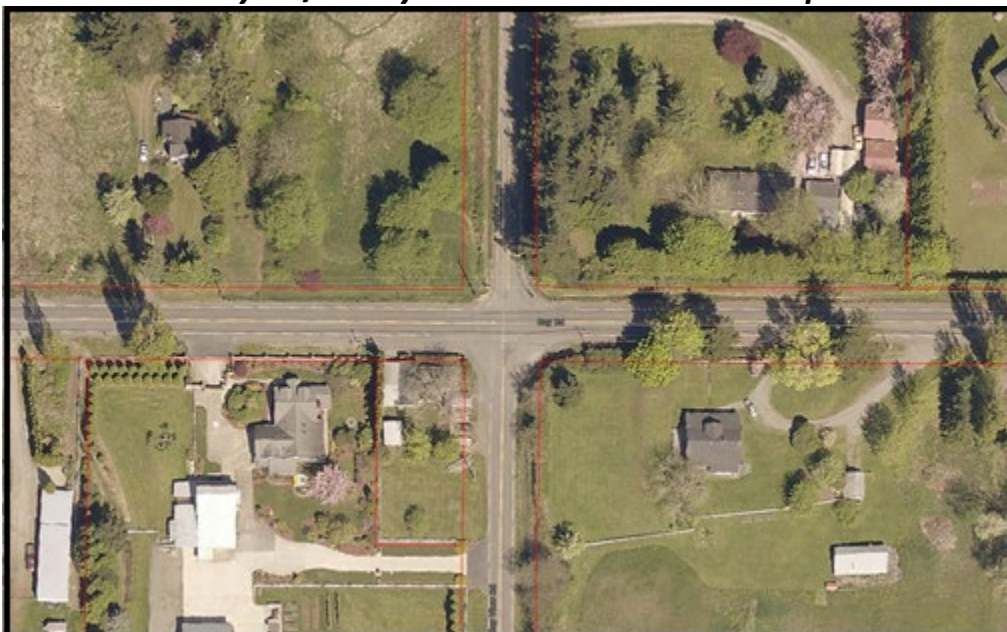
Bay Rd/Valley View Rd Intersection Map

Collision history, along with interest from concerned citizens of Whatcom County, are the basis for this study. This study will cover the intersection of Bay Rd (MP 4.25) and Valley View Rd (MP 1.01).
