**JOINT RESOLUTION OF THE BELLINGHAM CITY COUNCIL AND THE WHATCOM  
COUNTY COUNCIL ADOPTING THE LAKE WHATCOM WATERSHED FOREST  
MANAGEMENT PLAN**

The purpose of the Lake Whatcom Forest Management Plan is to provide an actionable document that guides management activities and provides recommendations for the long-term management of County and City-owned forestlands within the Lake Whatcom watershed. Implementing the recommendations in this plan is a separate process which will be undertaken by City and County work planning efforts respectively.

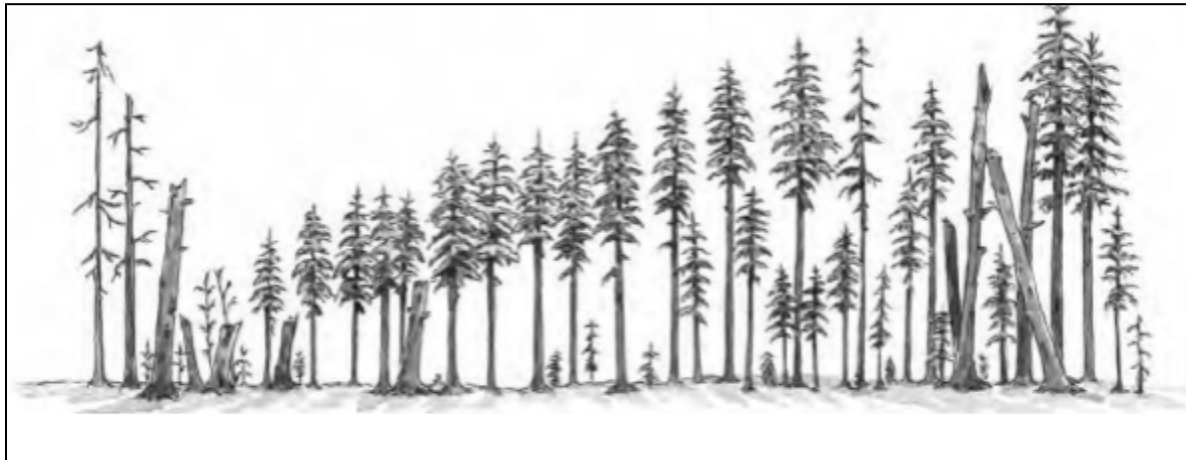
## Simple Model of Forest Development Following Stand-Replacing Wildfire

All forests begin their development from an initial disturbance event which heavily modifies the existing forest or outright replaces it, known as a stand-replacing event. Frequently the disturbance will leave behind components of the old forest — surviving older trees or large snags — known as legacy structures.

Localized disturbance agents continue creating gaps in the previously uniform overstory canopy, which over time results in a more diverse mosaic of stand conditions and the development of late-seral habitat characteristics. As members of the original cohort of trees begin to die, they create large-diameter standing snags and woody debris on the forest floor, and are eventually replaced by vigorous midstory trees. Over time, the initial pioneer tree cohort will give way to a mixture of species, including shade-tolerant trees that can regenerate underneath the shade of their canopies. The forest settles into a dynamic equilibrium until interrupted by another stand-replacing disturbance, and the process repeats.

Forest development is not always a clear linear path as described above, and development pathways may vary considerably by disturbance regime. As an example, a windstorm typically removes only the overstory, enabling more shade-tolerant trees in midstory and understory positions to quickly succeed into upper canopy positions. Conversely, because wildfire can disturb a combination of soil, understory vegetation, seedlings, and mid-canopy trees, but often spares the largest trees with the thickest bark, most post-wildfire regeneration comes from the seeds of these surviving trees. Sometimes the disturbance event is only partially stand-replacing and the new cohort of trees must grow up underneath an existing canopy.
