## SECTION 2.1. HAZARD SUMMARIES

## EARTHQUAKES

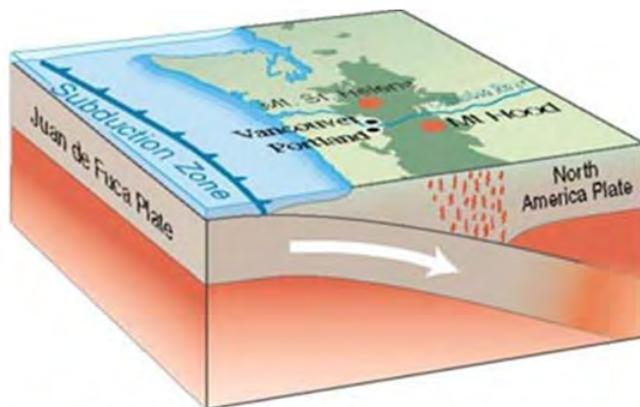
The Juan de Fuca Plate is an ocean tectonic plate that is colliding with the North American Continental Plate near the western coast of Washington State in a subduction zone called the Cascadia Subduction Zone (CSZ). The CSZ is shown in Figure 1. The CSZ extends from southern B.C. to northern California. One of the results of the colliding forces at the CSZ is the uplift that is occurring and is forming the Olympic and Cascade Mountain Range. The convergence of these two plates also creates a more immediate concern: earthquakes. Subduction zone earthquakes can be powerful and sustained for greater lengths of time than other types of earthquakes.

Figure 1 Courtesy of USGS Earthquake Hazards Program.

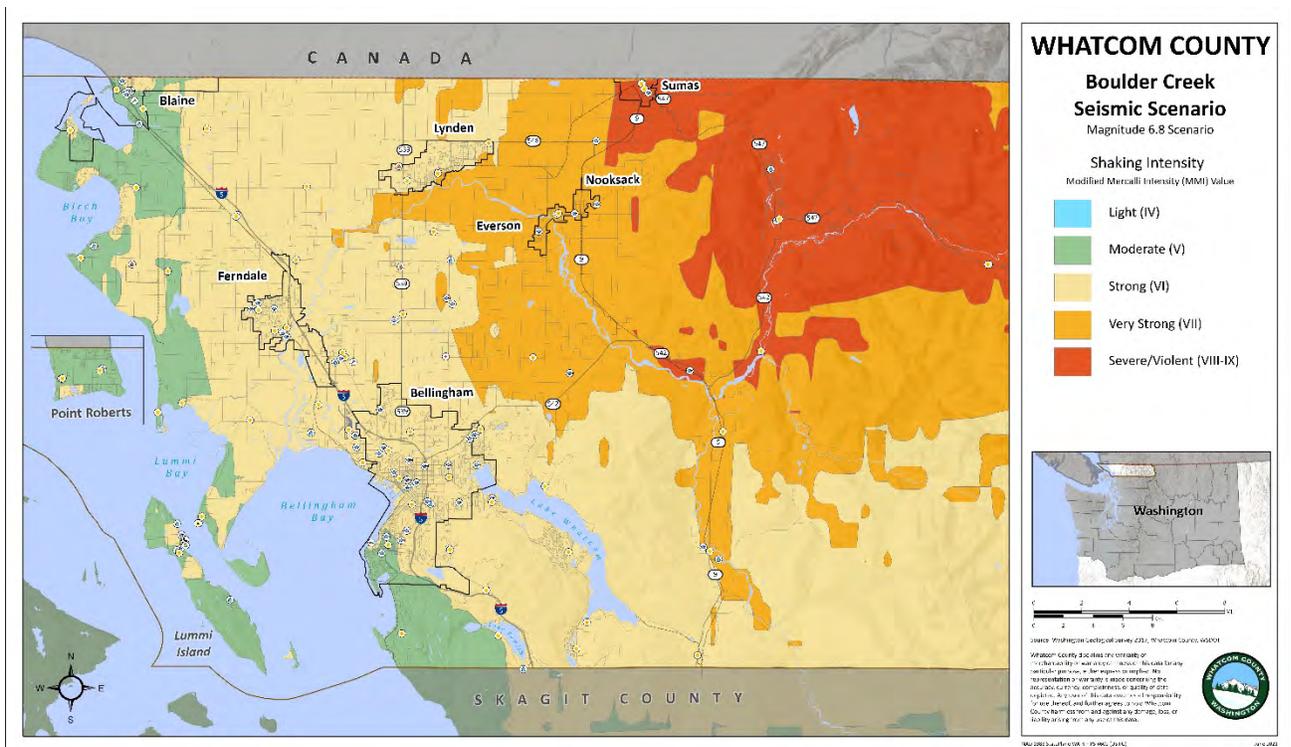
Washington Department of Natural Resources (WA DNR) 2017 Boulder Creek Fault Zone seismic scenario of magnitude 6.8 data. Displays extent and severity of the modeled earthquake in the Modified Mercalli Intensity (MMI) scale. According to the MMI Scale:

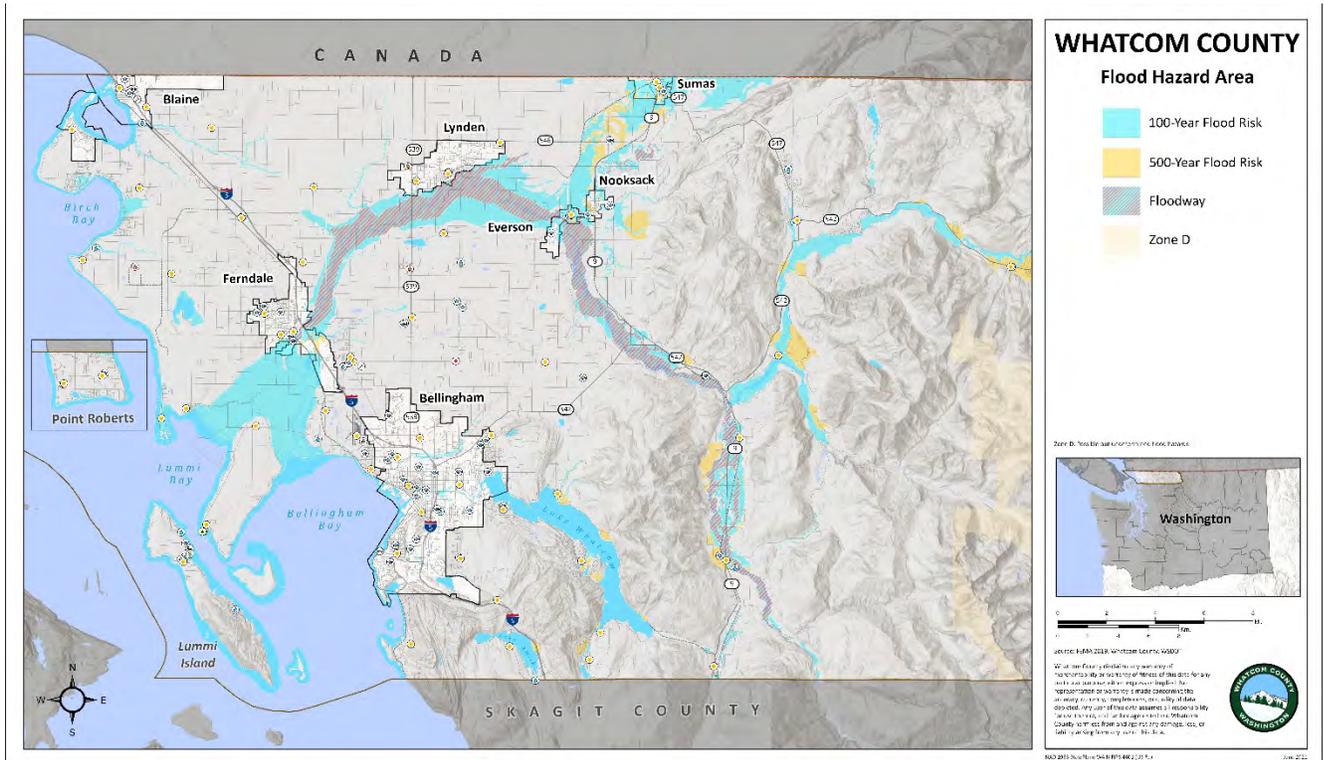
*FEMA 2019 flood hazard data showing 100-year flooding, 500-year flooding, floodways, and flood zones. FEMA flood data includes both riverine and coastal flooding.*

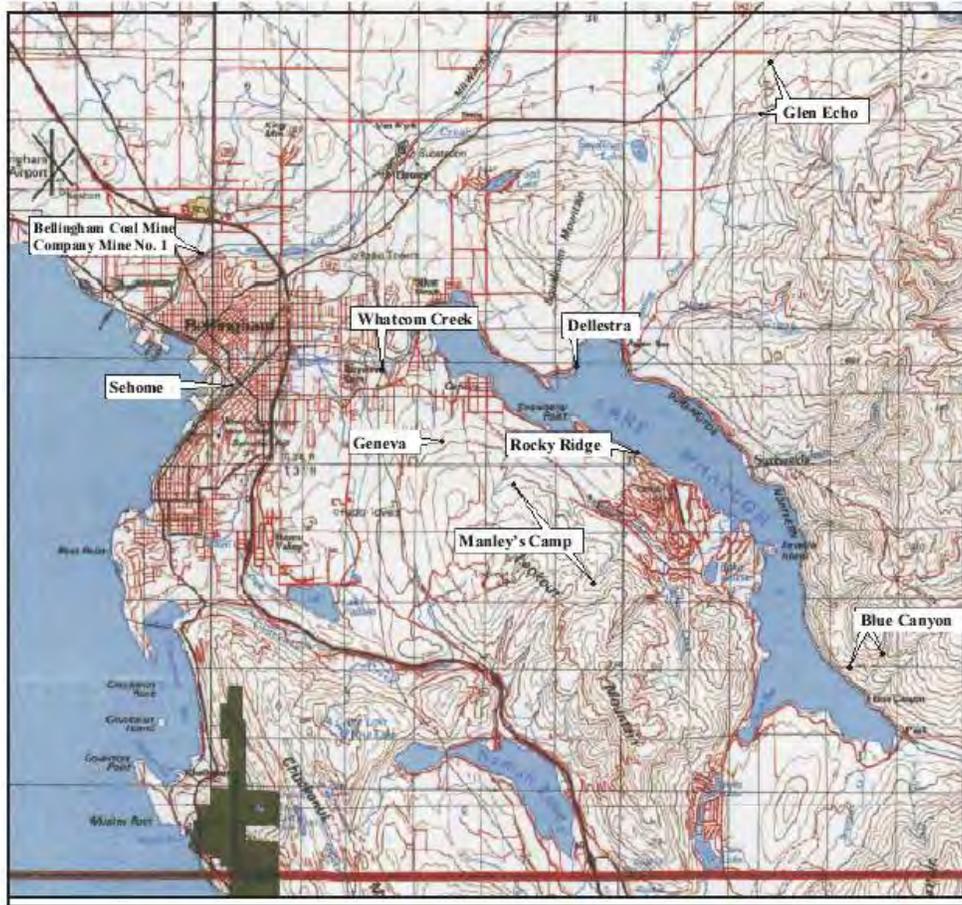
Figure 2 shows the Bellingham area's historic mine locations.

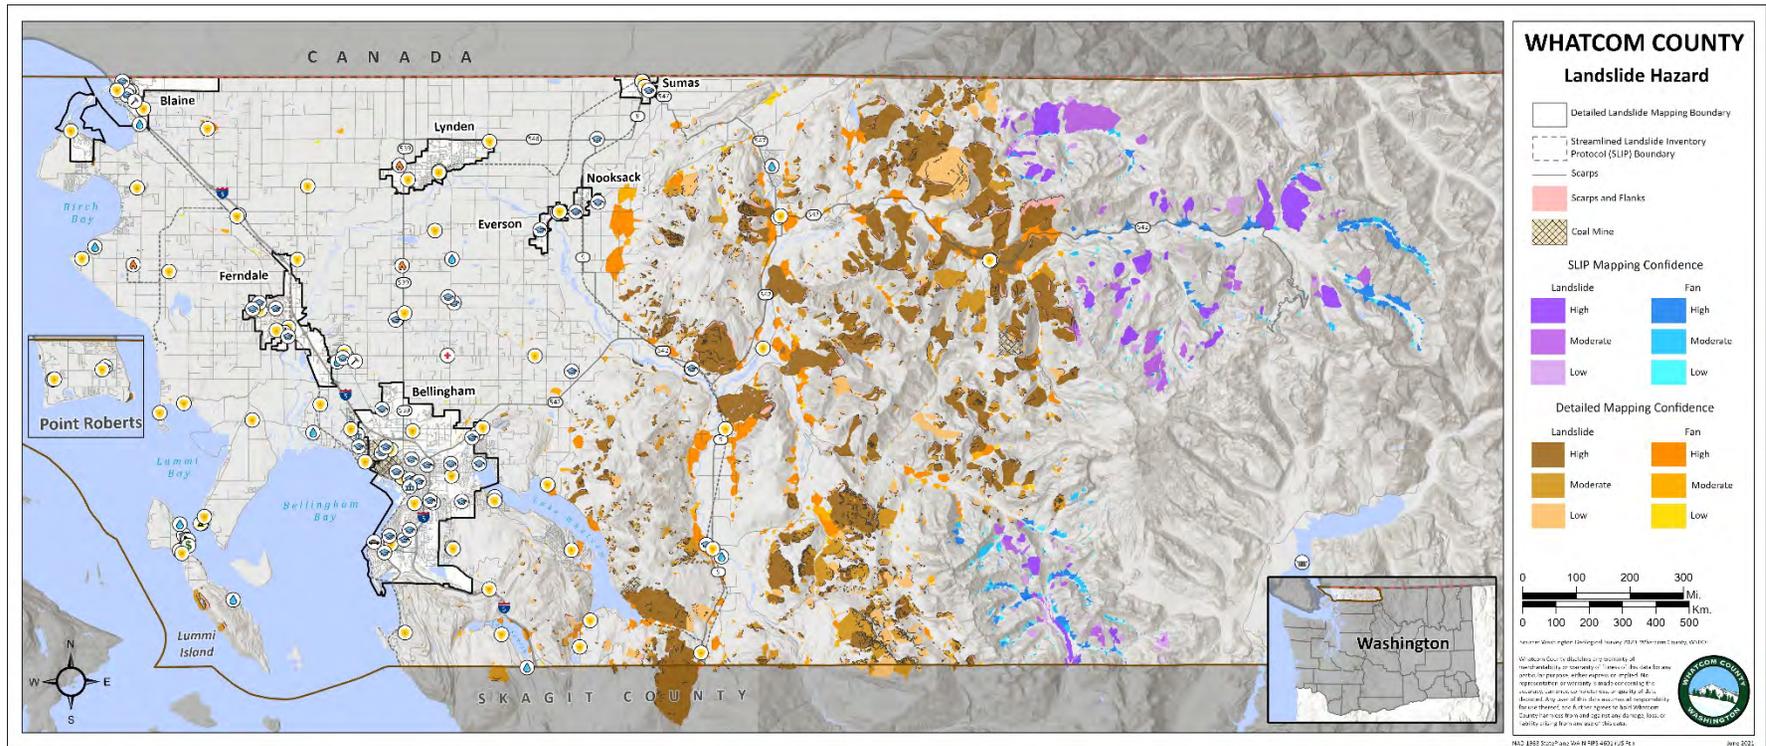
Washington Geological Survey (WGS) 2020 Washington landslide inventory data compiled following streamline landslide mapping protocol (SLIP). SLIP was developed by the WGS’s Landslide Hazards Program to help geologists rapidly map landslide landforms from lidar. This data shows both detailed mapping and SLIP landslide data. Landslides and alluvial fans are most prevalent in the Cascade foothills of eastern Whatcom County, on Lummi Island, and the southern end of Lake Whatcom. Coal mine areas, also shown on the map, are present in northwest Bellingham and south of Glacier.

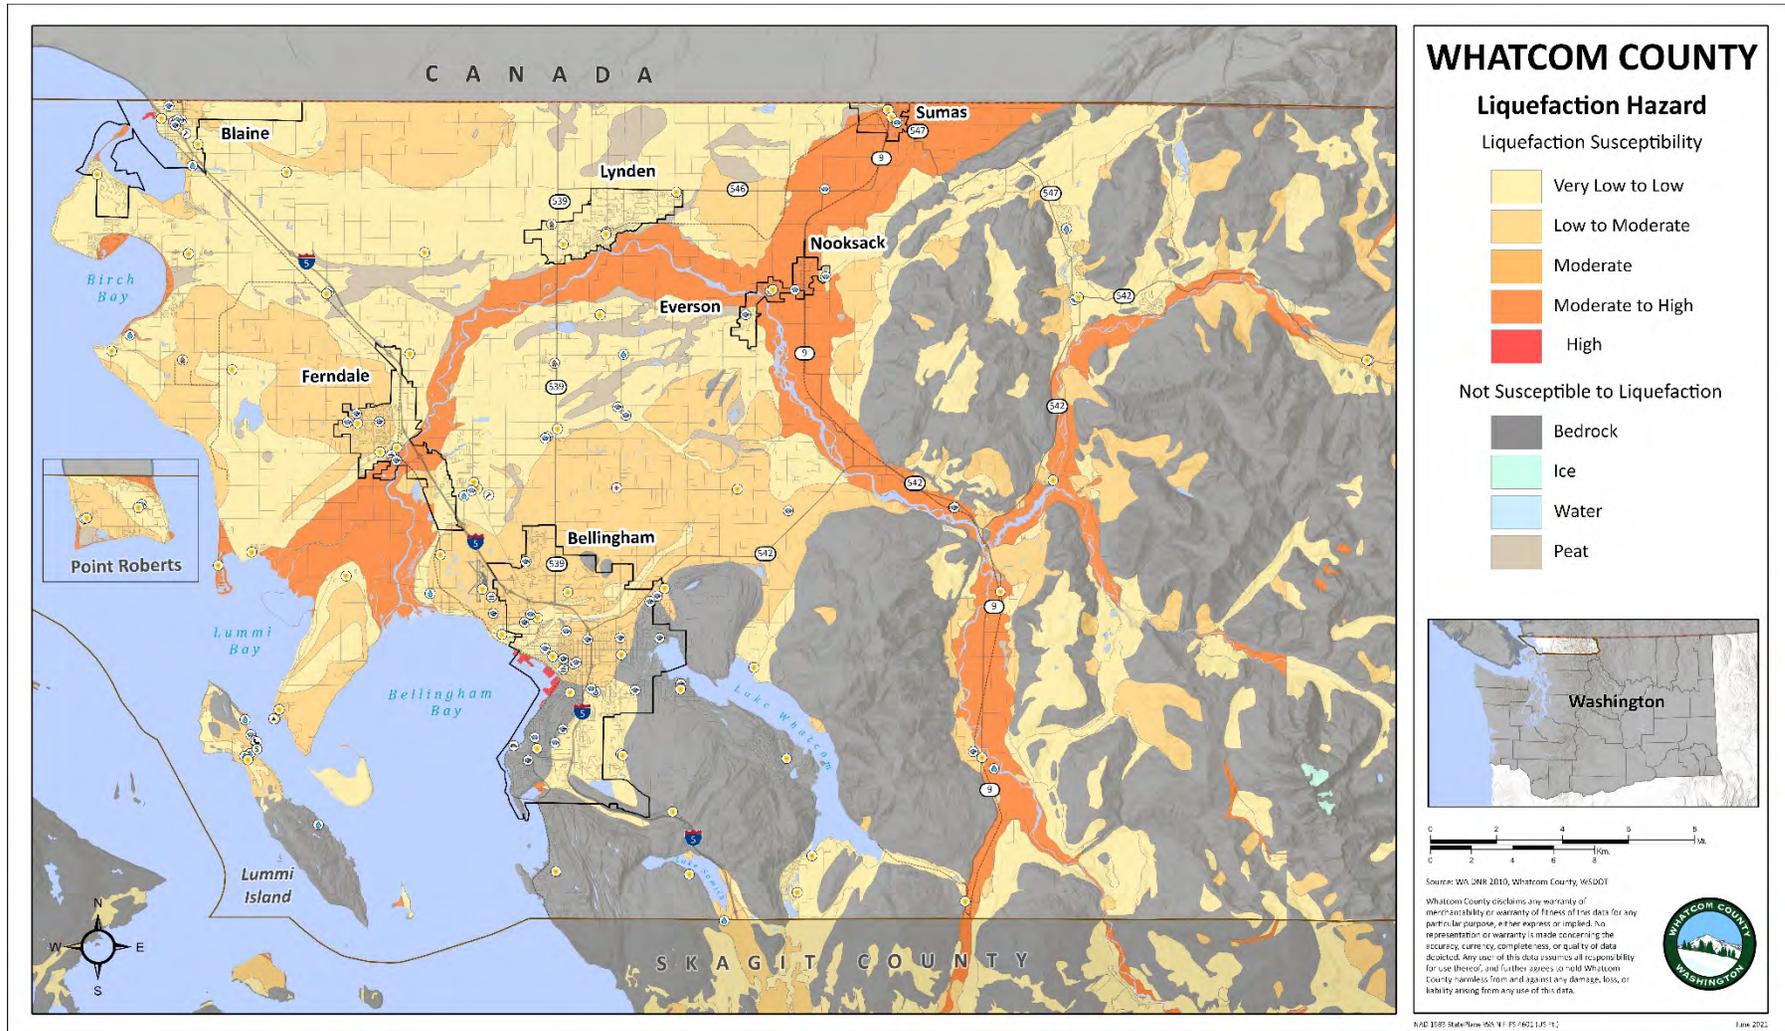
Washington Department of Natural Resources (WA DNR) 2010 liquefaction susceptibility data. This feature class is part of a geodatabase that contains statewide ground response data for Washington State.

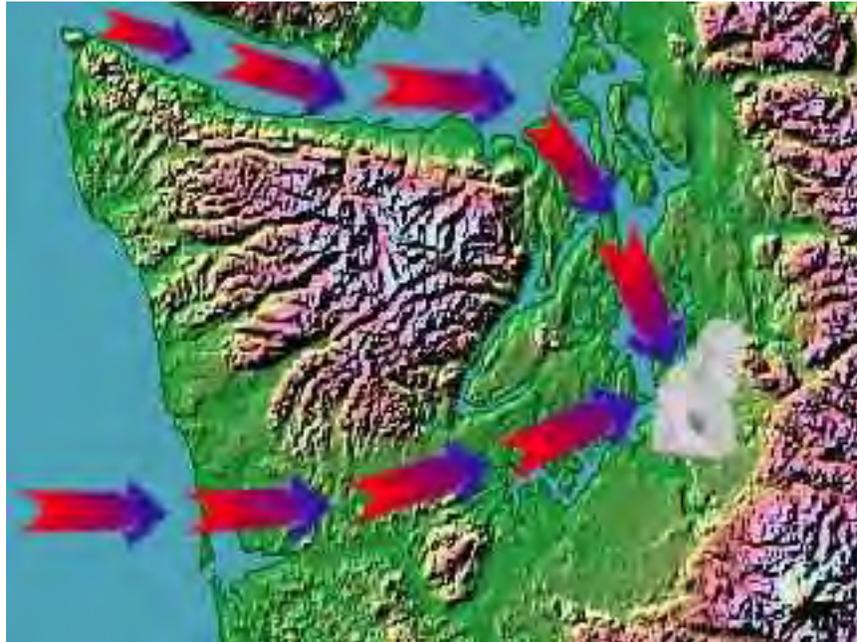
Westerly winds in Washington figure courtesy of <http://www.islandnet.com>

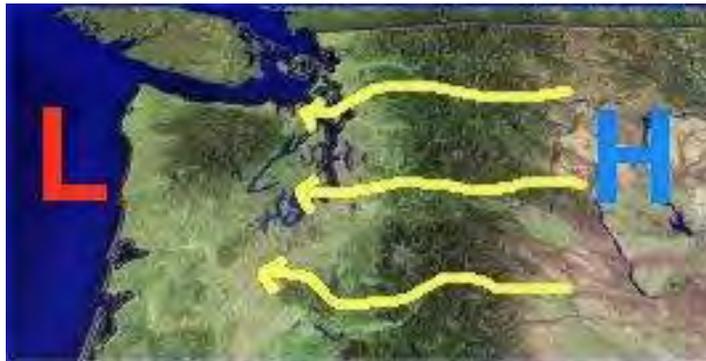
Easterly winds are caused by high pressure systems in eastern Washington, causing strong winds to form west of the Cascade mountain range that occur in late summer and early fall.

Easterly winds in Washington figure courtesy of <http://www.pep-c.org>

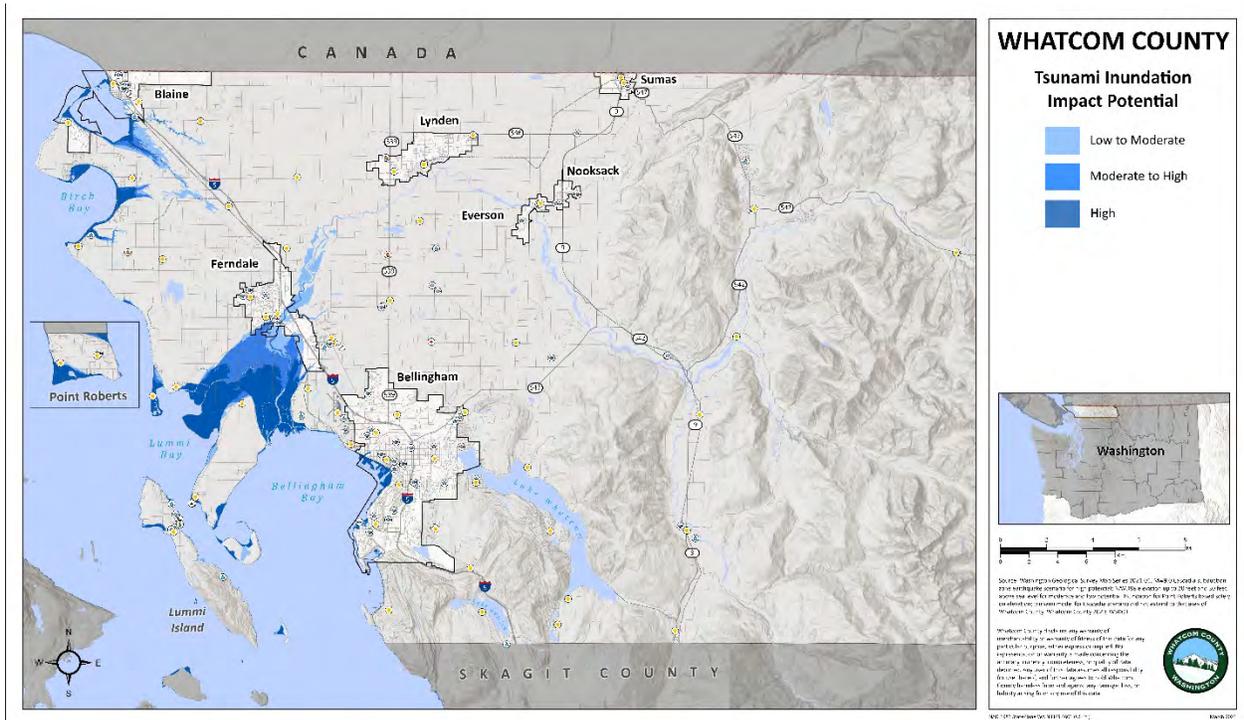
Map of Whatcom County tsunami inundation impact potential. The high impact potential zone is based upon Washington Geological Survey Map Series 2021-01, Mw9.0 Cascadia subduction zone earthquake scenario occurring at mean high tide. The moderate to high and the low to moderate impact potential areas are based upon elevation of up to 20 feet and 30 feet, respectively, above mean sea level (NAVD88). Inundation for Point Roberts is based solely on elevation; tsunami model for the Cascadia subduction zone scenario did not extend to Point Roberts.

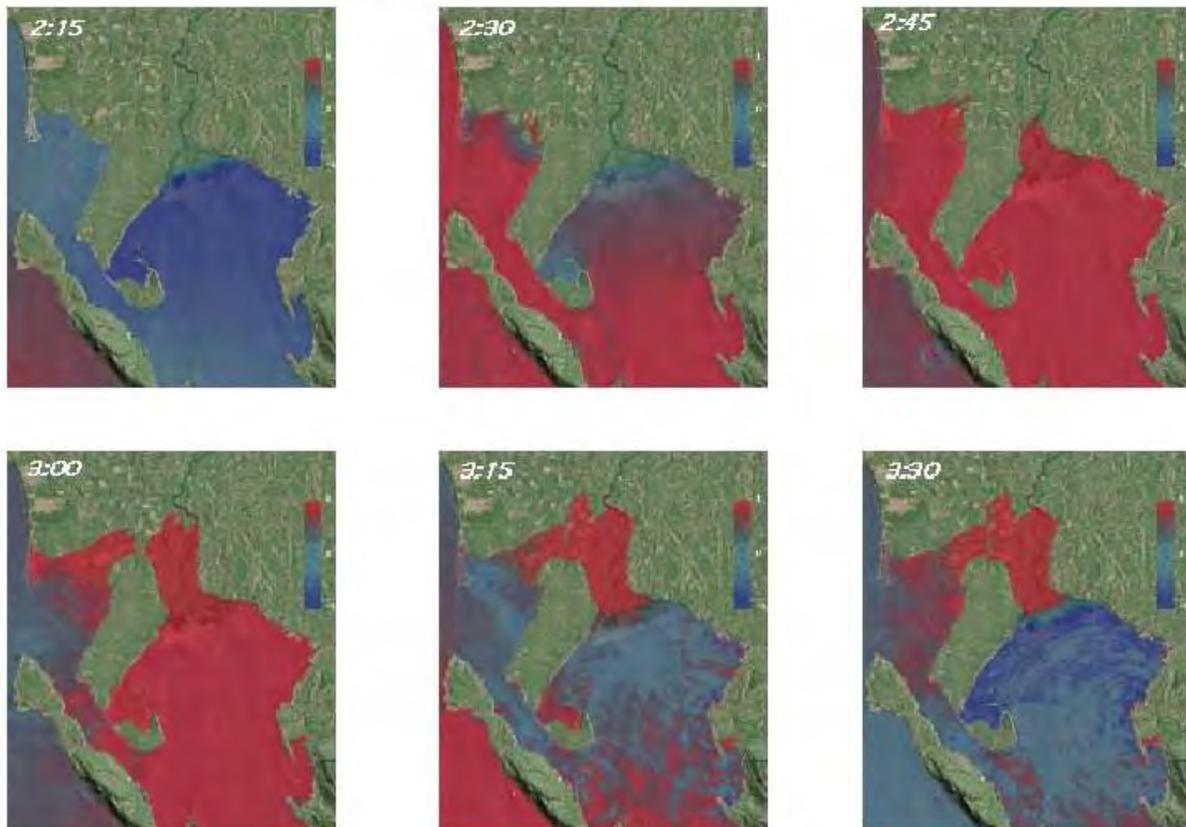
Tide gauge records at five locations in the bay show fluctuations of water surface elevation and also the time history of the waves. The initial water disturbance is a trough of about 1 meter at 2 hours after the earthquake followed by a crest at between 2.5 and 3 hours after the earthquake. At around 4 hours after the earthquake, a deeper trough occurs and reaches about 3 meters near the Port of Bellingham. A trough this large, if it occurred at low tide, could cause a significant grounding hazard for ships in the harbor. This is visually displayed in Figure 3, which shows an animation of the tsunami troughs and crests in and around Bellingham Bay.

Figure 3 – Screen shots of animation of a tsunami arriving in Bellingham area, lasting about 3:30 hours. Red areas are crests, blue are troughs. (Picture obtained from the NOAA T.I.M.E. Center)

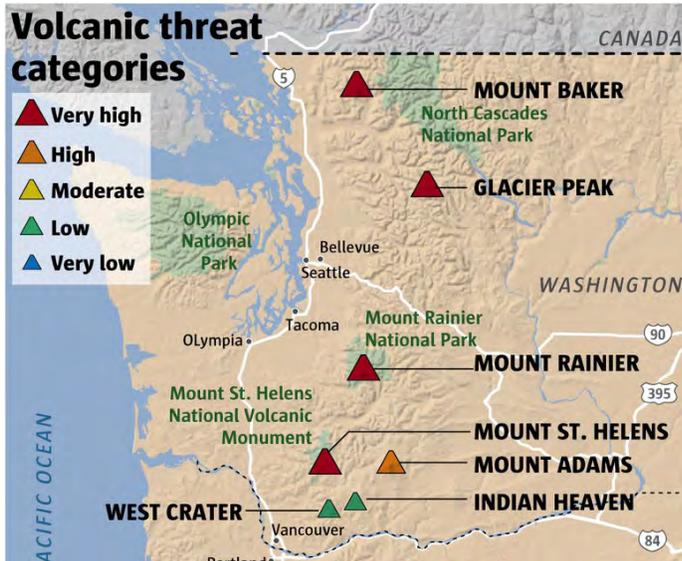
Figure 4. Washington Volcanoes and threat showing Mt. Baker as a major volcanic threat in Whatcom County. (Source: ESRI, USGS; created by Mark Nowlin/Seattle Times)

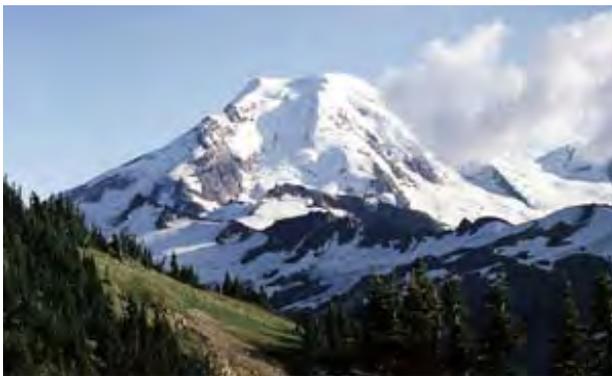
Photo of Mt. Baker in Whatcom County

Mount Baker, seen to the left, (3,285 meters; 10,778 feet) is an ice-clad volcano in the North Cascades of Washington State about 50 kilometers (31 miles) due east of the city of Bellingham. After Mount Rainier, it is the most heavily glaciated of the Cascades volcanoes: the volume of snow and ice on Mount Baker (about 1.8 cubic kilometers; 0.43 cubic miles) is greater than that of all the

other Cascades volcanoes (except Rainier) combined. Isolated ridges of lava and hydrothermally altered rock, especially in the area of Sherman Crater, are exposed between glaciers on the upper flanks of the volcano; the lower flanks are steep and heavily vegetated. The volcano rests on a foundation of non-volcanic rocks in a region that is largely non-volcanic in origin.

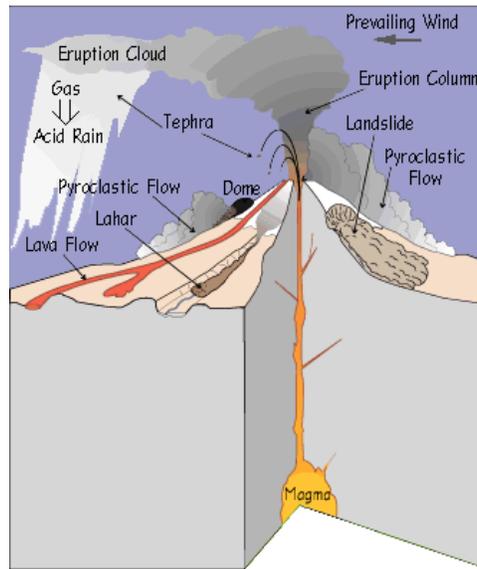
**Figure 5 – Effects of a Volcano Eruption**  
(Diagram courtesy of USGS Cascade Volcano Observatory)

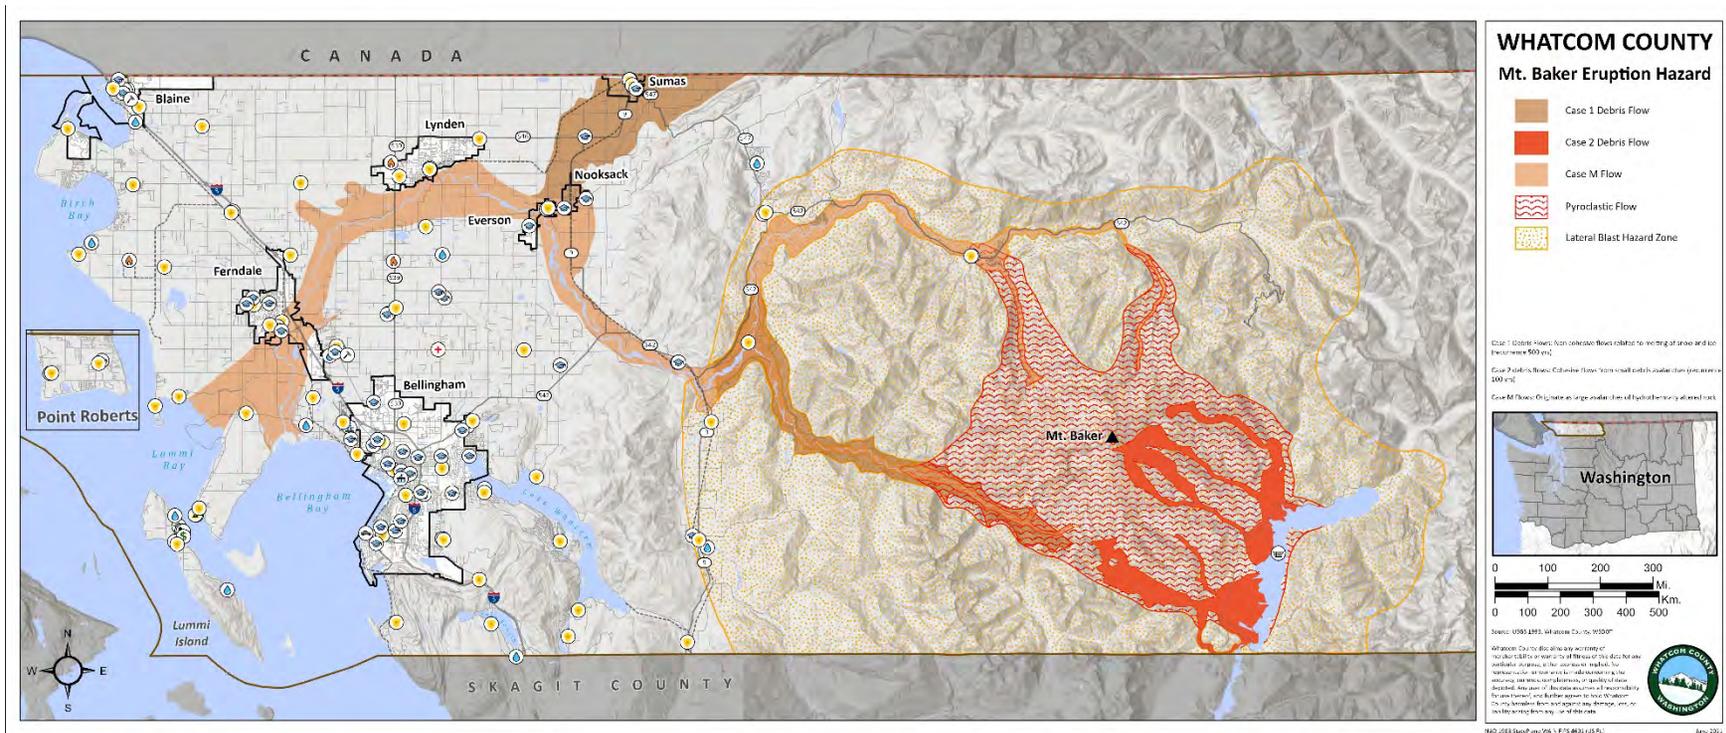
Hazards from Future Activity of Mount Baker, WA (1995) data shows different volcanic flows. Case M flows originate as large avalanches of hydrothermally altered rock. Case 1 debris flows are non-cohesive flows related to melting of snow and ice, with a recurrence of 500 years. Case 2 debris flows are cohesive flows from small debris avalanches, with a recurrence of 100 years.

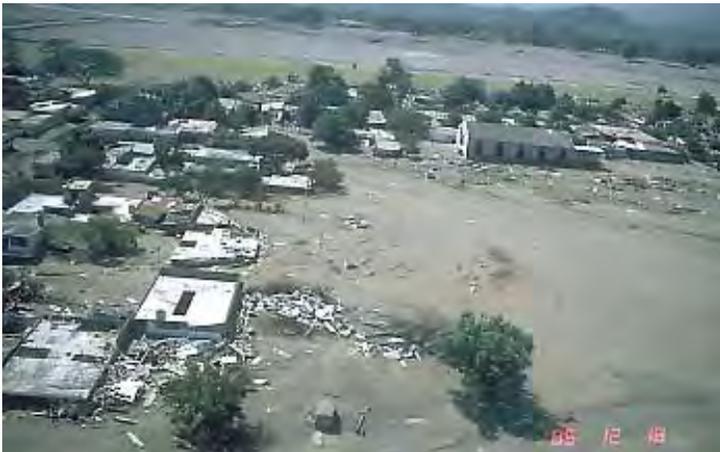
*Photo of a lahar and damaged buildings.*

Lahars flowing down and flooding the Nooksack, Baker, and Skagit Rivers may provide very little warning for evacuation to nearby populations. The potential destruction of a town is shown in the image above. Earthquakes accompanying an eruption may cause bridge or road damage and trigger landslides. Fine ash fall, even if only an inch thick, may make asphalt road surfaces slippery, causing traffic congestion on steep slopes or

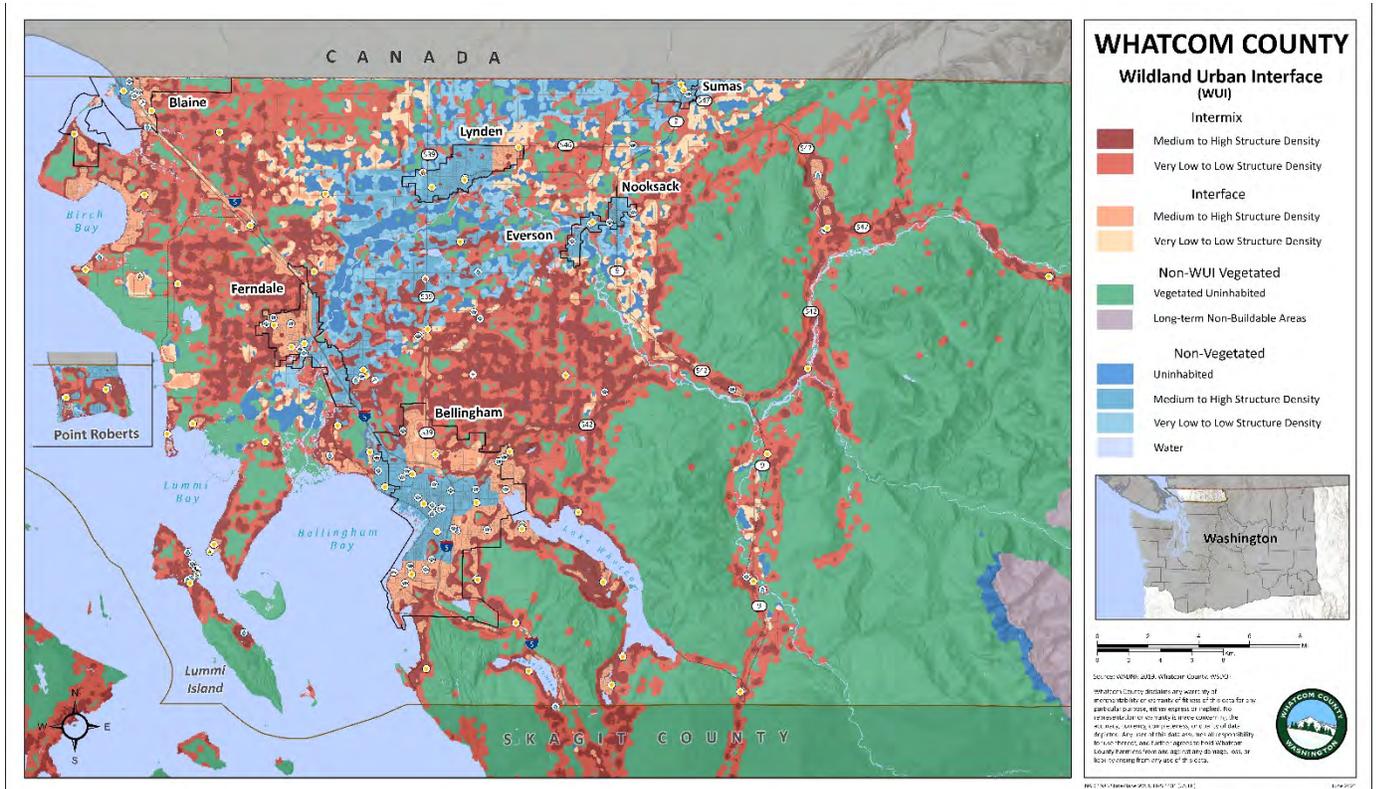
Washington Department of Natural Resources (WA DNR) 2019 mapped data of Washington's Wildland Urban Interface (WUI). The WUI displays areas of WA where structures and wildland overlap with specific structure densities.

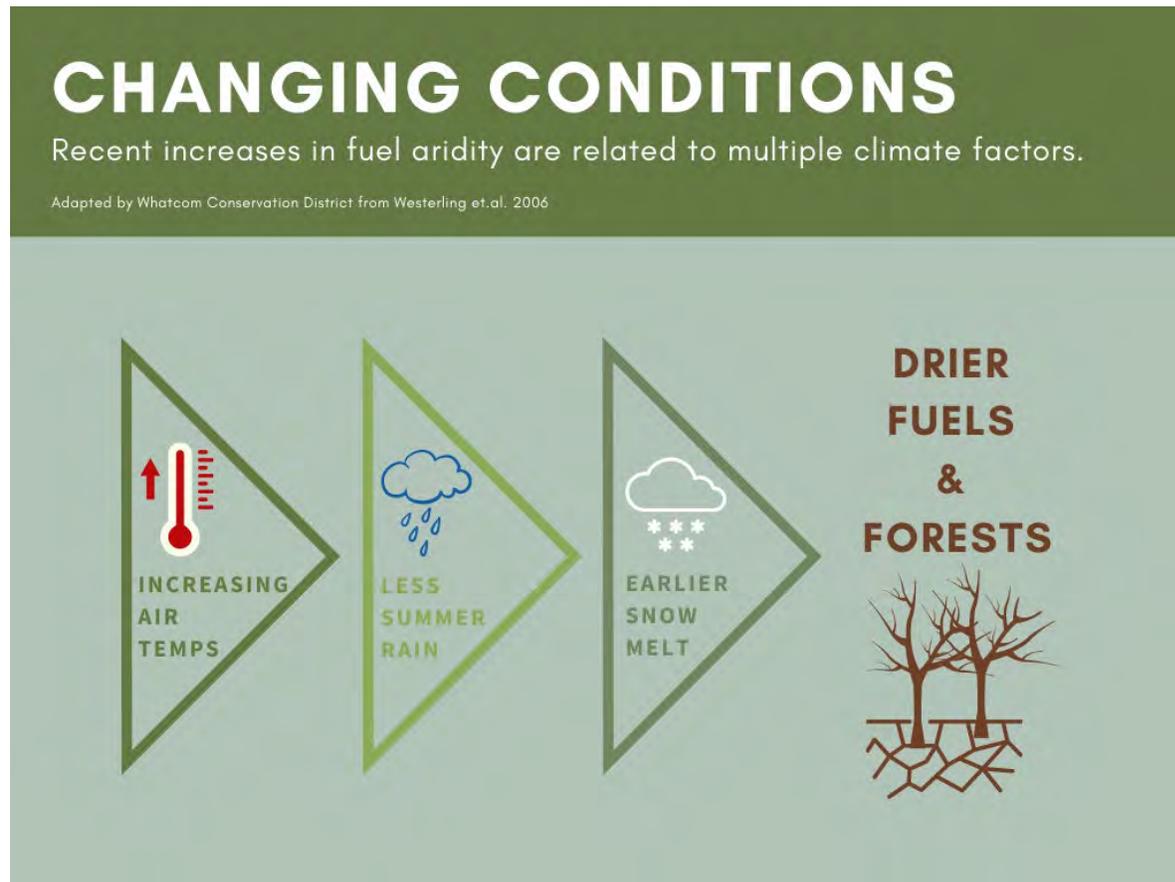
Changing weather patterns are creating conditions that leave western Washington’s environment more conducive to wildfire. Figure 6 is a graphic showing these condition changes. Increasing temperatures, less rain falling in the summer, and earlier snow melt are resulting in drier fuels and forests in our area. Drought conditions lead to dry and dead fuels which mean our forests are becoming increasingly more flammable and homes in the wildland-urban areas are more at risk.

*Figure 6 showing how changing yearly weather conditions leads to an increased risk of fire.*

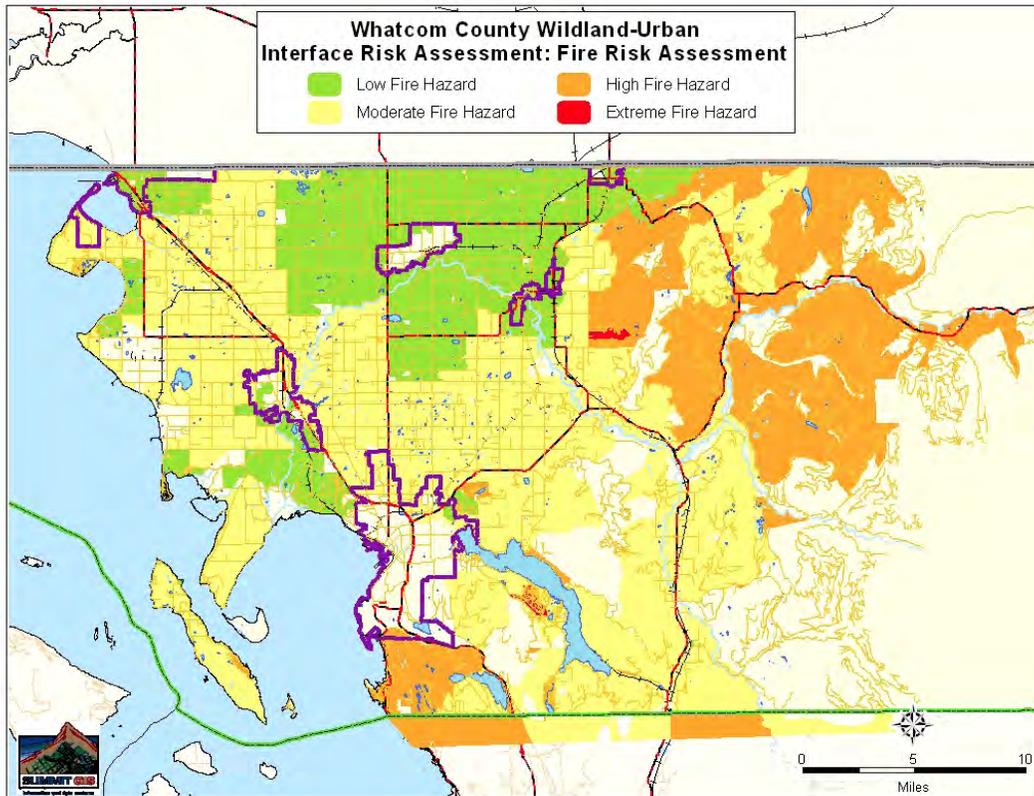
Figure 7. Interface Risk Assessment- Fire Risk Assessment map shows areas of the county at most risk of wildfire,

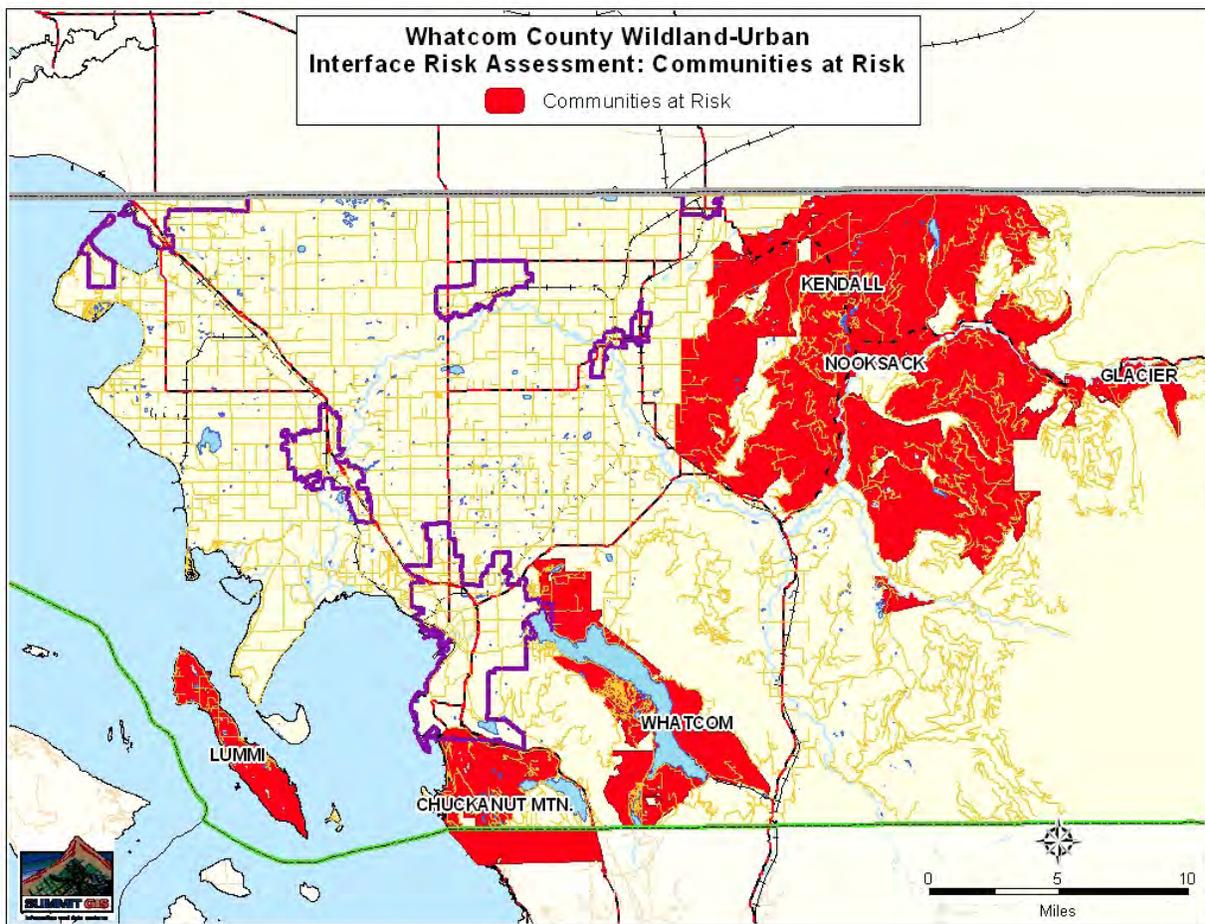
Figure 8. Interface Risk Assessment- Communities at Risk map shows communities most at risk of fire, including Lummi Island, communities around Lake Whatcom and in the Chuckanut Mountains, and the Kendall, Nooksack, and Glacier communities in east Whatcom County.
