Resolution amending the 2006 Birch Bay Comprehensive Stormwater Plan to include four Subwatershed Master Plans (Council acting as the Whatcom County Flood Control Zone District Board of Supervisors)

# BIRCH BAY

## COMPREHENSIVE STORMWATER PLAN

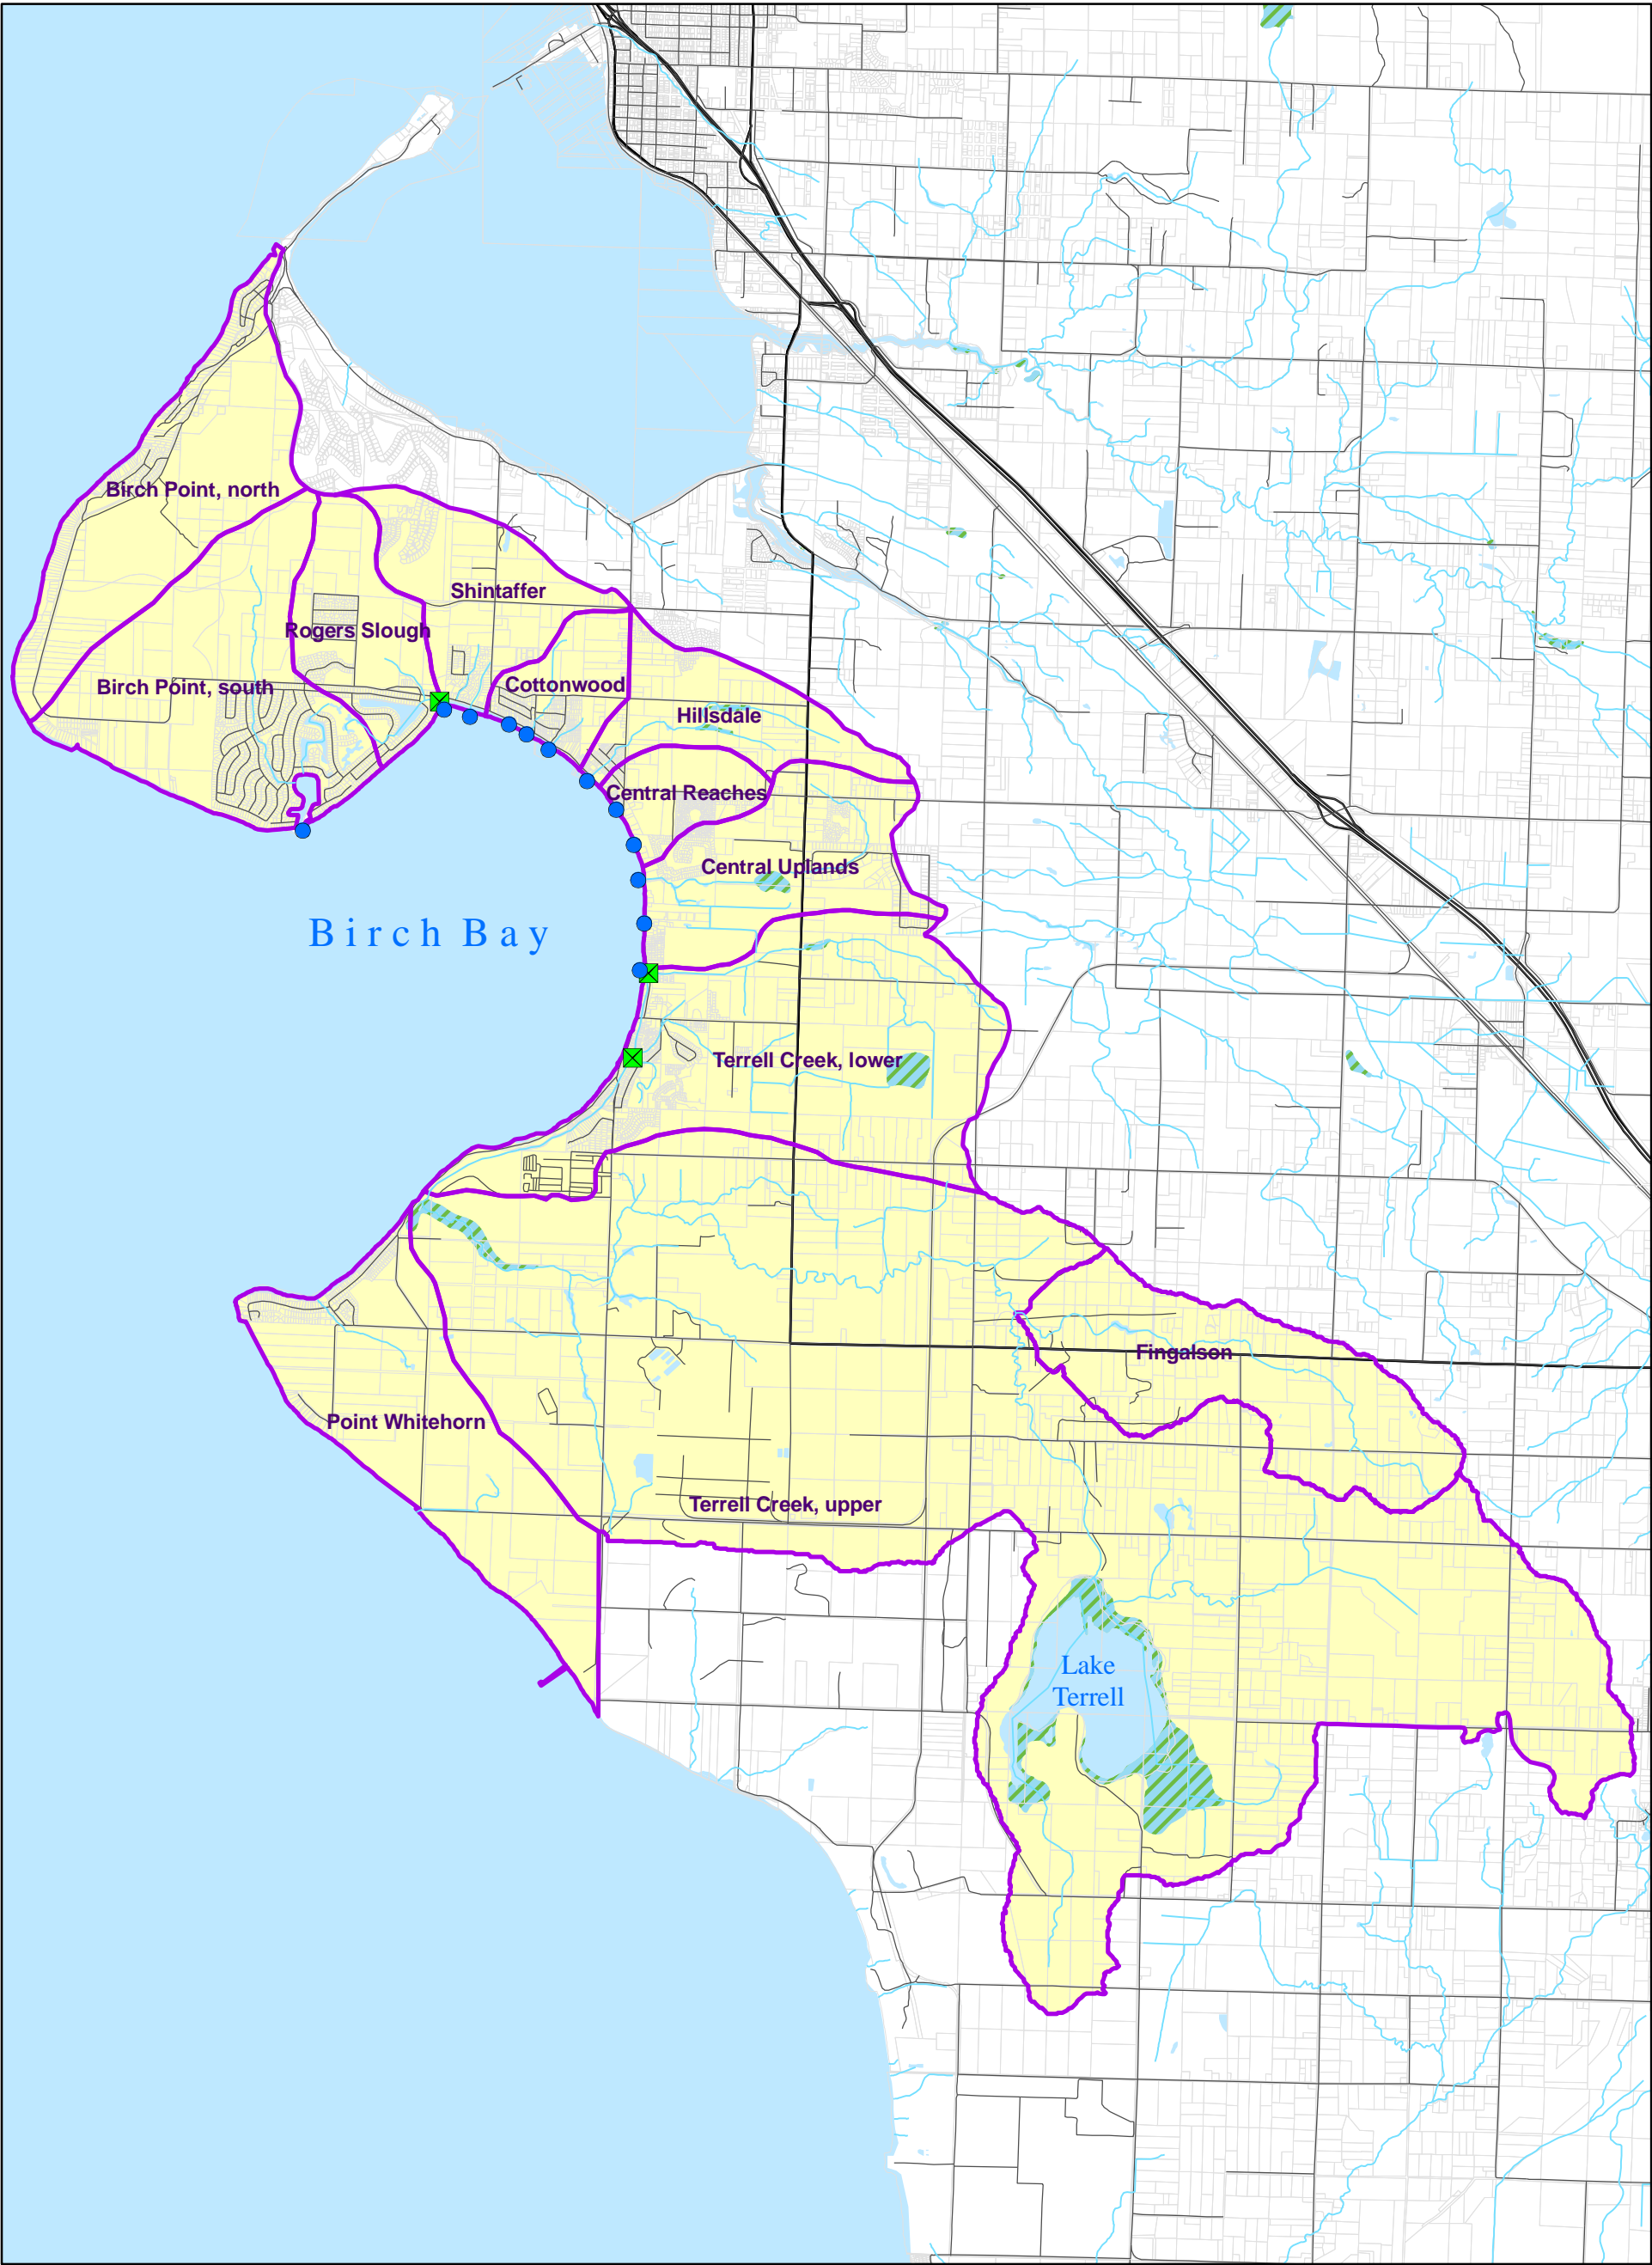
TABLE 3-1. BIRCH BAY WATERSHED DRAINAGE SUB-BASINS

- Major Outfall or Outlet
- Tide Gate
- Stream
- Drainage Subbasin
- Watershed

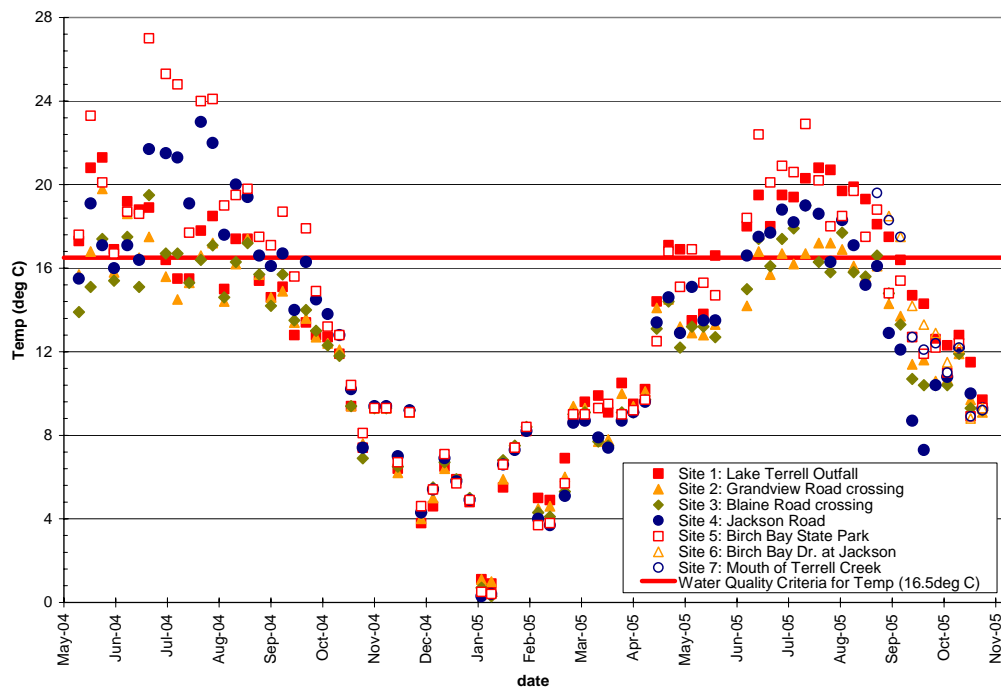
FIGURE 3-2. TEMPERATURE DATA FROM SITES ALONG TERRELL CREEK FROM MAY 2004 THROUGH NOVEMBER 2005

Note: Data in Figures 3-2 and 3-3 received from Nooksack Salmon Enhancement Association via personal communication on 11/4/05.

Weekly temperature data from May 2004 through November 2004 are shown in Figure 3-2 for the seven sites in Terrell Creek. The water quality criterion for temperature of 16.5°C is also shown. Most of the data taken between the months of June and October exceeded the criterion. A similar pattern is evident for dissolved oxygen as well, with most samples reading below the criterion of 9.5 mg/L for the months of June through November (Figure 3-3).

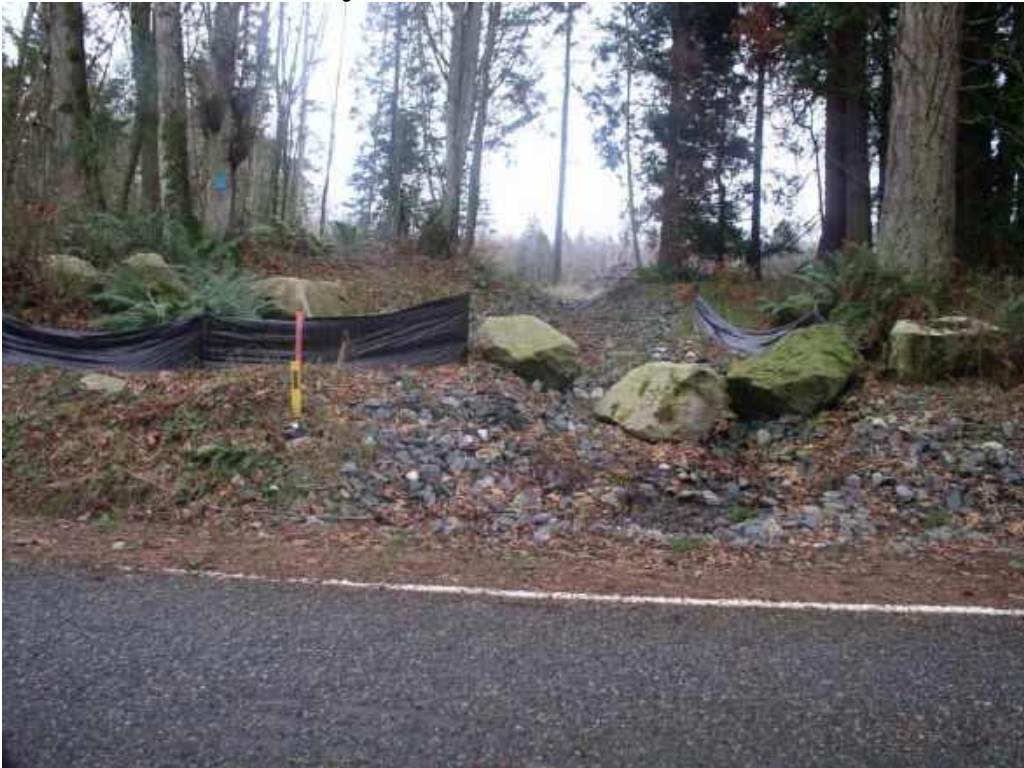
**FIGURE 1**  
Channelized Stormwater Flow along Semiahmoo Drive in Birch Point Area

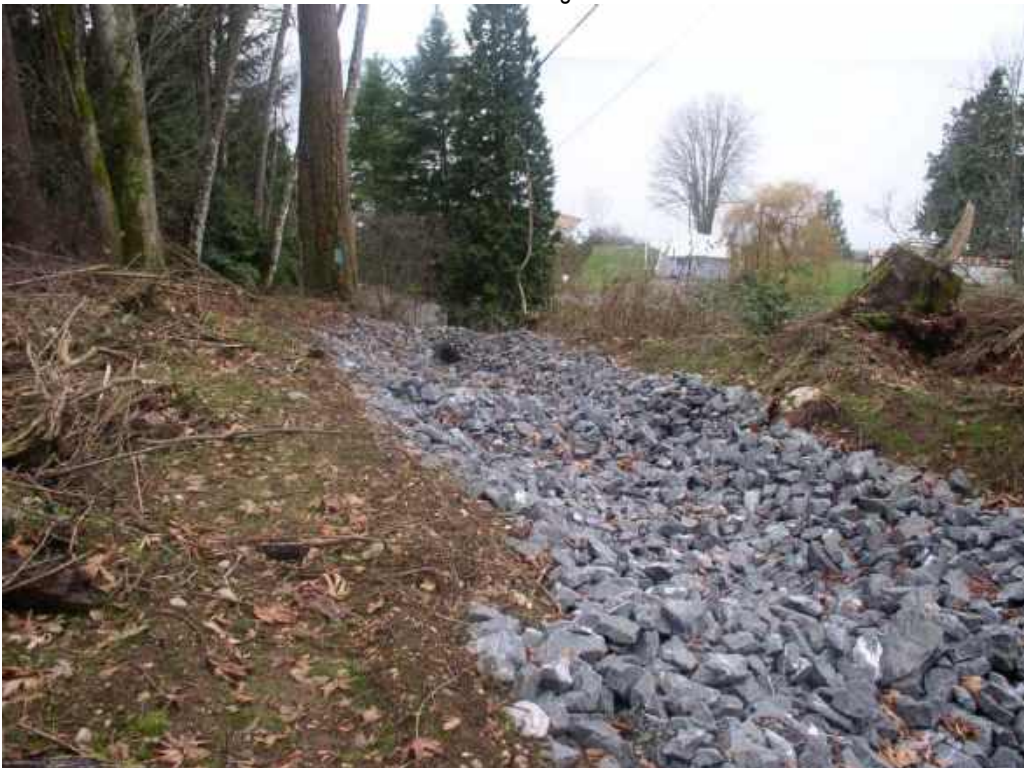
**FIGURE 2**  
Modifications made to Channelized Stormwater Flow along Semiahmoo Drive in Birch Point Area

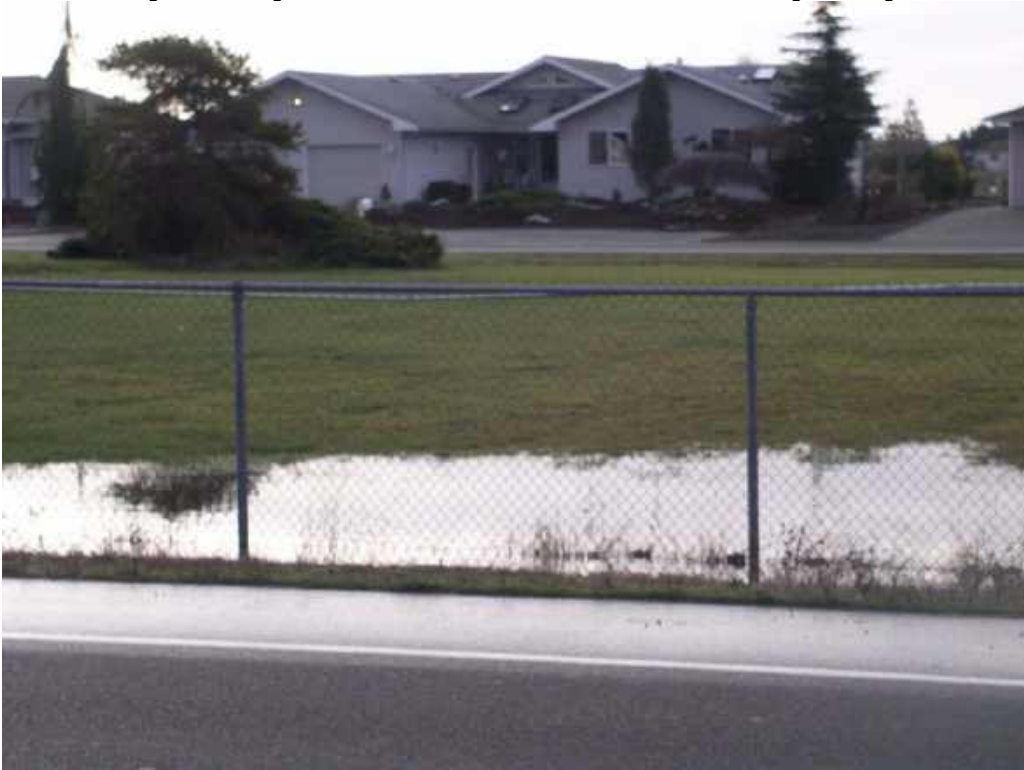
**FIGURE 3**

Flooded drainage ditch along the south side of Birch Point Road to the west of Rogers Slough

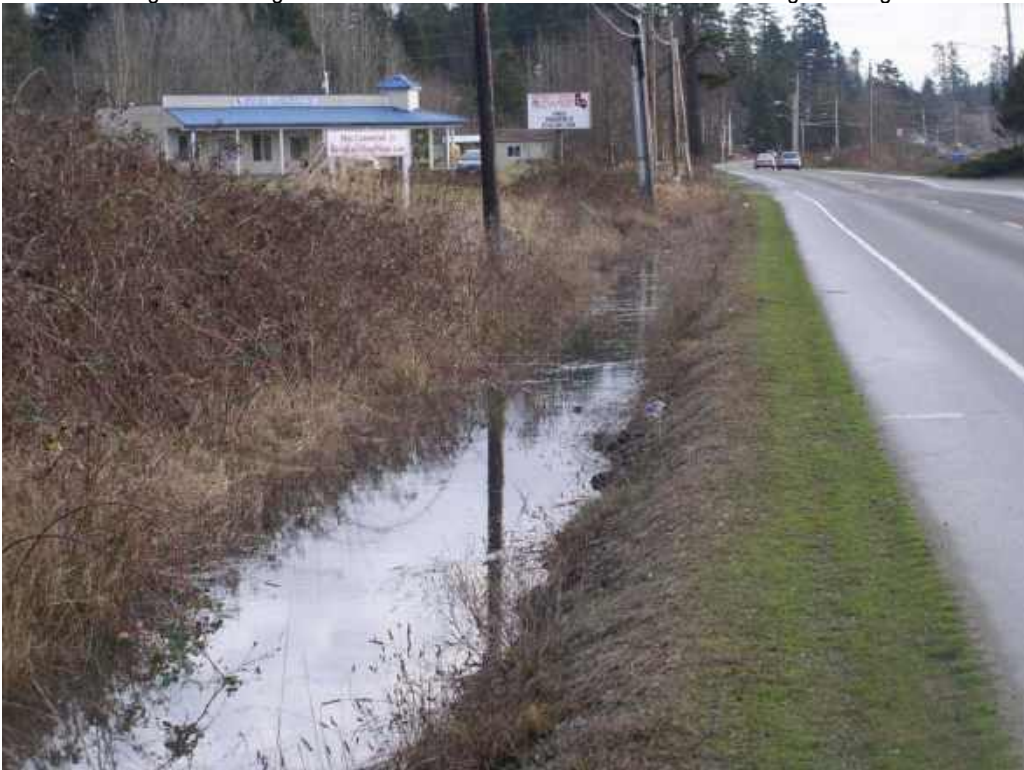
**FIGURE 4**

Flooded drainage ditch along the north side of Birch Point Road to the west of Rogers Slough

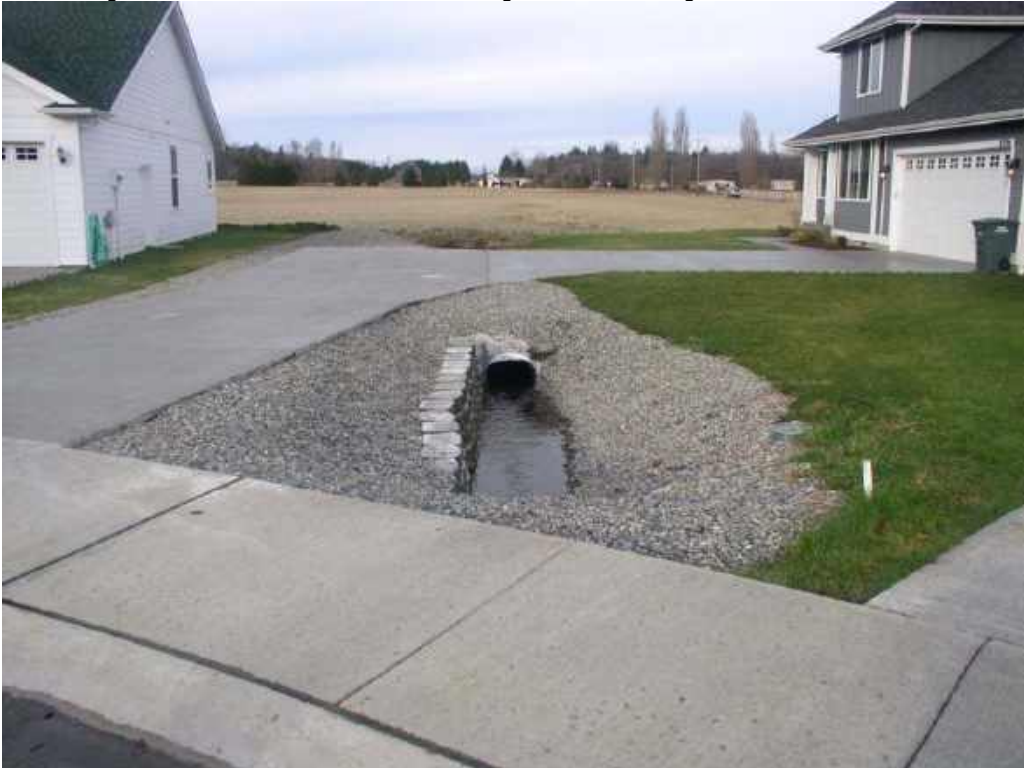
**FIGURE 5**

The drainage channel downstream of the two 90-degree bends entering the Richmond Park Subdivision, looking north

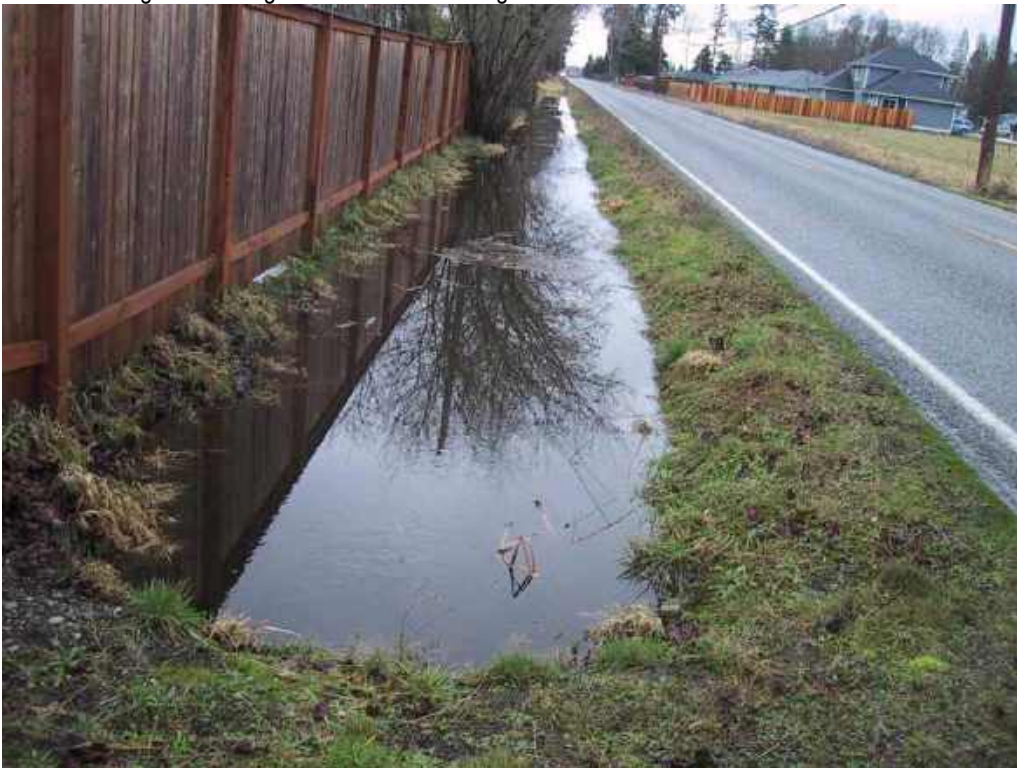
**FIGURE 6**

The full drainage ditch along Shintaffer Drive looking south

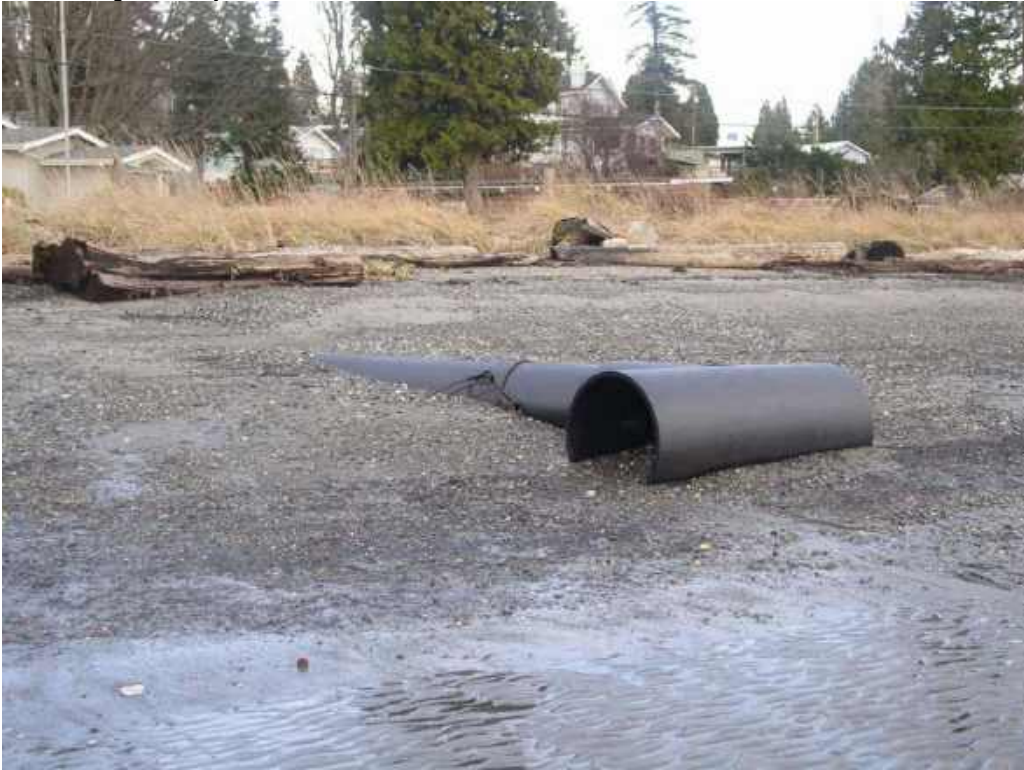
**FIGURE 7**

Outfall along Birch Bay Drive near Cedar

When the outfall pipe(s) are clogged or otherwise blocked or under extreme high tide conditions, the hydraulic head builds up and may create a backwater condition in the closed-pipe system. Figure 7 shows the hammerhead-type outlet structure of the northern outfall, and Figure 8 shows flooding that has occurred in the area. According to local residents, the lack of regular maintenance may lead to periodic flooding emergencies throughout Birch Bay. In both the January 2006 cases, the outfall had been obstructed by accumulated material that contributed to the drainage issues.

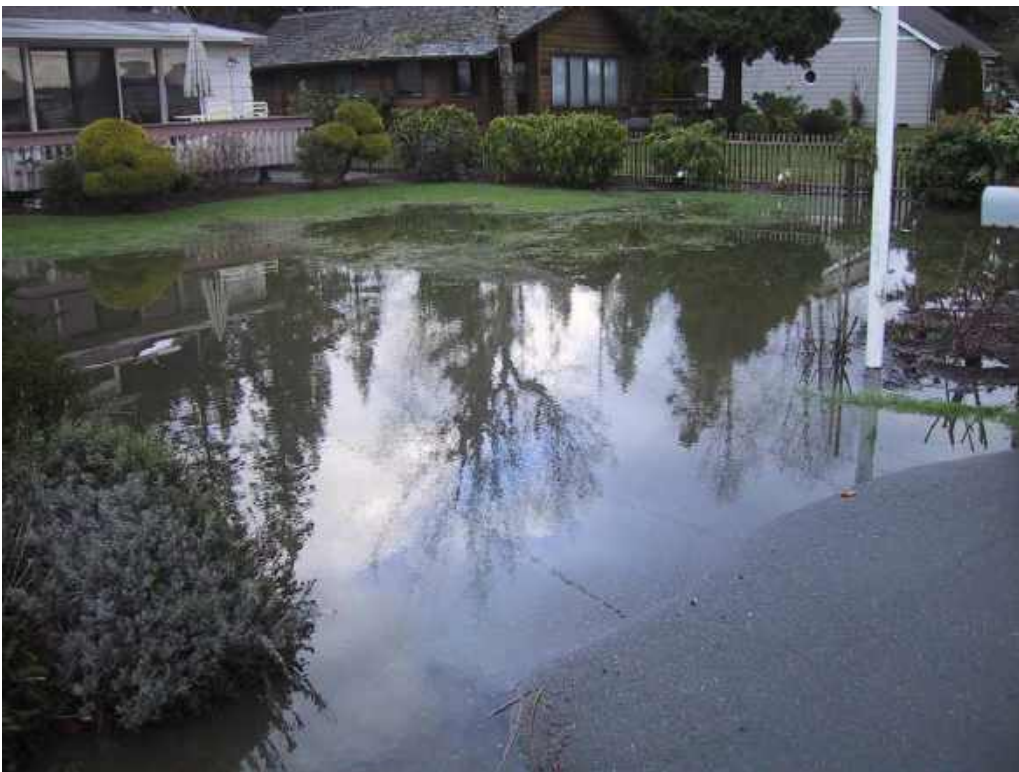
**FIGURE 8**

Flooding that occurred in January, 2006 along the 8200 block of Birch Bay Drive

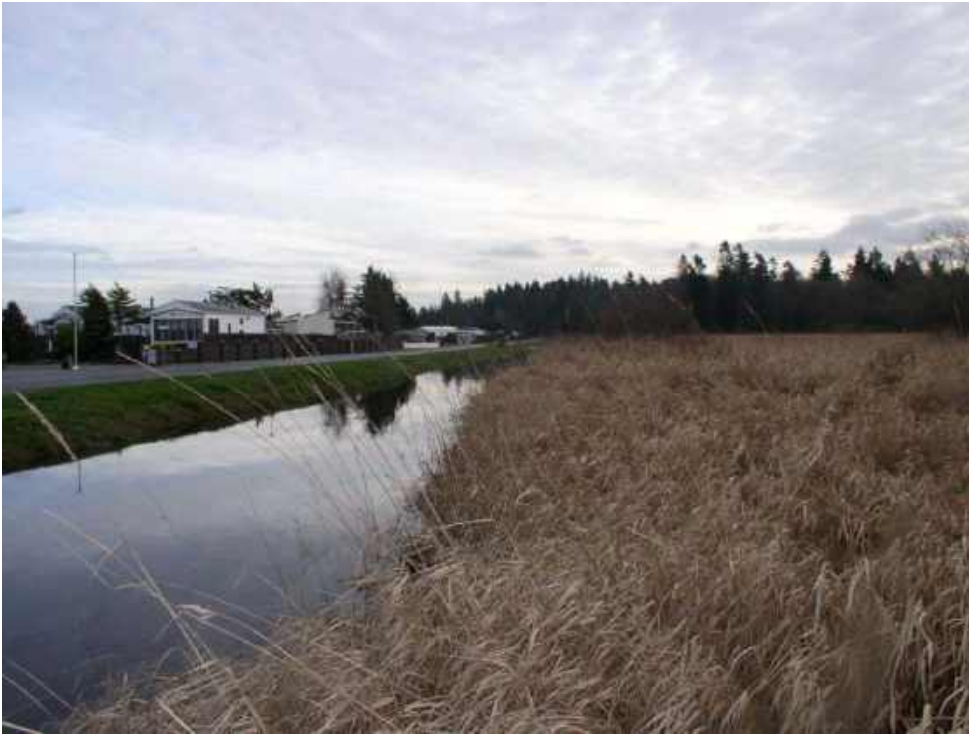
**FIGURE 9**

Looking east along the drainage ditch behind the tide gate at Lora Lane discharging to the mouth of Terrell Creek. The Leisure Park is shown on the left of the picture. Portions of the area to the right of the drainage ditch are classified as wetlands.

The area to the south and east of the Leisure Park is low-lying and flat and is part of the sub-basin draining to the ditch along Lora Lane. This ditch then discharges through the tide gate to Terrell Creek and on to Birch Bay. The yards of homes along Pine Drive are routinely full of runoff. Figure 9 shows the view looking east along the ditch along Lora Lane, with the Leisure Park on the left side of the picture. The tide gate to the mouth of Terrell Creek is just west of where the picture was taken (behind the photographer). Figure 10 shows the general low-lying area draining to the drainage ditch and the proximity of several homes in relation to the low-lying area. Figure 11 shows the area to the east and upstream of the home in Figure 10, taken looking to the northwest towards the drainage ditch and tide gate to Terrell Creek. The Birch Bay Subarea Plan Update (Kask Consulting, 2004) indicates that a large portion of this low-lying area is classified as wetlands. Much of the development in this area most likely occurred in areas that were originally wetlands.

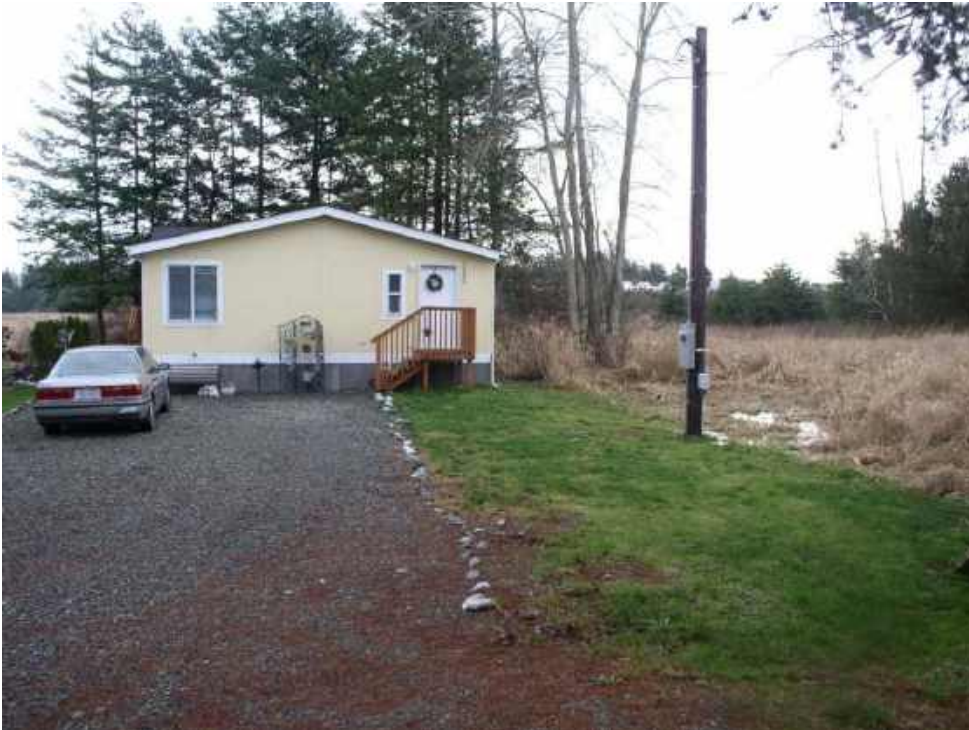
**FIGURE 10**

Low-lying area upstream of the drainage ditch shown in Figure 9. Note ponding water. Portions of this area are classified as a wetland.

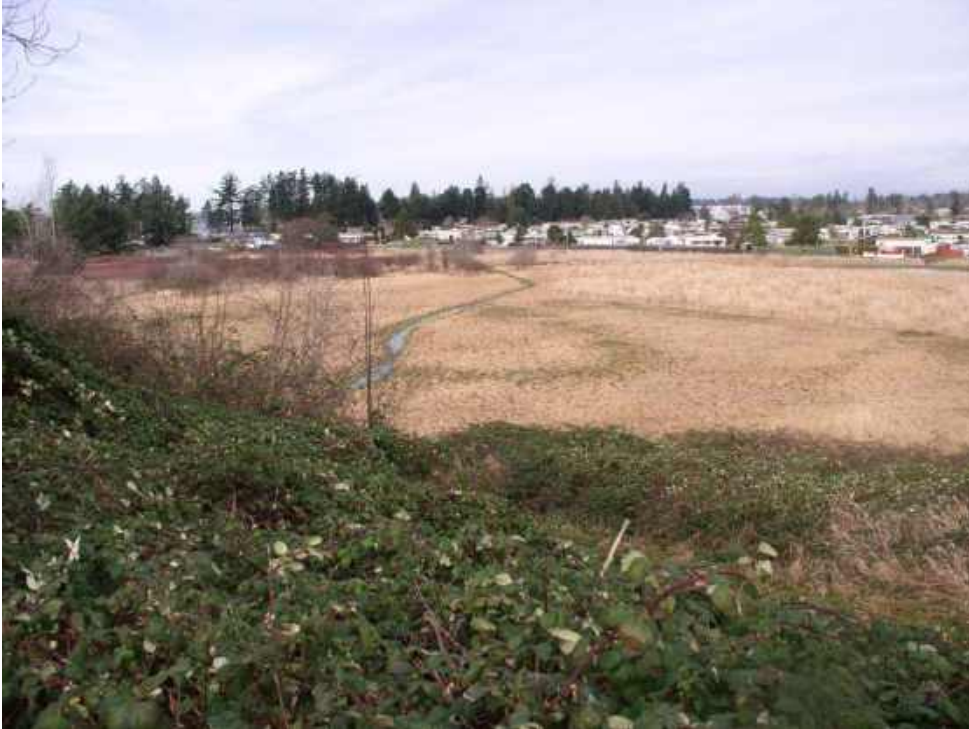
**FIGURE 11**

Area behind (to the east of) homes shown in Figure 11, shown looking northwest. Portions of this area are classified as a wetland.

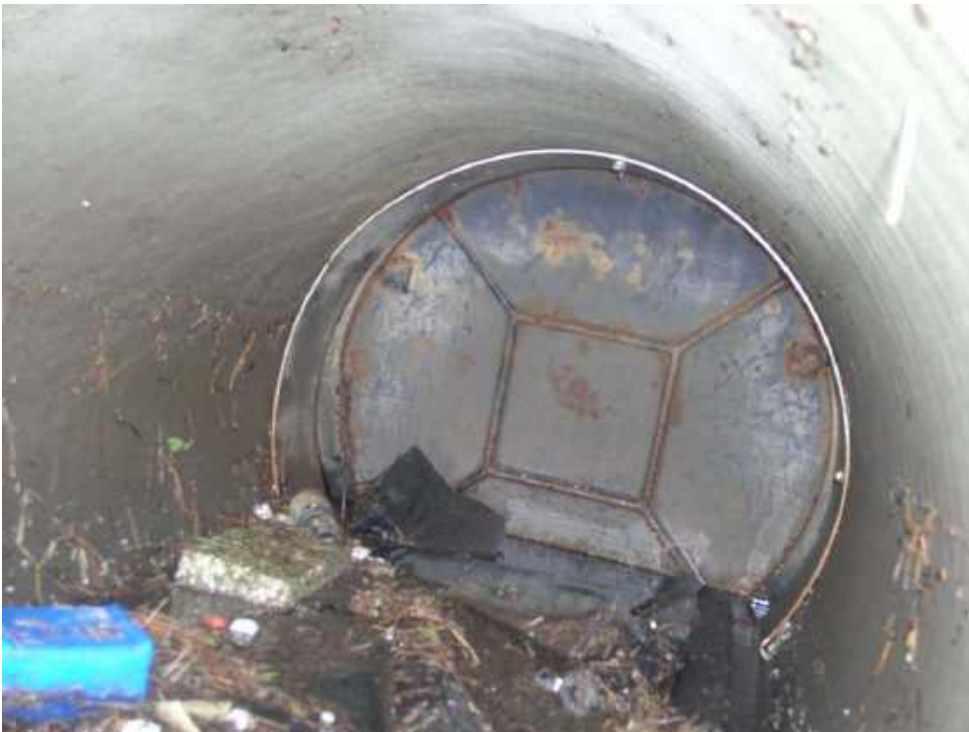
**FIGURE 12**

Material accumulated within the tide gate and culvert at the Corner of Wooldridge and Morrison, 01/04/06.

The culvert and tide gate at the corner of Wooldridge and Morrison often becomes blocked and causes road and yard flooding in the area. Water is often present over the roadway. Figure 12 shows the accumulated trash and other material propping open the tide gate during a site visit on 1/4/06. Figure 13 shows the culvert behind the tide gate under flooded conditions on 1/6/06. Because the tide gate was propped open and the picture was taken near the time of the high tide, the flooding shown may represent the approximate natural high tide level that day.

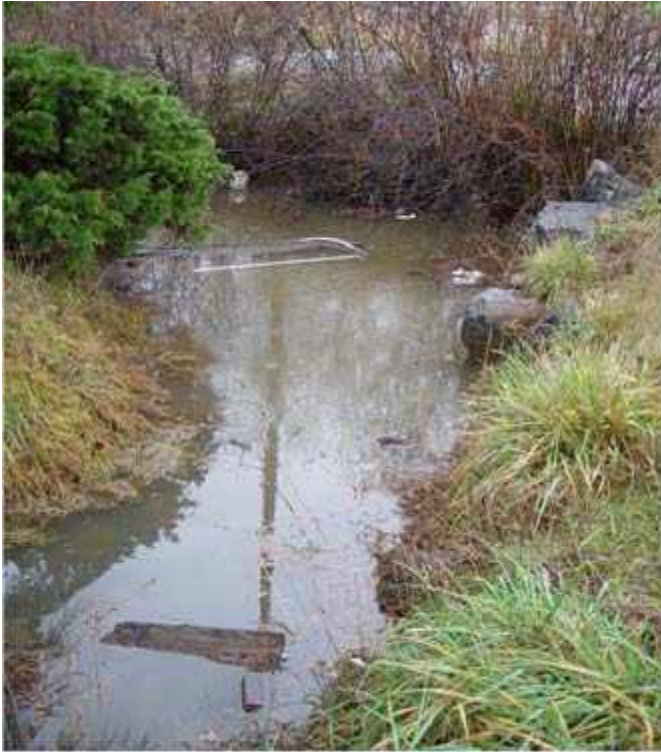
**FIGURE 13**

Flooded Ditch on the NE Corner of Wooldridge and Morrison behind tide gate, January 2006

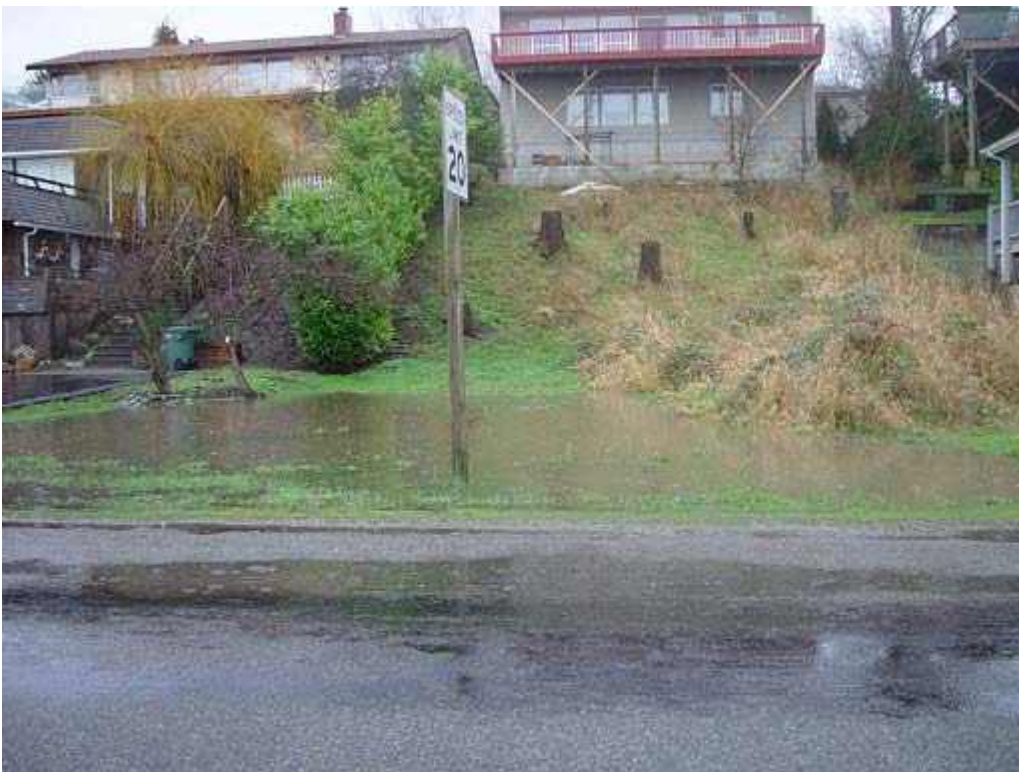
**FIGURE 14**

Flooding along Wooldridge just north of Jackson, January 2006

Yard flooding has been reported along Wooldridge just north of Jackson. This has been documented with photographs taken by local residents. Figure 14 shows an example of this flooding.

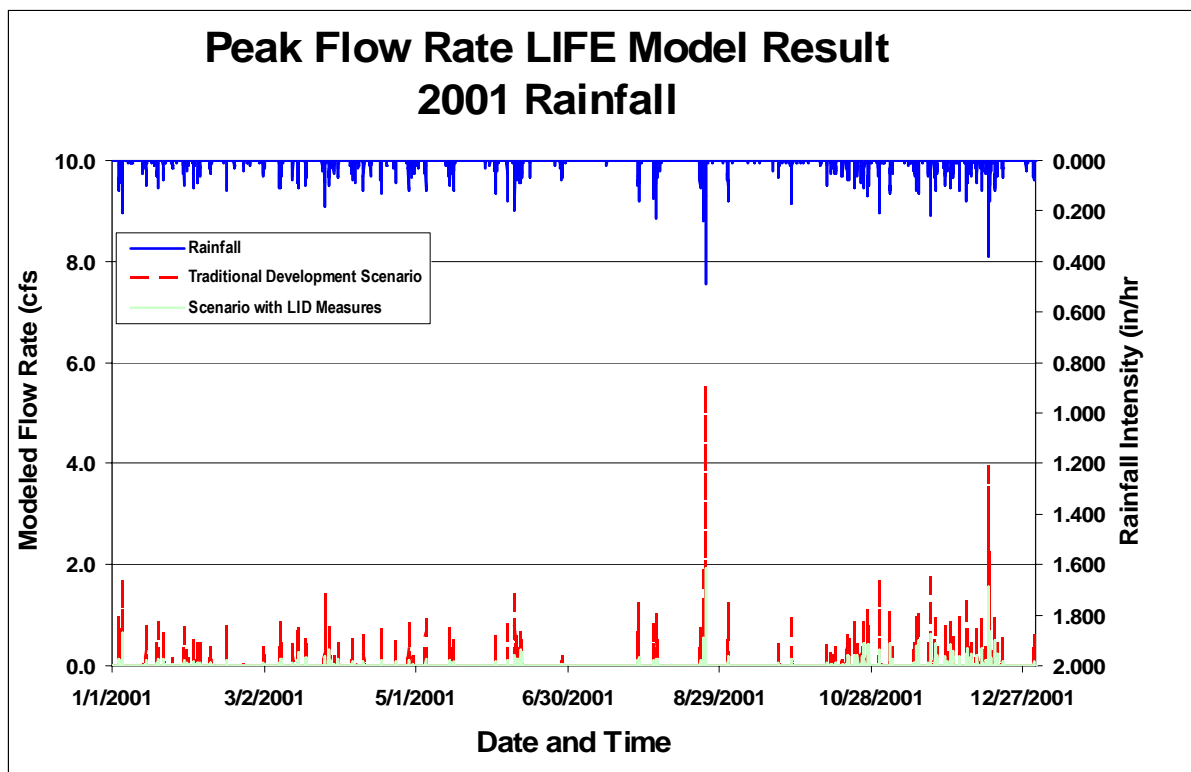
**FIGURE 1**  
LIFE™ Model Output Hydrographs for Continuous Model for both Modeled Scenarios

LID measures also yield a reduction in peak rate of runoff over the year. Under the Traditional Development scenario, the peak rate of runoff from the largest event of the year (approximately equal to the 1-year 24-hour event) was 5.5 cubic feet per second (cfs) (see Table 3). With LID measures, the peak runoff rate from this event was 1.9 cfs. This is a reduction in peak runoff rate of nearly 66 percent. Figure 1 shows the hydrographs under both the Traditional Development and Development with LID scenarios.

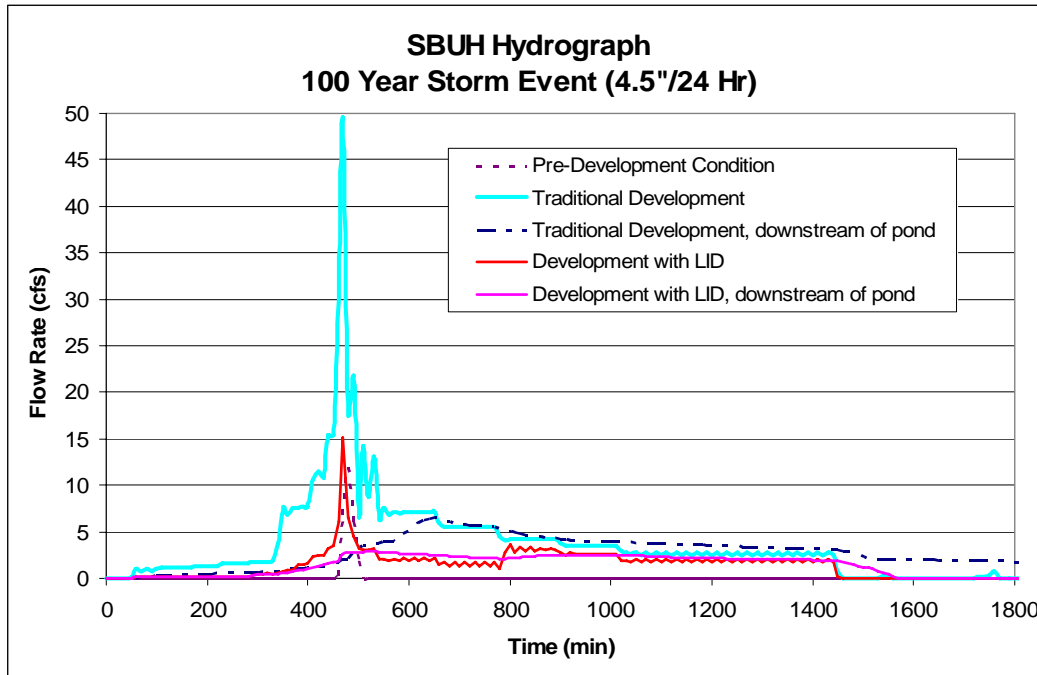
**FIGURE 2**  
LIFE™ Model Output Hydrograph for the 100-year 24-hour event for all Modeled Scenarios

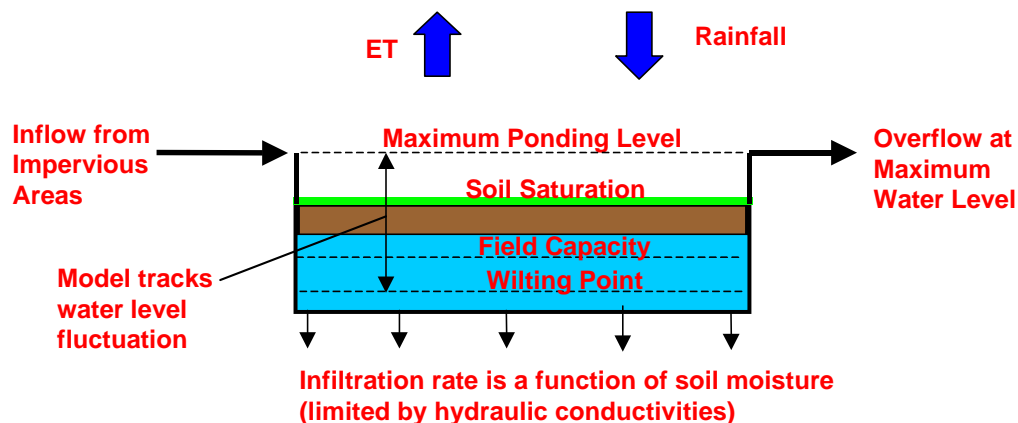
Simulating of the movement of water through pervious surface objects is at the heart of most LIFE™ model simulations. This process is described in more detail in the following chart.

Soil depth is the assumed size of the soil “reservoir.” Water flows into this ‘reservoir’ from direct rainfall and inflow from other objects (e.g., impervious surface runoff). If the rate of input exceeds the saturated hydraulic conductivity (SHC) of the surface soil, the excess becomes surface runoff. When the soil moisture is between wilting point and field capacity, water loss occurs through ET only. When the soil moisture is between field capacity and maximum water content (e.g., between 30 and 50 percent water content for the above swale), water will infiltrate out of the soil layer (in addition to ET losses). The rate of infiltration varies linearly between field capacity (where the rate is zero) and maximum water content. The slope of this line is governed by the soil water half-life (SWHL) value

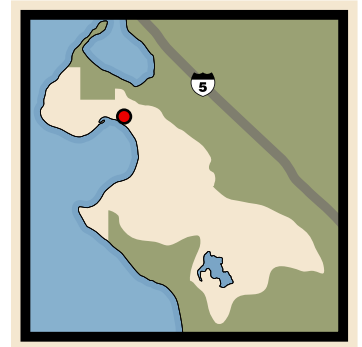
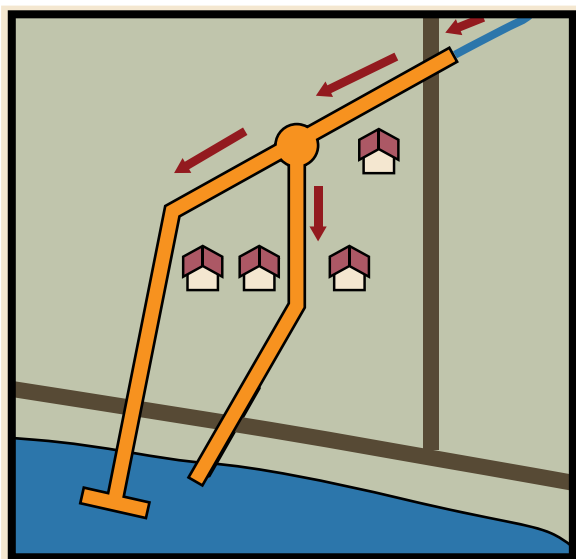
Stormwater runoff for a large portion of the Cottonwood Neighborhood is conveyed through the open channel through the County Park and into a closed-pipe system consisting of one pipe leading to a structure diverting flow to two different outfalls along Cottonwood Beach. Flooding occurs in the yards along Birch Bay Drive close to the system outlets. Development is expected to continue in the upstream portions of the drainage basin. This system must be capable of handling any additional flows due to these new developments. The failing system is on private property and was constructed by private property owners.

- Installation of cast-in-place lining in the northernmost outlet pipe and replacement of outfall structures on both the outlet pipes, pending results from additional analysis/data review; improvements to inlet structures for safety
- Perform additional analysis of system conditions and conveyance requirements, site investigation techniques such as CCTV, dye testing, and survey, hydrologic and hydraulic modeling

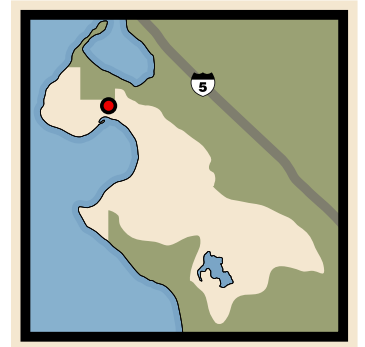
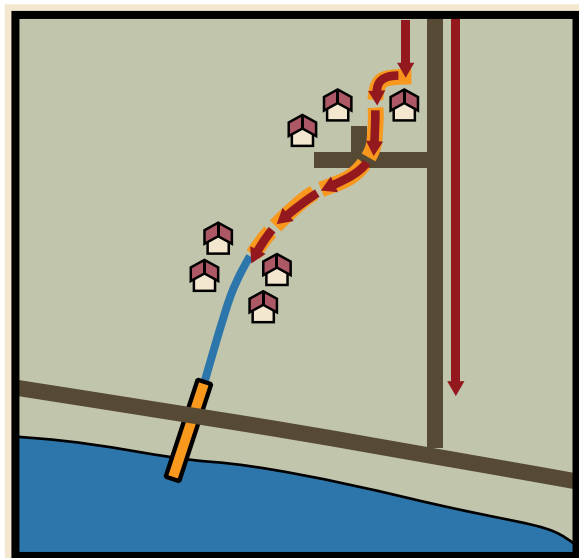
The drainage ditch flowing south along the West side of Shintaffer Road conveys runoff from a large area that stretches west and north of Lincoln Road. The ditch along the west side of Shintaffer flows through two 90-degree bends from the drainage ditch along Shintaffer towards the Richmond Park Subdivision. Runoff is then conveyed in ditches and culverts through the subdivision before discharging to a creek system through a ravine flowing to the south towards Birch Bay. The creek enters a culvert under Birch Bay Drive then enters Birch Bay within Rogers Slough. Yards in the Richmond Park Subdivision are submerged during heavy rains as the system backs up. Residents near the creek have experienced erosion and slope degradation in backyards along the ravine.

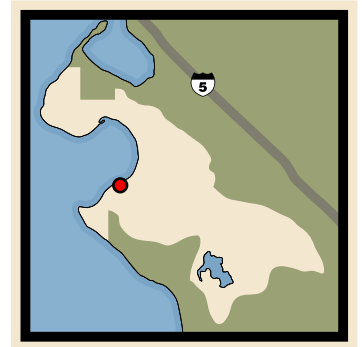
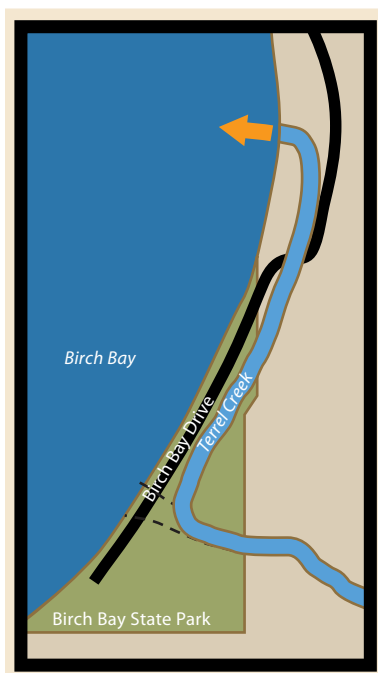
CC-12

At one time, Terrell Creek followed a natural path through the area. It is natural for a coastal stream to move in the direction of long-shore drift. Then, occasionally during a large storm event, the creek would cut through to a new more direct outlet to salt water and the process starts over. As development in Birch Bay proceeded, sections of Terrell Creek were confined and the creek no longer was allowed to find a natural course. Terrell Creek has low dissolved oxygen levels and high temperatures due to upstream activities within the watershed plus the confined nature of its path that limits circulation.

One alternative under this project would involve a feasibility analysis plus the design and construction of a more direct outlet for Terrell Creek. However, this alternative may be more harmful than it is helpful, as the current configuration of Terrell Creek includes an extensive estuarine area that provides habitat for several species of birds and waterfowl.

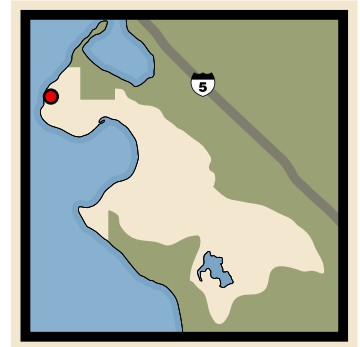
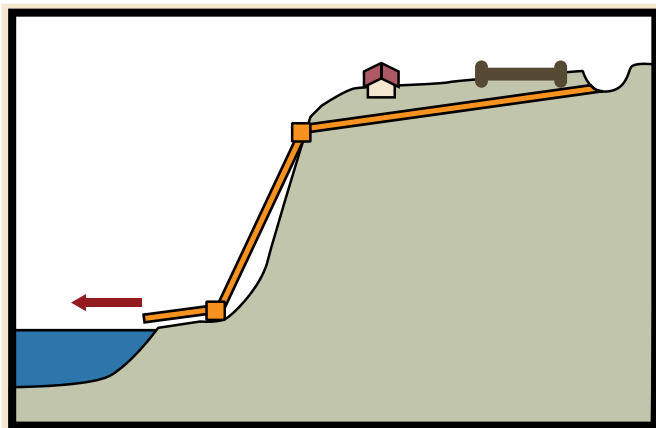
# BR02

The natural hydrology in the Birch Point area has been altered due to past development. Construction of roadways, roadside ditches, and homes has altered the surface and sub-surface flow. Loss of vegetation has increased volumes of runoff and peak flows. Surface flow is conveyed in cross-culverts and roadside ditches then flows towards Birch Bay in concentrated flow streams that may contribute to erosion and stability problems at the bluff.

Several localized surface drainage issues have been identified in the Birch Point Area. This project would involve addressing these issues by increasing capacity of these drainages in a manner consistent with BMPs for active landslide areas. The most immediate need is for proper conveyance of drainage from upstream contributing areas. This project would involve the design and construction of tight-line drainage at the edge of the slope then down the slope. This setup would be repeated up to three additional times depending on location and magnitude of runoff flows from upstream areas.

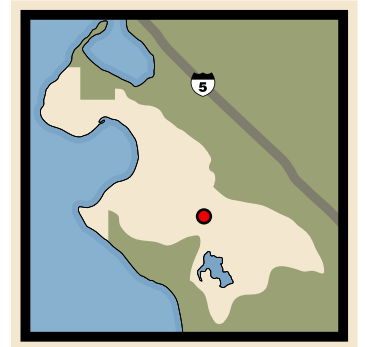
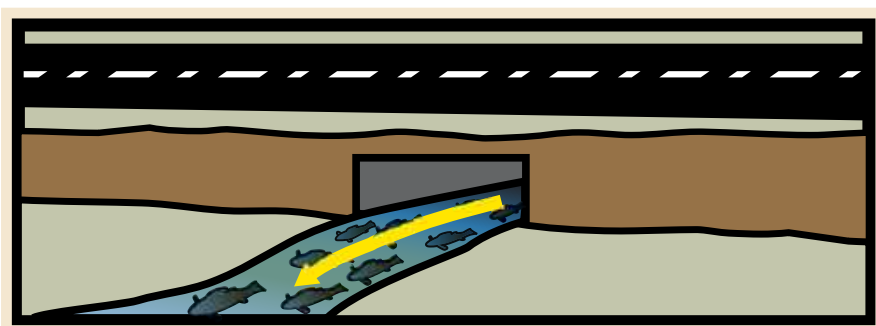
CC-11

The Grandview Road crossing of Terrell Creek is currently a fish passage barrier under low flow conditions. The culvert is situated high enough above the creek bed that any fish passage is impossible under low flows.

The preferred alternative is the installation of a fish-friendly culvert such as a box culvert that would allow passage under low flow conditions.

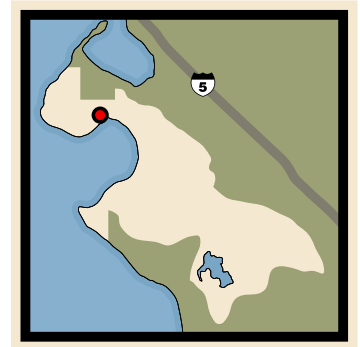
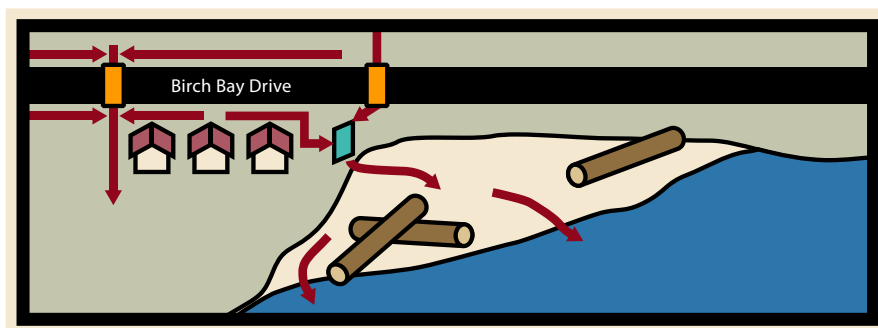
# BV-01

Drainage ditches discharging to Rogers Slough back up behind the tide gate under high tide and/or wet weather conditions. When these ditches overflow, backyard flooding occurs in the homes within Birch Bay Village that have backyards along Birch Point Road. Ditches also back up along the north side of Birch Point Road. Much of this area may be at or just above high tide level. During wet periods, runoff will backup behind the existing tide gate until the tide recedes and this runoff can discharge through the gate. Note that the flooded areas are low and historically are likely to have been wet even before homes and roads were built in the area.

- Construct drainage system improvements such as replacement of culverts, ditches, and other infrastructure
- Fill in yards and other low spots that flood
- Coordination with programmatic solution of increased maintenance – removal of logs other accumulated material within Rogers Slough
