Resolution amending the 2006 Birch Bay Comprehensive Stormwater Plan to include four Subwatershed Master Plans (Council acting as the Whatcom County Flood Control Zone District Board of Supervisors)

# BIRCH BAY

## COMPREHENSIVE STORMWATER PLAN

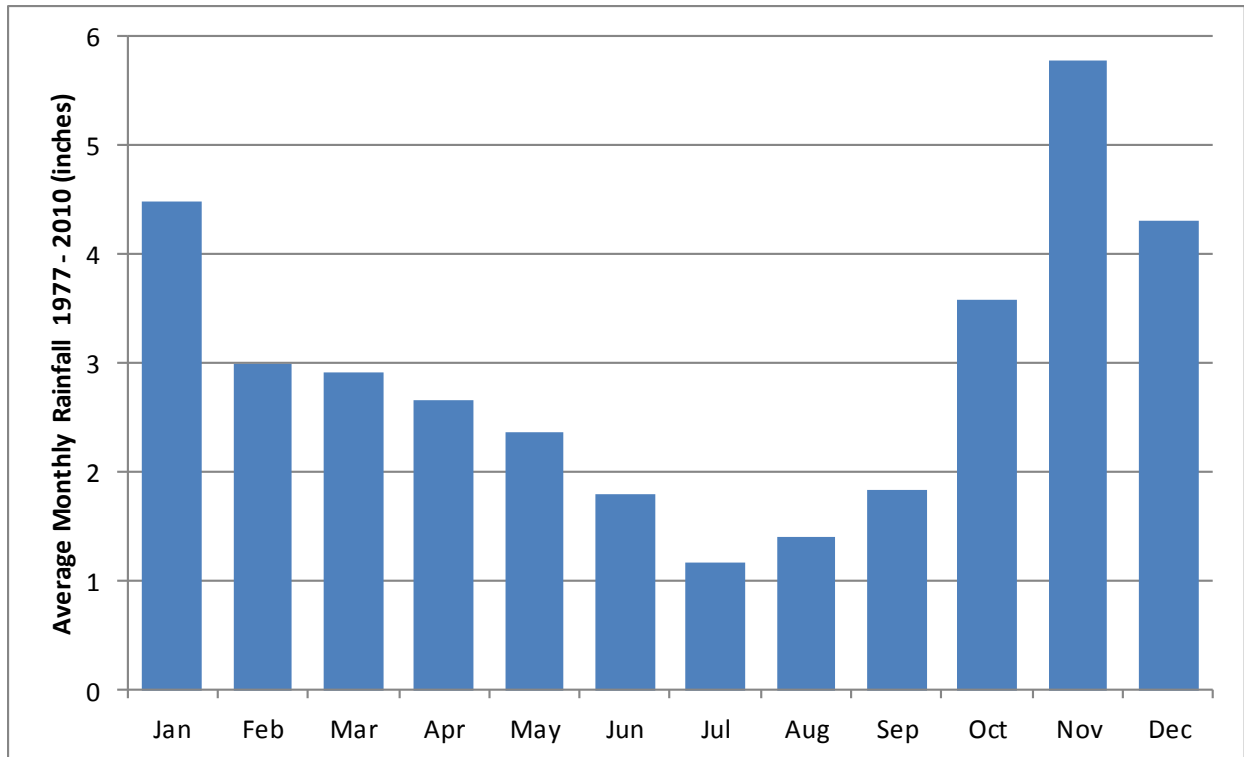
Figure 2-1. Average Monthly Rainfall—Birch Bay (BBWSD, 2011)

Birch Bay experiences a mild marine with cool, dry summers and mild, wet winters. Average monthly temperature ranges from about 37°F in January to 62°F in August. However, extreme temperatures can occur, with temperatures below freezing an average of about 70 days per year. Temperature rarely gets above 90°F (WRCC, 2011). The Birch Bay area receives an average of about 35 inches of rain annually. Some precipitation occurs as snow, with about 14 inches in an average year. Figure 2-1 shows the average monthly rainfall measured at the Birch Bay Water and Sewer District (BBWSD) near Birch Bay State Park. Typically, winter rainfall occurs as long-duration, low-intensity events over a day or more.

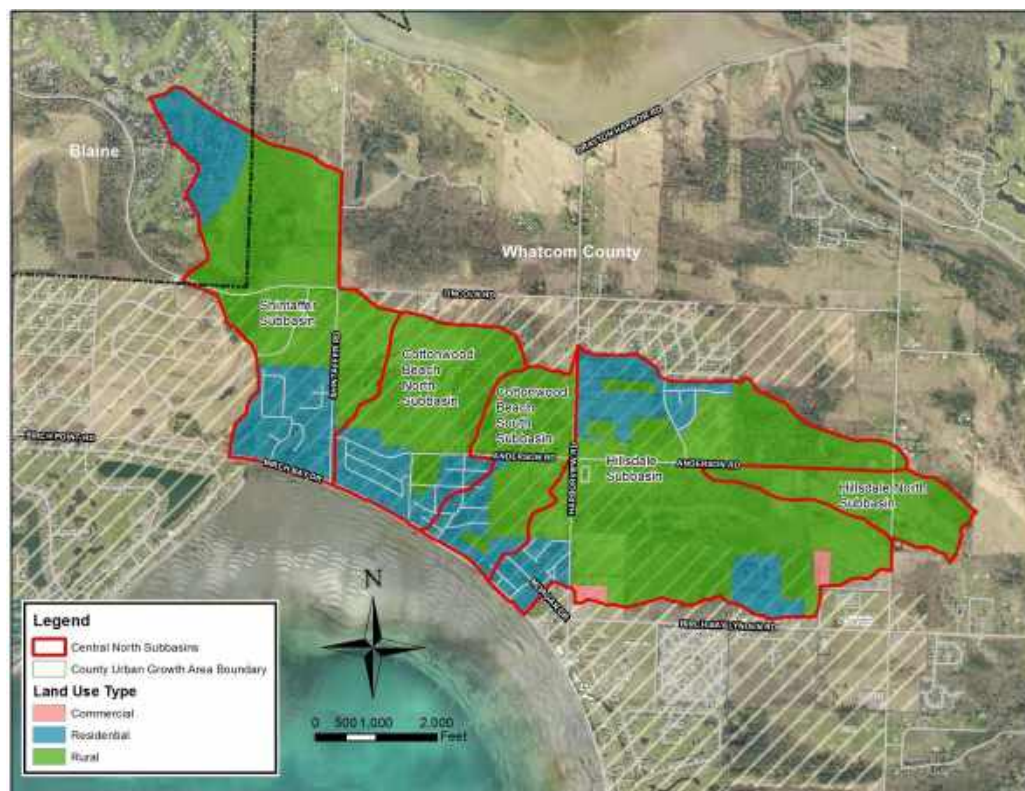
Figure 2-4. Current Land Use (October 2011) in the Central North Subwatershed

Current land use (2011) in the Central North subwatershed is primarily high- and medium-density residential (including mobile homes sites) near Birch Bay, with some commercial land uses such as hotels, shops and restaurants. Residential areas are also located in the area east of Harborview Drive north of Anderson Road. Current land use is shown in Figure 2-4 and listed in Table 2-2.

Prior to European settlement, the Birch Bay watershed was covered with a mixture of coniferous and deciduous forest. The watershed was logged in the early 1900s, followed by development as a resort community near the bay and agricultural uses in the upland areas (ESA Adolfson, 2007). A large portion of the Central North subwatershed is in unincorporated Whatcom County, so regulation of development primarily falls under County jurisdiction. A small area on the western edge of the subwatershed north of Lincoln Road falls within the municipal boundary of the City of Blaine. South of Lincoln Road, the subwatershed is in the Birch Bay urban growth area; the area north of Lincoln Road is in the City of Blaine urban growth area. Urban growth boundaries are shown in Figures 2-4 and 2-5.

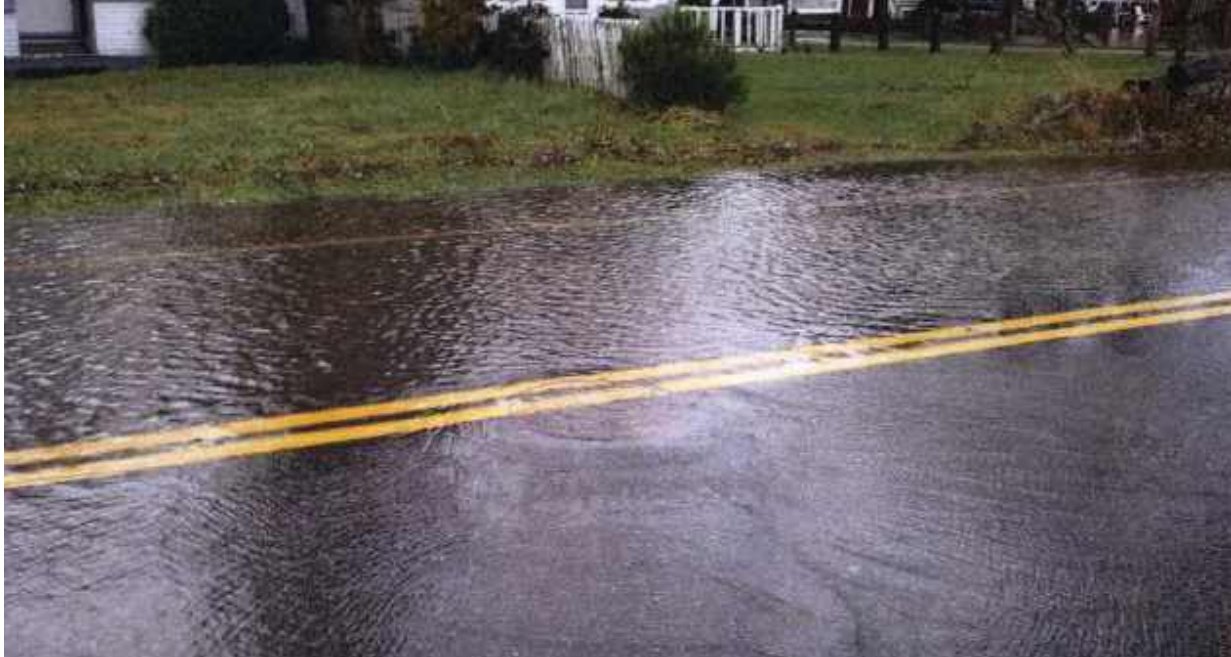
*Figure 4-1. Street Ponding on Birch Bay Drive near Cottonwood Court*

Naturally occurring ponding in an undisturbed system is beneficial because it slows the rate of runoff, thus reducing the likelihood of conveyance and erosion problems downstream. However, if ponding poses a safety concern or property damage risk (see Figure 4-1), then correction is required. Most ponding in the Central North subwatershed occurs because of high tide during storm events, lack of drainage infrastructure and low ground slopes.

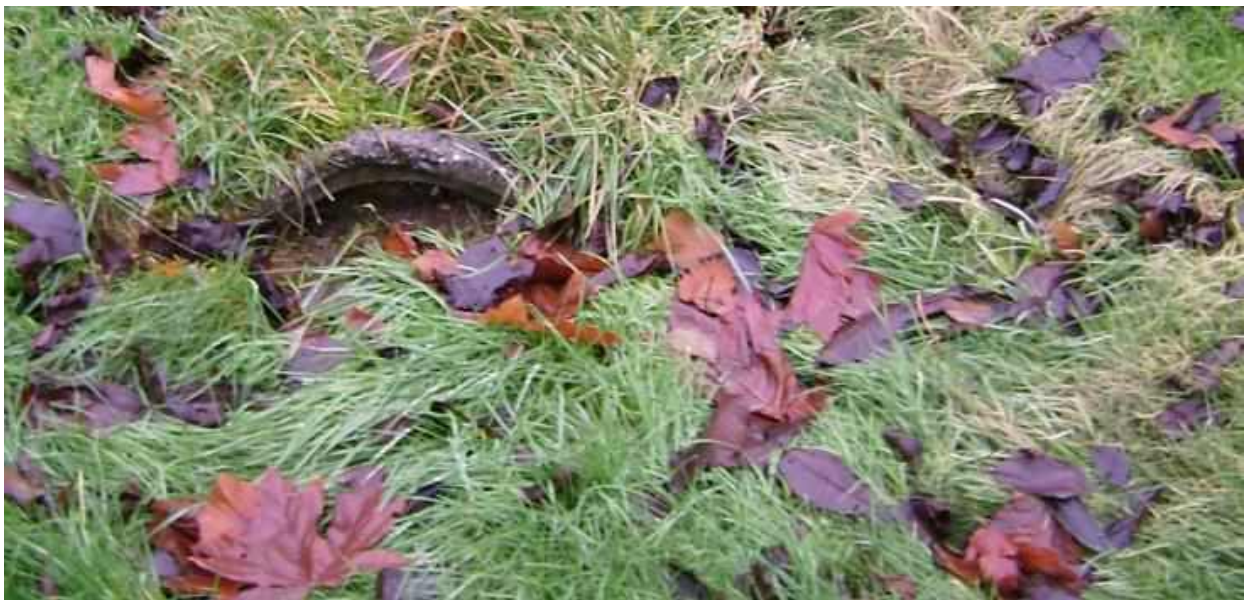
*Figure 4-2. Blocked Culvert*

Drainage structures fill with sediment over time in the absence of a regular cleaning program (see Figure 4-2). When structures become blocked, stormwater may overflow during rainfall events, causing damage to surrounding public and private property. Drainage structures in the Central North subwatershed are especially prone to siltation and blockage due to the ditch-and-culvert configuration, which brings sediment into the system. Sediments from developed areas have been shown to contain high levels of pollutants. Also, stormwater outfalls to Birch Bay are susceptible to blockage due to tidal fluctuation that washes sand and mud into outfall pipes and offshore currents that float debris over the opening.

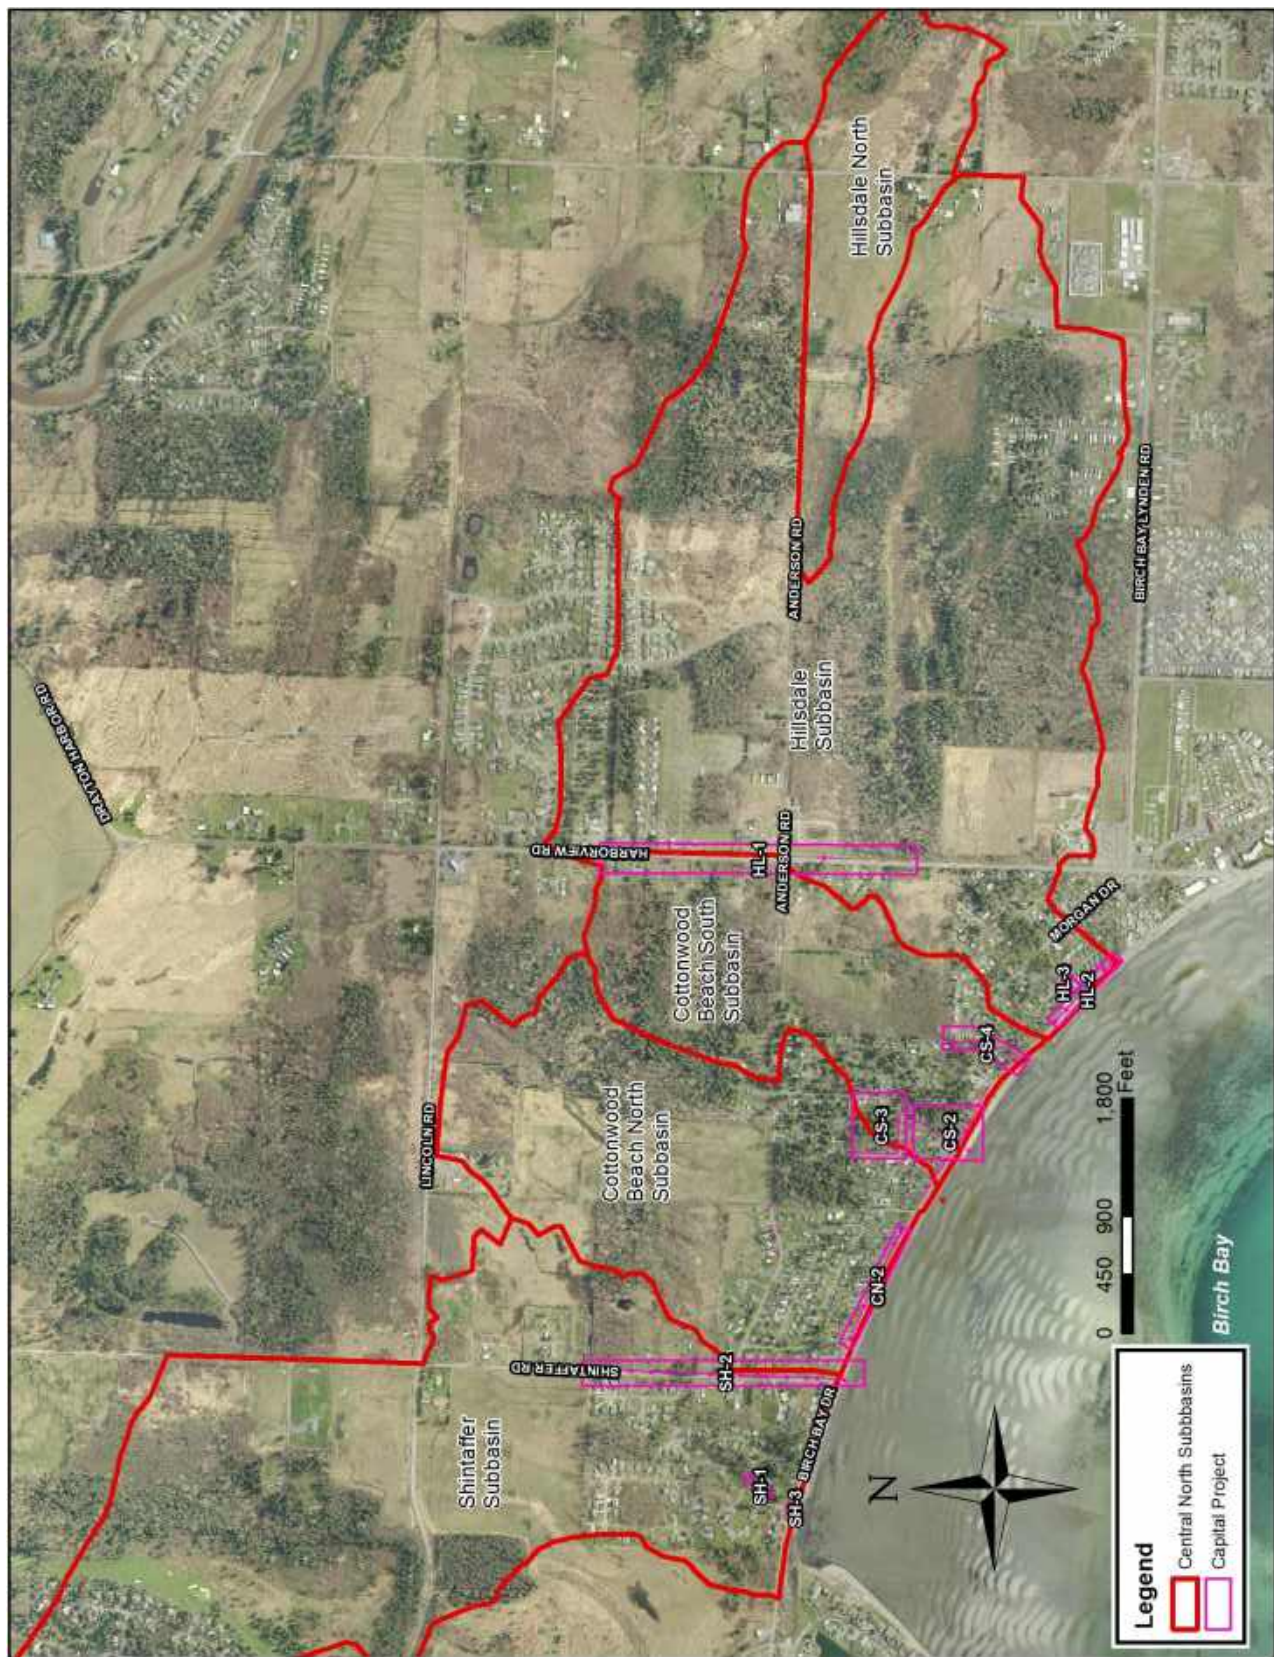
Figure 6-2. Capital Projects

Eleven capital projects were developed to address 18 drainage problems, as listed in Table 6-5. In some locations, a single project addresses more than one problem. The proposed projects include a total of 5,300 feet of new or replacement storm drain pipeline, 500 feet of culvert pipe, regrading or reestablishment of 50 feet of a roadside ditch, 42 new catch basins, 170 feet of water quality swale, and eight new tide valves. Figure 6-2 shows the project locations. Detailed project descriptions are provided in Appendix C. Table 6-6 shows a breakdown of estimated project costs.

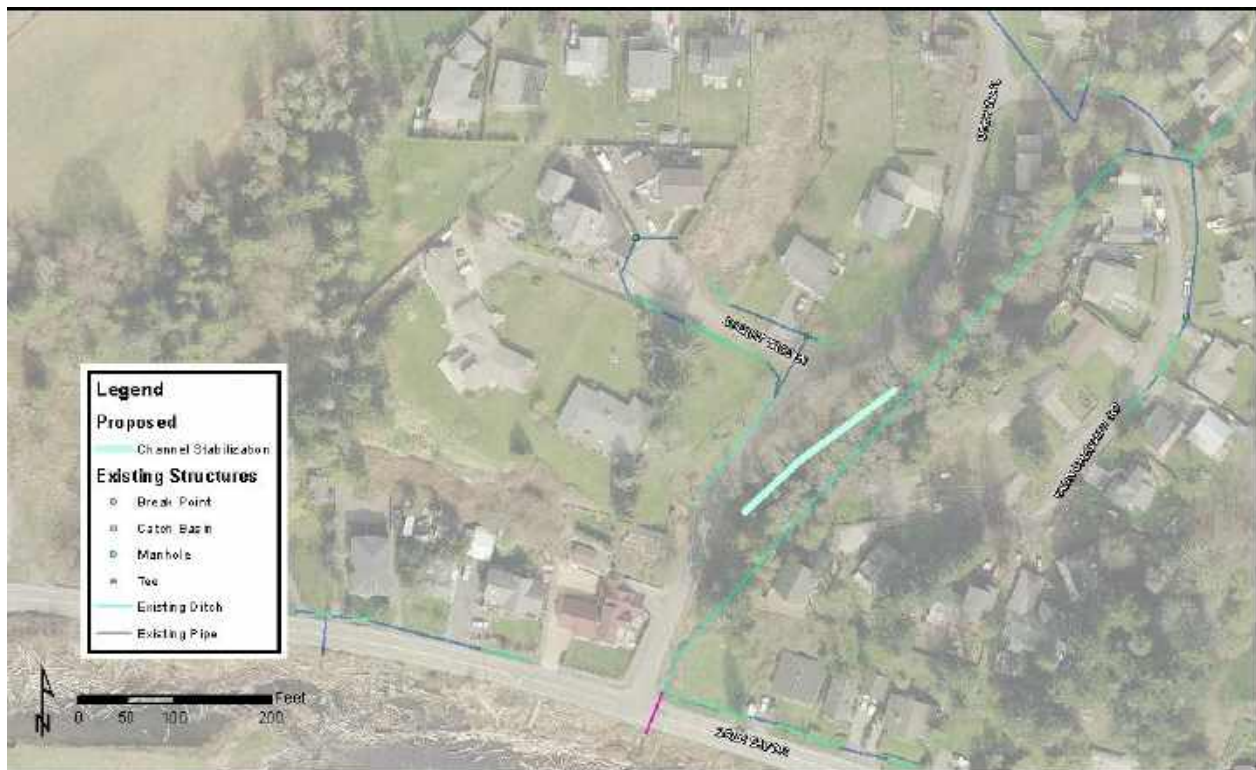
**BIRCH BAY URBAN SUBWATERSHED MASTER PLAN  
CAPITAL PROJECT PLANNING LEVEL CONSTRUCTION COST OPINION**

- Stabilize and restore 200 feet of streambank.

PROJECT: <u>SH-1 (Problem SH-13)</u>	BY: <u>GMS</u>
DESCRIPTION: <u>Streambank stabilization upstream of Birch Bay Drive</u>	CHECKED BY: _____
SUBBASIN: <u>Shintaffer</u>	DATE: <u>May 8, 2012</u>

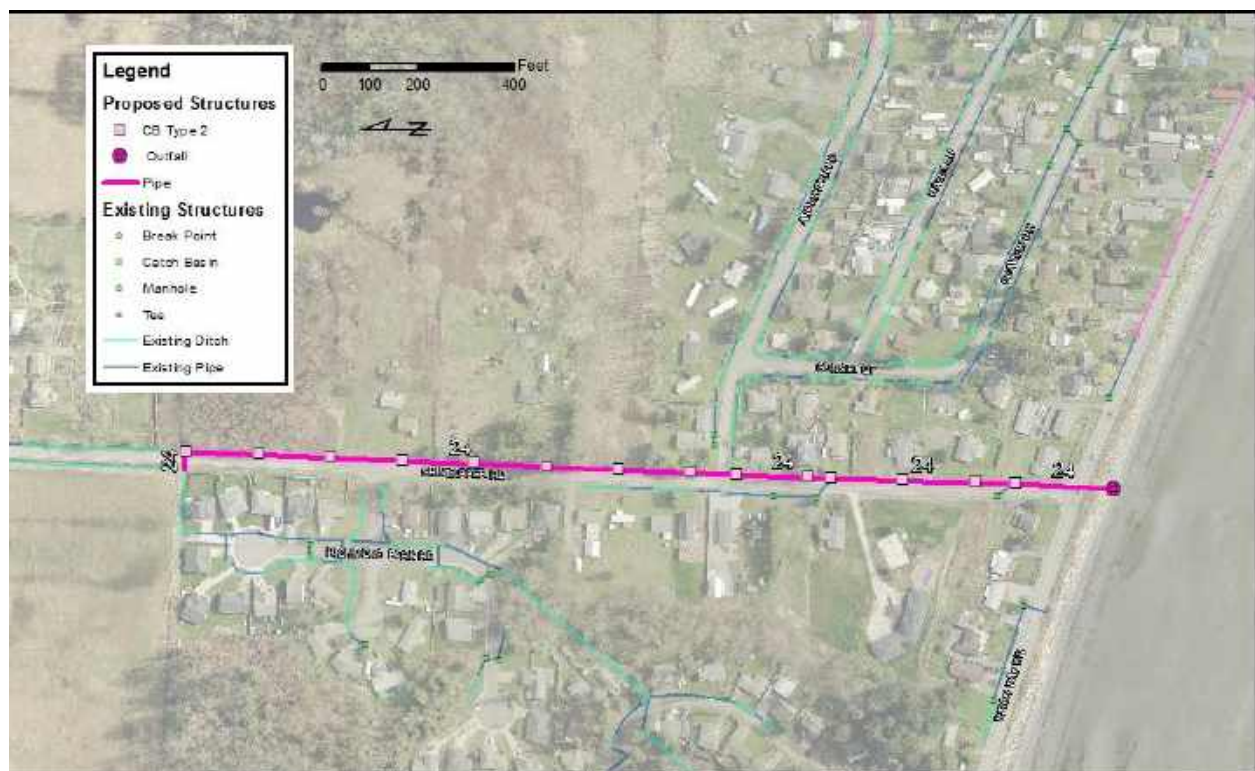
**BIRCH BAY URBAN SUBWATERSHED MASTER PLAN  
CAPITAL PROJECT PLANNING LEVEL CONSTRUCTION COST OPINION**

- Install 40 lineal feet 24-inch diameter cross culvert under Shintaffer Road and north side of Richmond Park subdivision.
- Replace ditch and culvert system on east side of Shintaffer Road with 2,000 lineal feet of 24-inch diameter HDPE.
- Install 15 CB Type 2 structures.
- Install new outfall to Birch Bay.

**PROJECT:** SH-2 (Problem SH-7, SH-8, SH-9)  
**DESCRIPTION:** Shintaffer Road Drainage Improvements  
**SUBBASIN:** Shintaffer

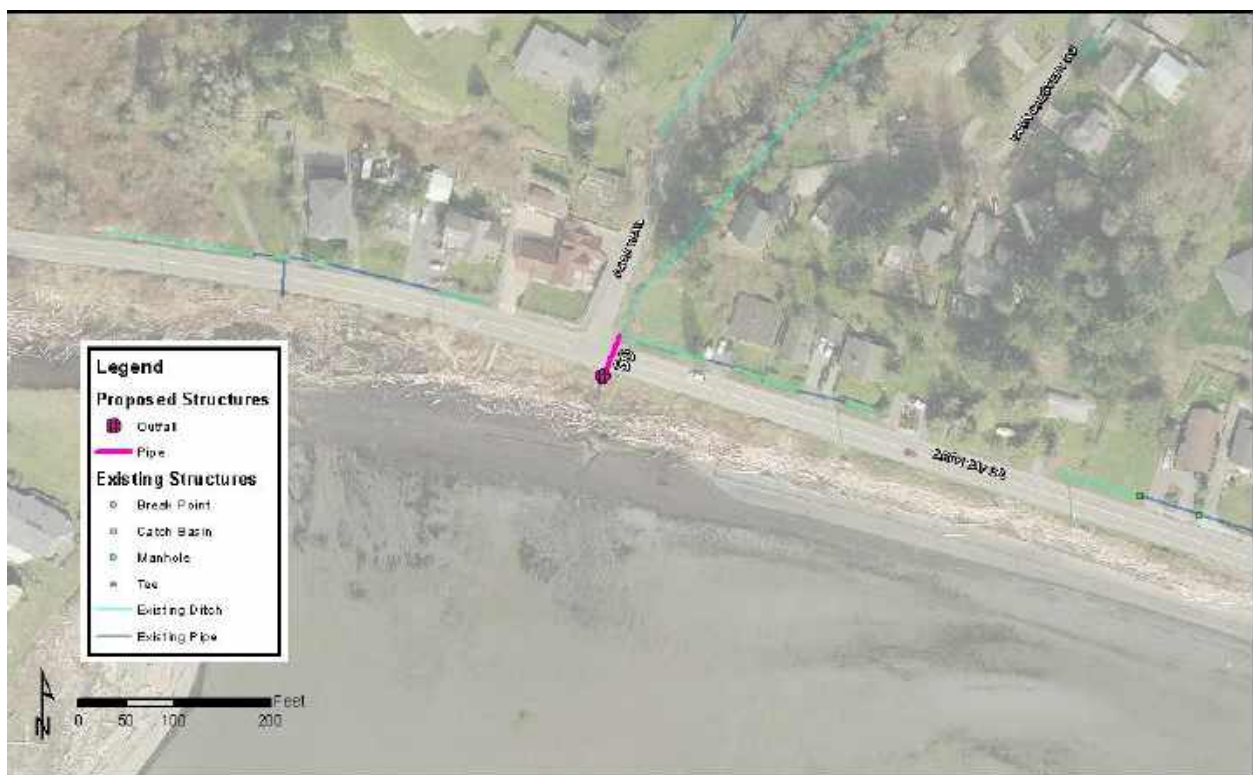
**BIRCH BAY URBAN SUBWATERSHED MASTER PLAN  
CAPITAL PROJECT PLANNING LEVEL CONSTRUCTION COST OPINION**

- Install 45 lineal feet 30-inch diameter pipe under Birch Bay Drive.
- Install new 30-inch outfall with tide valve to Birch Bay.

<b>PROJECT:</b> <u>SH-3 (Problem SH-3)</u>	<b>BY:</b> <u>GMS</u>
<b>DESCRIPTION:</b> <u>Birch Bay Deer Trail Outfall Replacement</u>	<b>CHECKED BY:</b> _____
<b>SUBBASIN:</b> <u>Shintaffer</u>	<b>DATE:</b> <u>September 12, 2012</u>

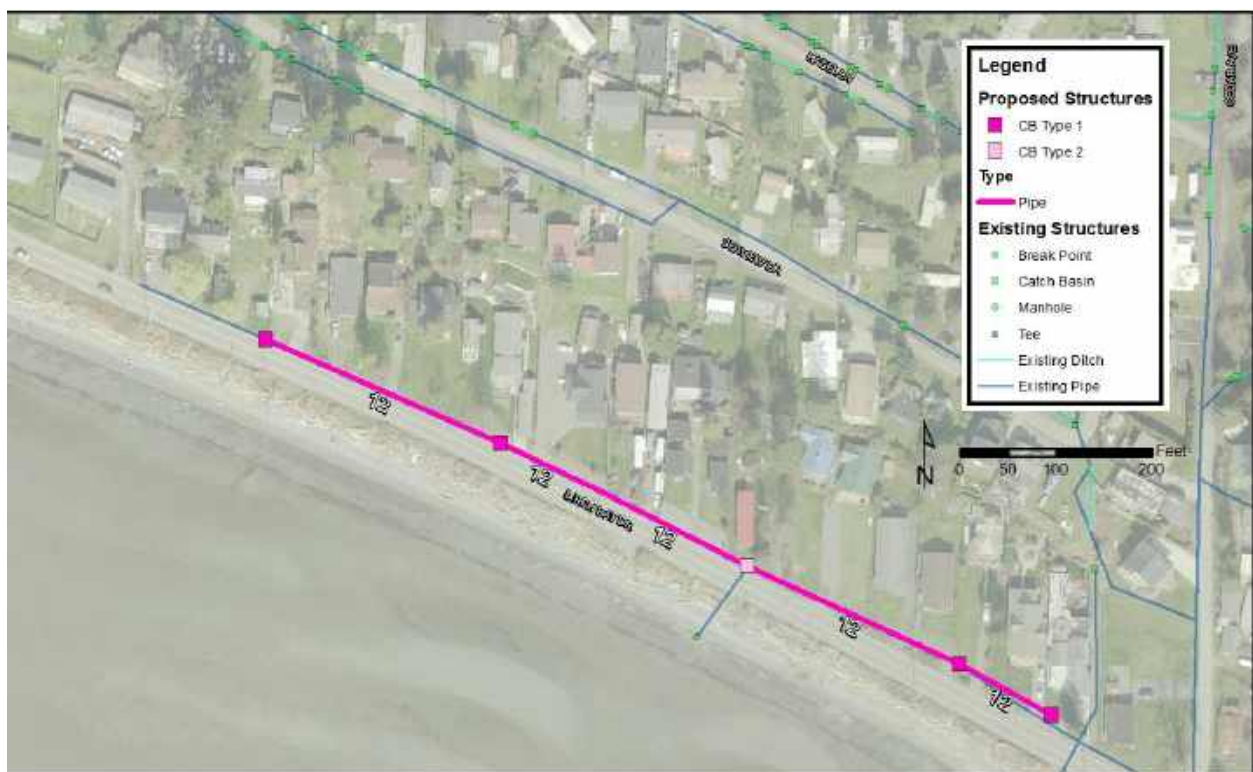
**BIRCH BAY URBAN SUBWATERSHED MASTER PLAN  
CAPITAL PROJECT PLANNING LEVEL CONSTRUCTION COST OPINION**

- Replace 355 lineal feet of 4-inch diameter pipe with 12-inch diameter HDPE pipe
- Replace 287 lineal feet of 12-inch diameter CMP with 12-diameter HDPE pipe.
- Replace 267 lineal feet of 8-inch diameter HDPE pipe with 12-diameter HDPE pipe.
- Install 4 CB Type 1 and 1 CB Type 2 structures.

**PROJECT:** CN-2 (Problem CN-3)  
**DESCRIPTION:** Replace storm drain on Birch Bay Drive  
**SUBBASIN:** Cottonwood Beach North

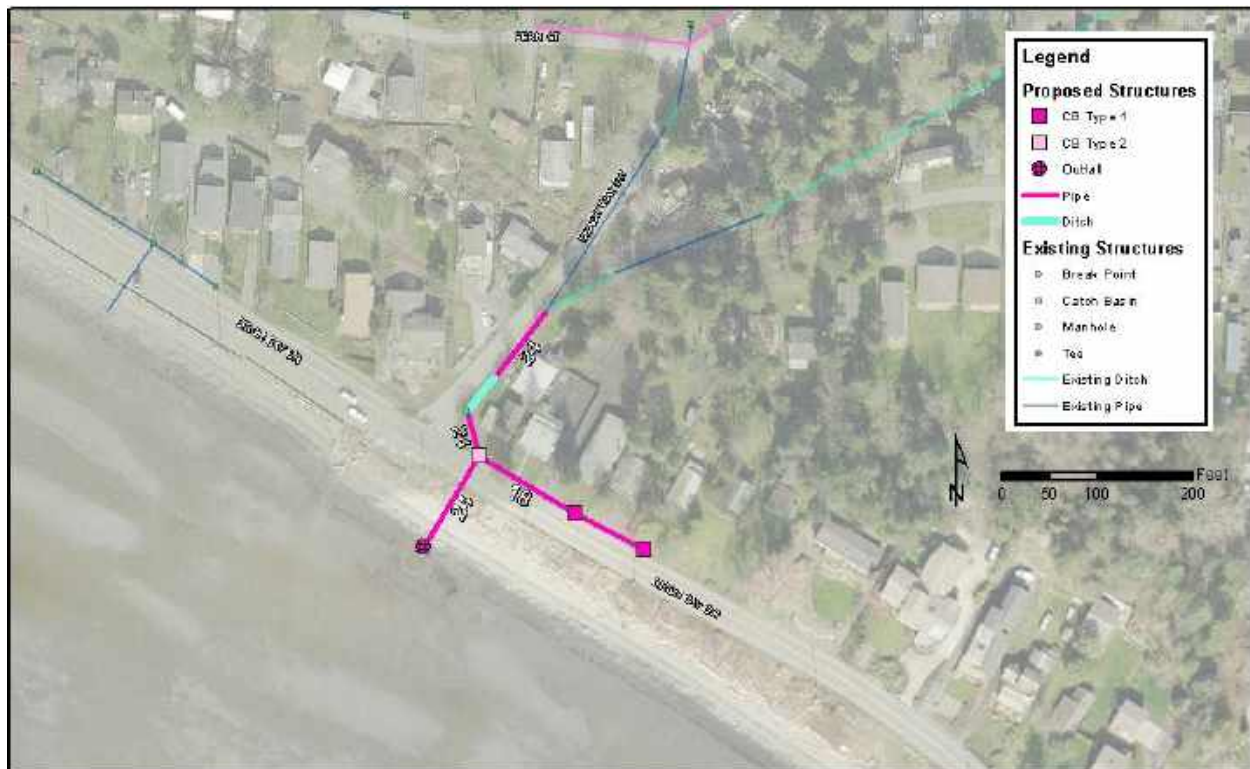
**BIRCH BAY URBAN SUBWATERSHED MASTER PLAN  
CAPITAL PROJECT PLANNING LEVEL CONSTRUCTION COST OPINION**

- Replace 200 lineal feet of 12-inch diameter storm drain with 18-inch diameter HDPE on north side of Birch bay Road
- Replace 18-inch diameter driveway culvert and 18-inch diameter storm drain and outfall with 240 lineal feet of 24-inch diameter HDPE pipe.
- Regrade 45 lineal feet of roadside ditch
- Construct 24-inch diameter outfall with tide valve.

PROJECT: <u>CS-2 (Problem CS-2)</u>	BY: <u>GMS</u>
DESCRIPTION: <u>Beachway Drive and Birch Bay Drive Storm Drain Impr</u>	CHECKED BY: _____
SUBBASIN: <u>Cottonwood Beach South</u>	DATE: <u>May 8, 2012</u>

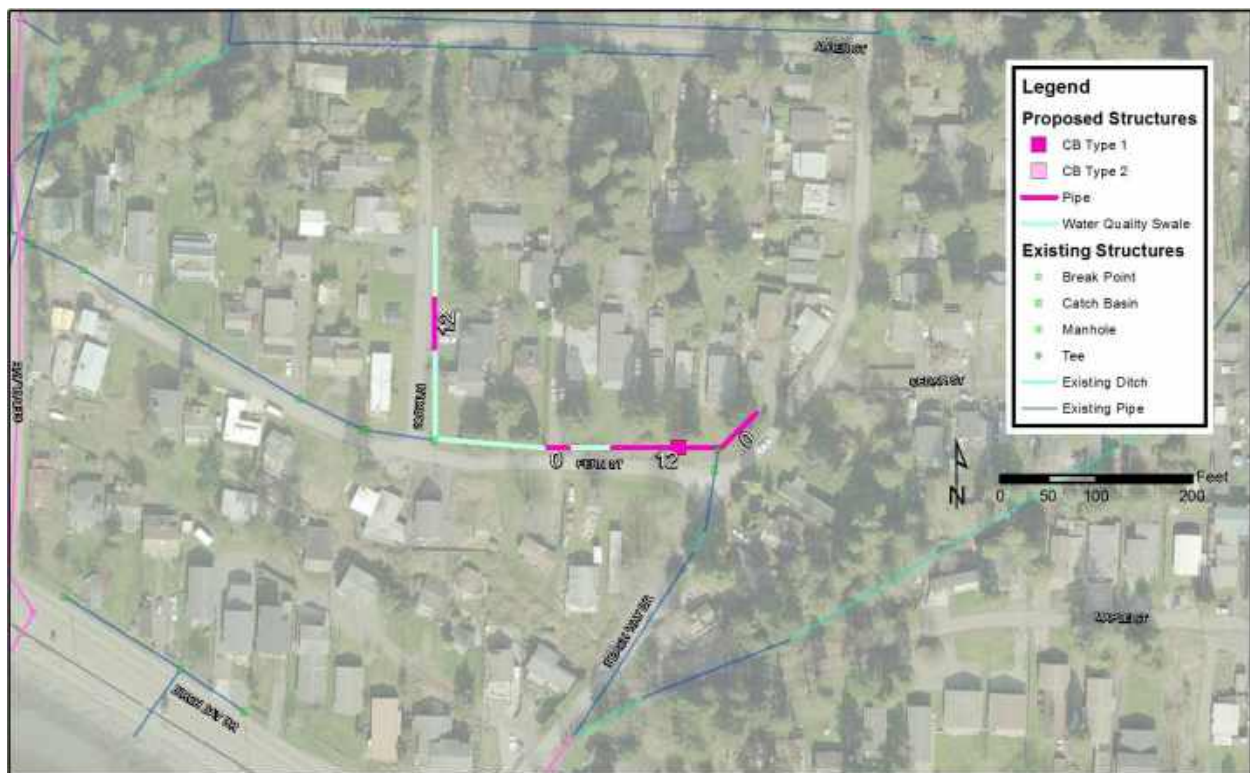
**BIRCH BAY URBAN SUBWATERSHED MASTER PLAN  
CAPITAL PROJECT PLANNING LEVEL CONSTRUCTION COST OPINION**

- Install 290 lineal feet of new 12-inch diameter HDPE
- Install 330 lineal feet of water quality swale
- Install 1 CB Type 1.

<b>PROJECT:</b> <u>CS-3 (Problem CS-9)</u>	<b>BY:</b> <u>GMS</u>
<b>DESCRIPTION:</b> <u>Fern Street Storm Drain System</u>	<b>CHECKED BY:</b> _____
<b>SUBBASIN:</b> <u>Cottonwood Beach South</u>	<b>DATE:</b> <u>May 8, 2012</u>

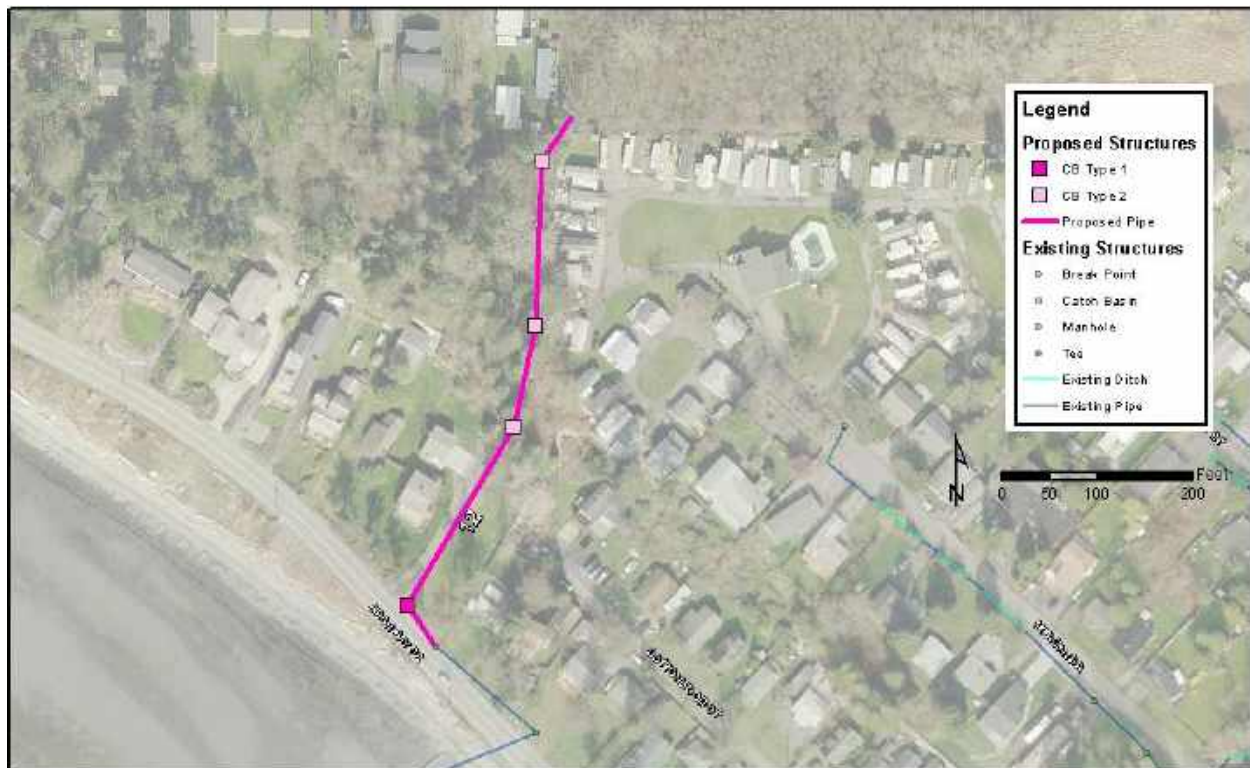
**BIRCH BAY URBAN SUBWATERSHED MASTER PLAN  
CAPITAL PROJECT PLANNING LEVEL CONSTRUCTION COST OPINION**

- Install 600 lineal feet of 12-inch diameter HDPE pipe.
- Install 1 new Type 1 CB, 2 new Type 2 CBs and 1 new Type 2 CB as energy dissipater.

PROJECT: <u>CS-4 (Problem CS-11)</u>	BY: <u>GMS</u>
DESCRIPTION: <u>Tightline and Storm Drain between North Bay Trailer</u>	CHECKED BY: _____
SUBBASIN: <u>Cottonwood Beach South</u>	DATE: <u>May 8, 2012</u>

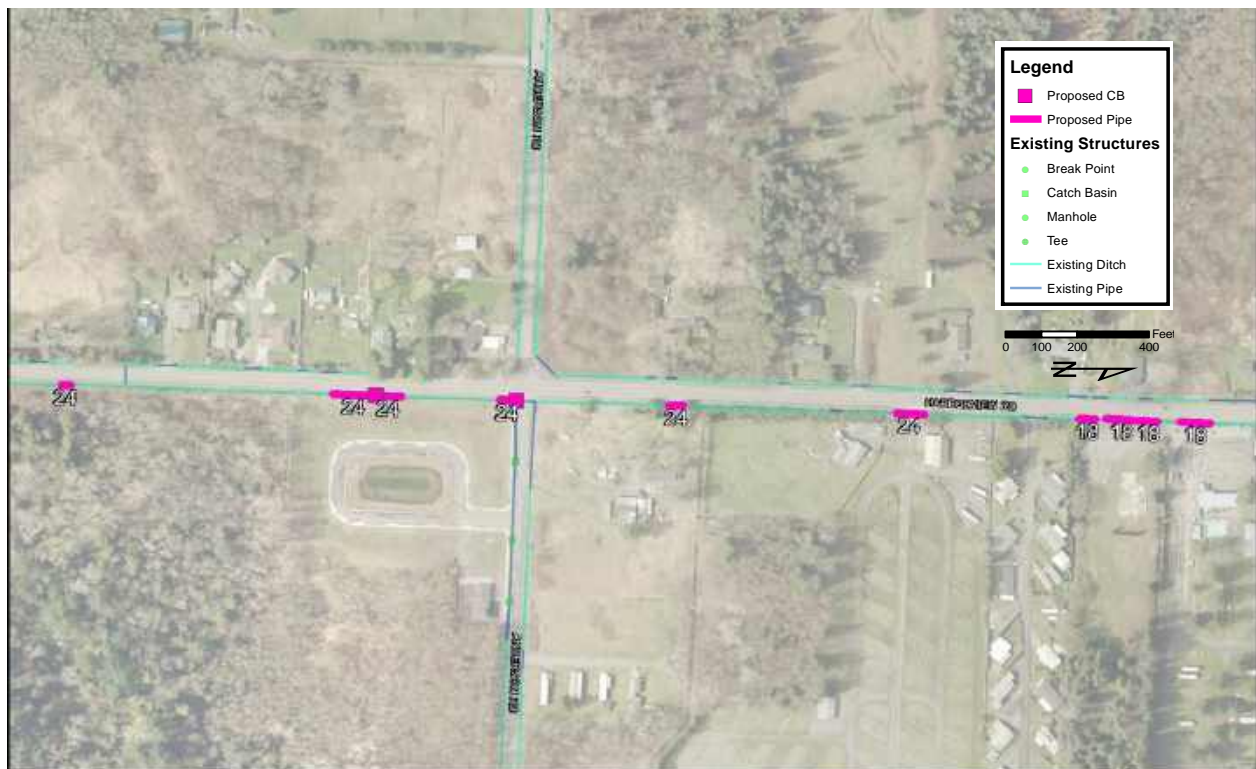
**BIRCH BAY URBAN SUBWATERSHED MASTER PLAN  
CAPITAL PROJECT PLANNING LEVEL CONSTRUCTION COST OPINION**

- Replace six 12- and 18-inch diameter road and driveway culverts (280 lineal feet) with 24-diameter HDPE pipes. Total replacement culvert pipe length is 280 feet.
- Replace four 12- inch diameter road and driveway culverts (200 lineal feet) with 18-diameter HDPE pipes.
- Replace two catch basins with Type 2 CBs.
- A local peak flow increase of about 9 percent would occur in the reach downstream of Harborview Drive. The average channel velocity is also predicted to increase slightly by 3 percent in this reach also. Flow and velocity increase are attenuated and not transferred downstream.

**PROJECT:** HL-1 (Problem HL-5)  
**DESCRIPTION:** Replace 10 culverts, east side Harborview Rd.  
**SUBBASIN:** Hillsdale

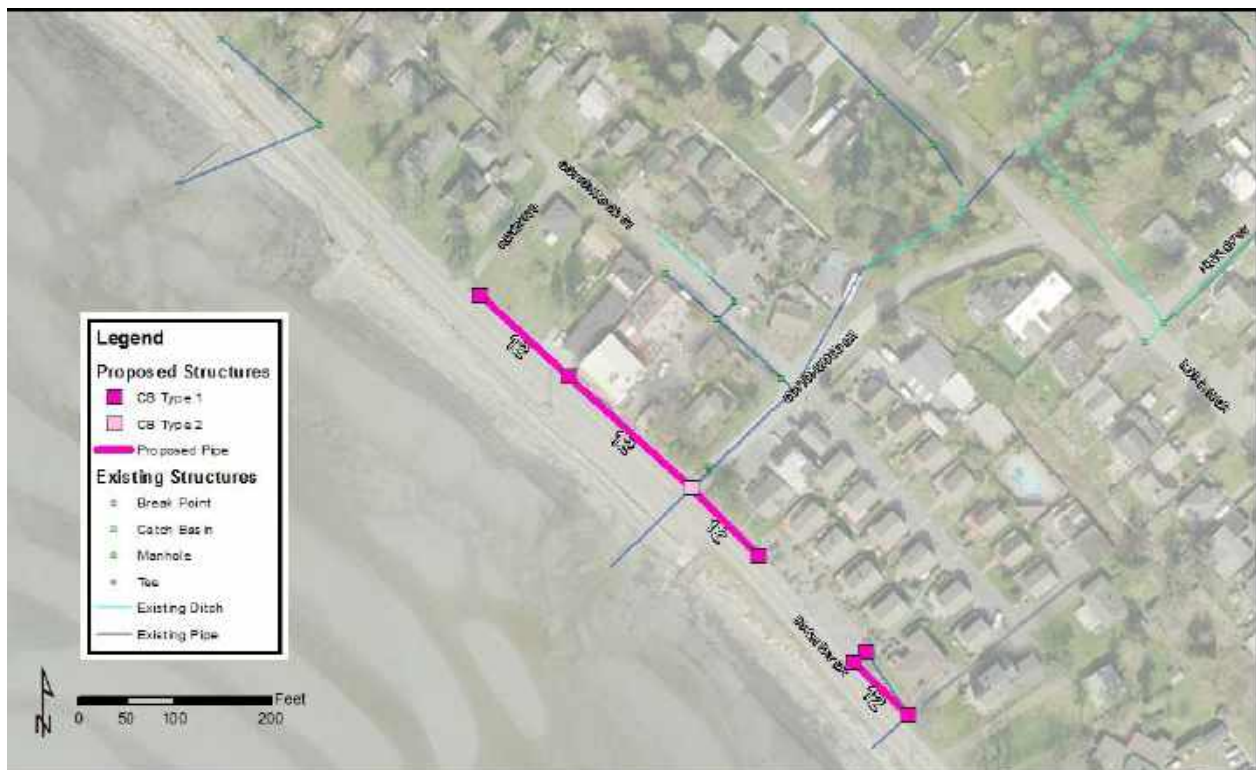
**BIRCH BAY URBAN SUBWATERSHED MASTER PLAN  
CAPITAL PROJECT PLANNING LEVEL CONSTRUCTION COST OPINION**

- Replace 325 lineal feet of 6- and 8-inch diameter storm drain with 12- diameter HDPE pipe.
- Install 175 lineal feet of 12- inch diameter HDPE pipe.
- Replace 4 catch basins with Type 1 CBs.
- Install 2 new Type 1 CBs
- Install 1 new Type 2, 72-inch diameter CB to connect new storm drain to existing 30-inch diameter pipeline outfall.

PROJECT: <u>HL-2 (Problem HL-1 and HL-8)</u>	BY: <u>GMS</u>
DESCRIPTION: <u>Replace storm drain, Birch Bay Dr. at Cottonwood Dr.</u>	CHECKED BY: _____
SUBBASIN: <u>Hillsdale</u>	DATE: <u>May 8, 2012</u>

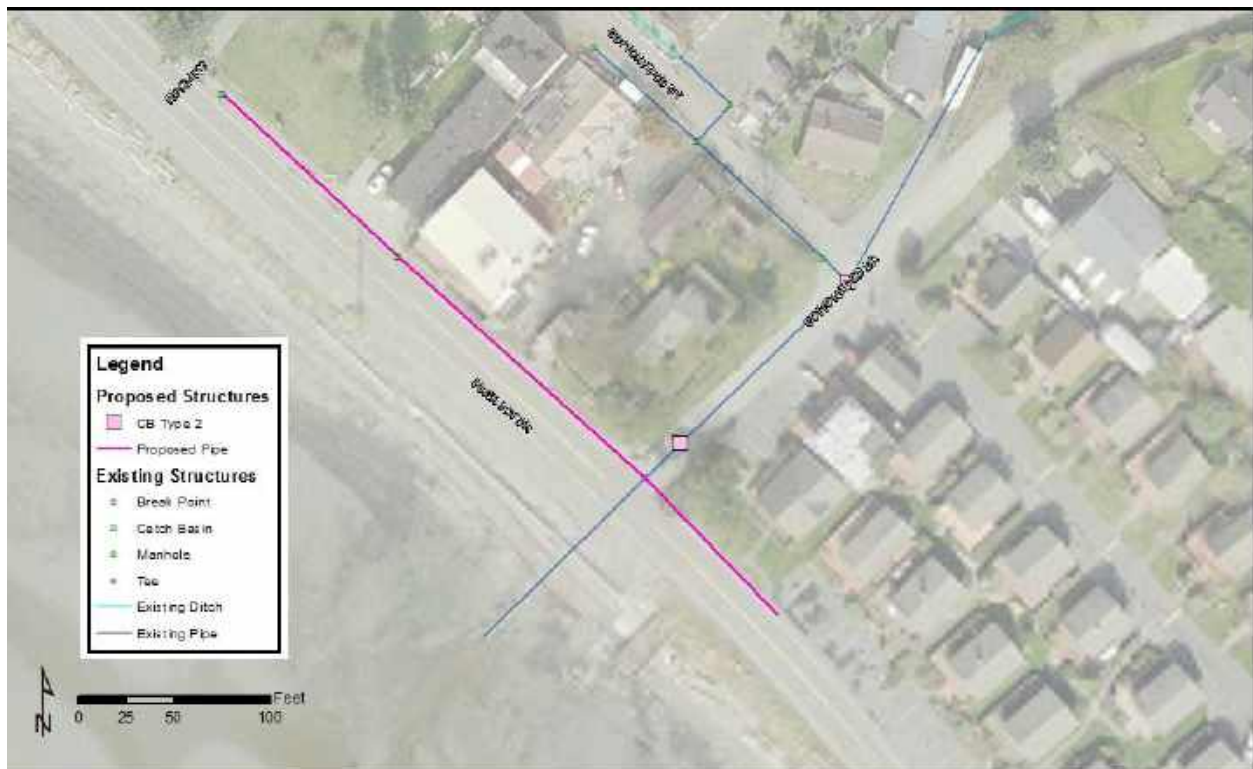
**BIRCH BAY URBAN SUBWATERSHED MASTER PLAN  
CAPITAL PROJECT PLANNING LEVEL CONSTRUCTION COST OPINION**

- Replace two blind tee connections with type 2 CBs.
- Connect existing pipe to CBs.

**PROJECT:** HL-3 (Problem HL-13 and HL-14)  
**DESCRIPTION:** Cottonwood Drive Maintenance Improvements  
**SUBBASIN:** Hillsdale

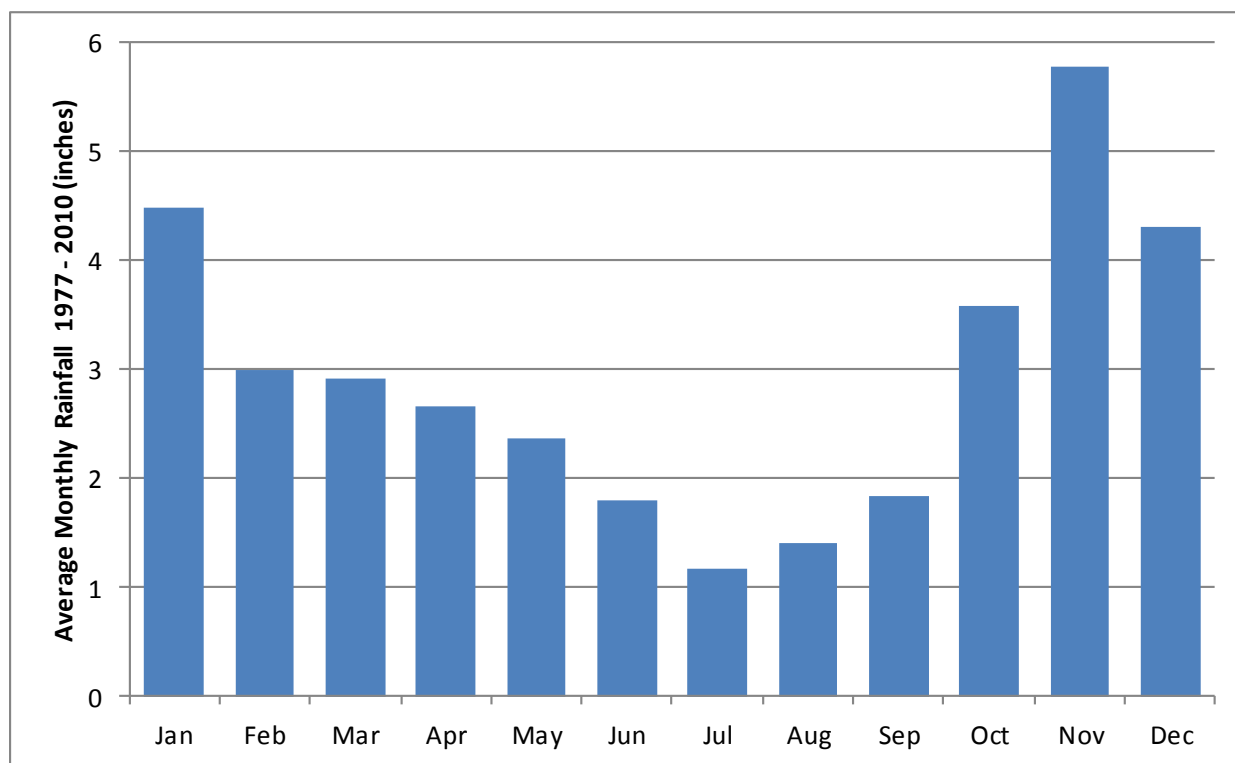
Figure 2-1. Average Monthly Rainfall—Birch Bay (BBWSD, 2011)

Birch Bay experiences a mild marine climate with cool, dry summers and mild, wet winters. Average monthly temperature ranges from about 37°F in January to 62°F in August. However, extreme temperatures can occur, with temperatures below freezing an average of about 70 days per year. Temperature rarely gets above 90°F (WRCC, 2011). The Birch Bay area receives an average of about 35 inches of rain annually. Some precipitation occurs as snow, with about 14 inches in an average year. Figure 2-1 shows the average monthly rainfall measured by the Birch Bay Water and Sewer District (BBWSD) near Birch Bay State Park. Typically, winter rainfall occurs as long-duration, low-intensity events over a day or more.

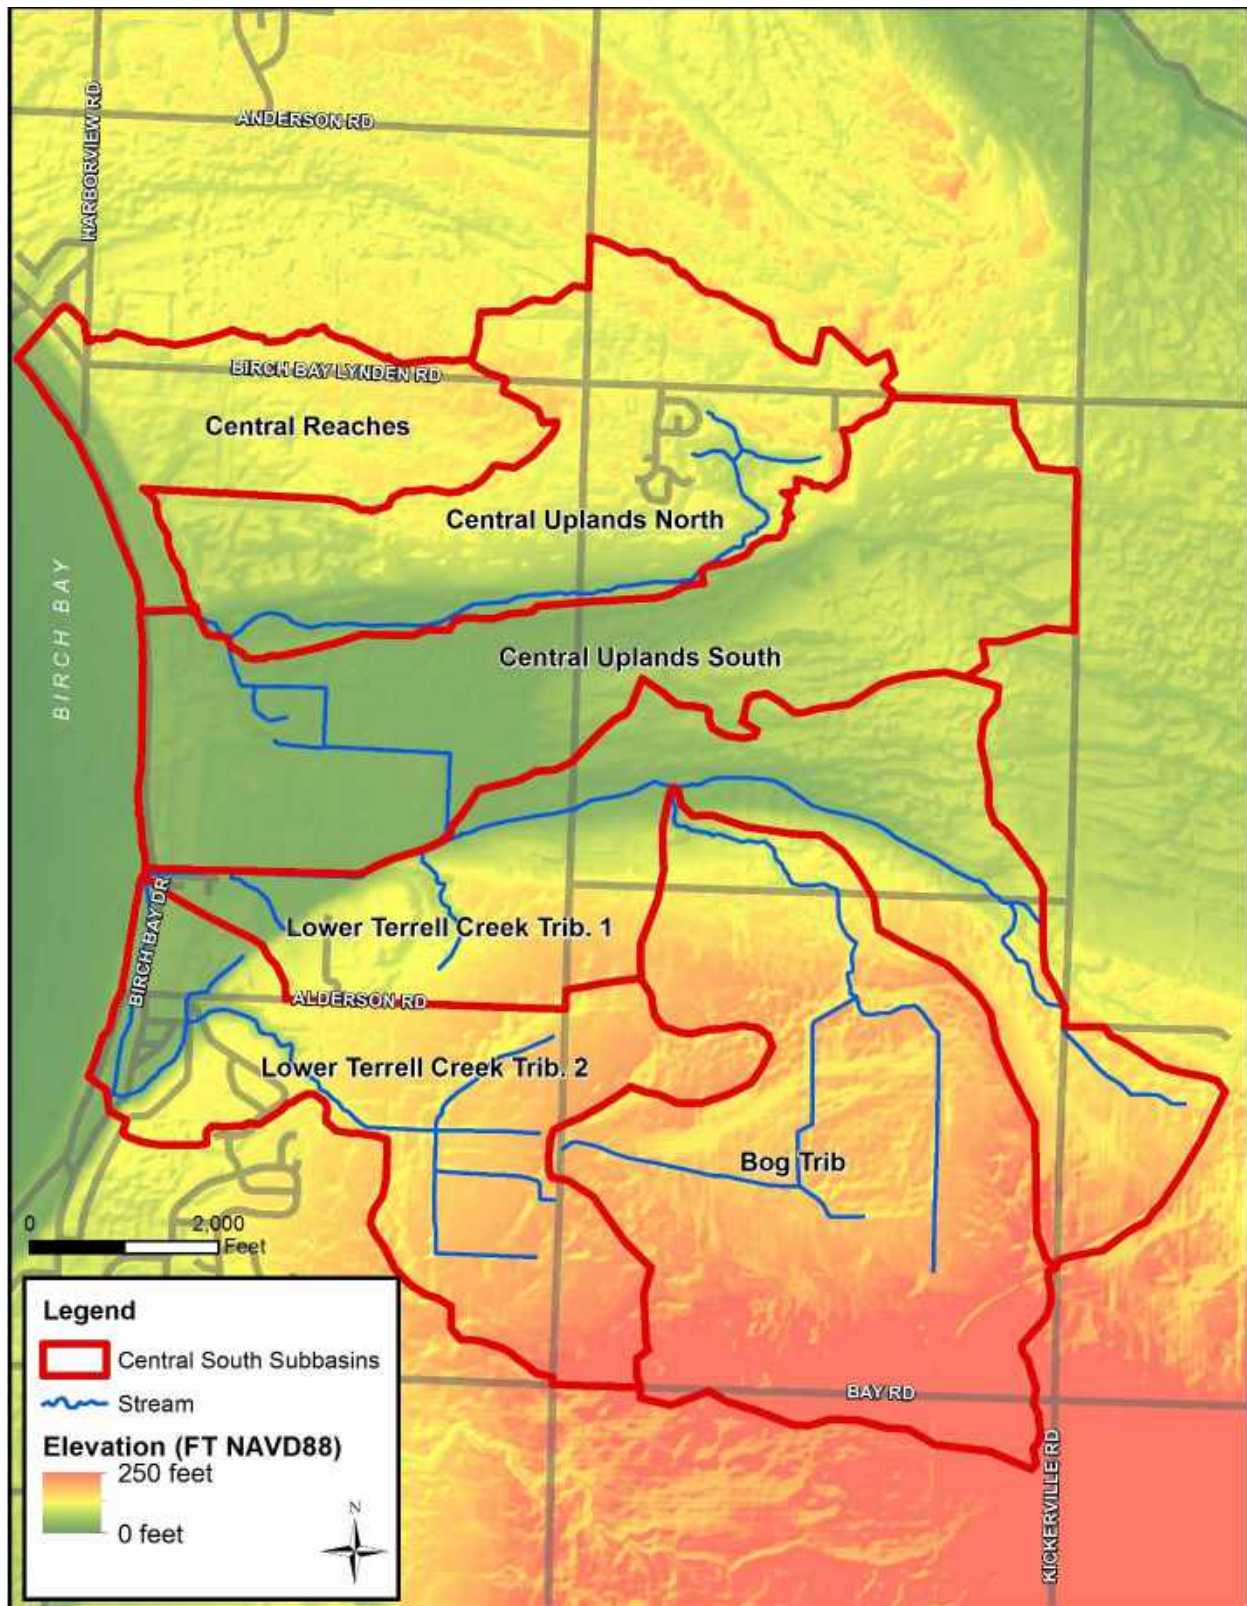
Figure 2-2. Topography of the Central South Subwatershed

The Central South Subwatershed is a rectangular basin extending 1.75 miles east to west and 2.0 miles north to south. Surface runoff flows east to west to Birch Bay through six distinct drainages. The elevation is higher on the northern and southern edges of the subwatershed, with a distinct trough through the center. The elevation of the lowland area ranges from 10 to 30 feet NAVD88 (North American Vertical Datum 1988). The higher southern and northern portions are much steeper and have elevations up to 60 feet NAVD88 at the northern end and 120 feet NAVD88 at the southern end. Figure 2-2 shows the topography of the Central South Subwatershed.

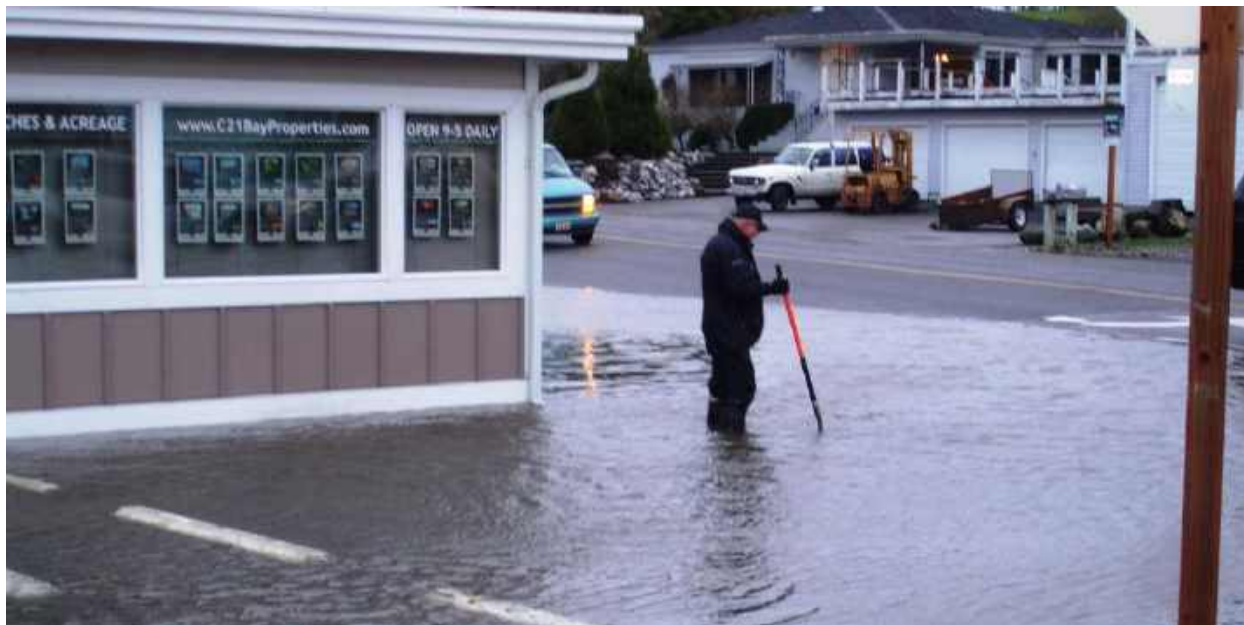
*Figure 4-1. Street Ponding on Birch Bay Drive Near Harborview Road (Photo by Whatcom County)*

Naturally occurring ponding in an undisturbed system is beneficial because it slows the rate of runoff, thus reducing the likelihood of conveyance and erosion problems downstream. However, if ponding poses a safety concern or property damage risk (see Figure 4-1), then correction is required. Most ponding in the Central South Subwatershed occurs because of high tide during storm events, lack of drainage infrastructure and low ground slopes.
