Resolution amending the 2006 Birch Bay Comprehensive Stormwater Plan to include four Subwatershed Master Plans (Council acting as the Whatcom County Flood Control Zone District Board of Supervisors)

# BIRCH BAY

## COMPREHENSIVE STORMWATER PLAN

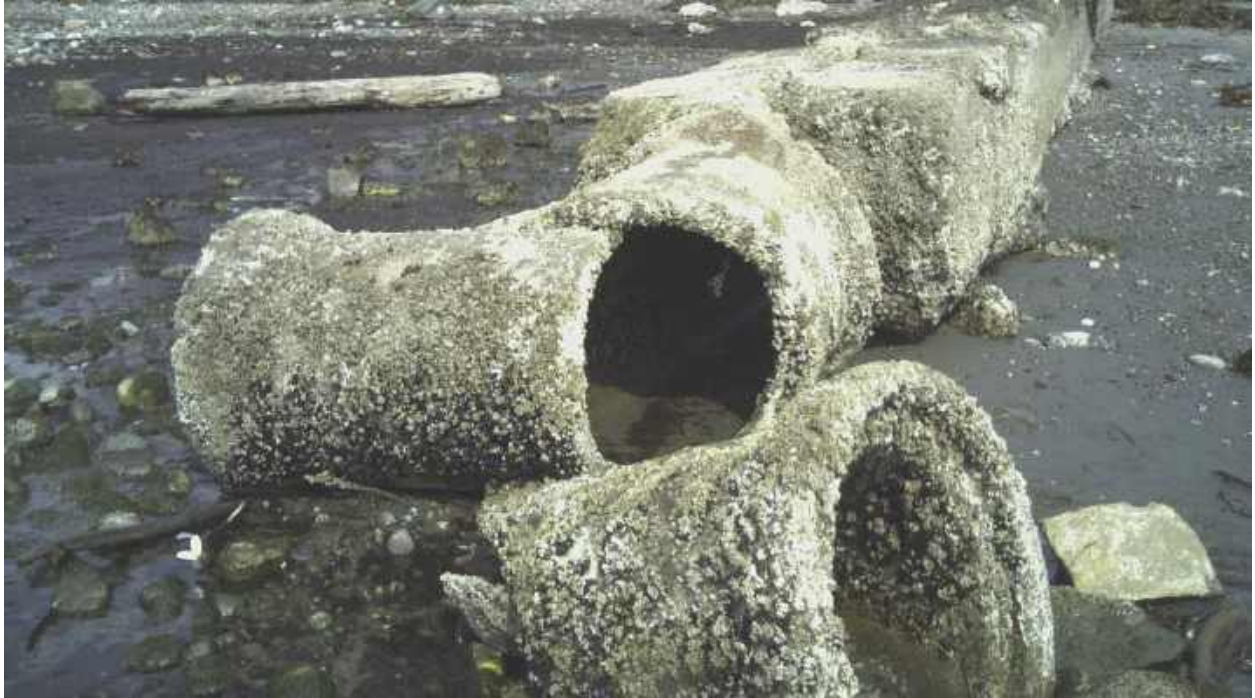
*Figure 4-2. Harborview Road Outfall Near Birch Bay Drive (photo by Wilson Engineering)*

Drainage structures are considered inadequate when they are too small to accommodate stormwater flows, whether by original design or because land use changes increase flows to levels beyond the system's capacity. It is not economical to design systems with capacity for every possible storm, but systems that are inadequate for a reasonable design storm must be improved by performing a hydraulic analysis of the system and designing improvements to meet local design criteria. Within the study area, many of the existing drainage structures were installed fairly recently and are of adequate size. More significant is the lack of any drainage infrastructure in several of the older neighborhoods. Inadequate infrastructure also includes structures in poor condition and in need of replacement, as shown in Figure 4-2.

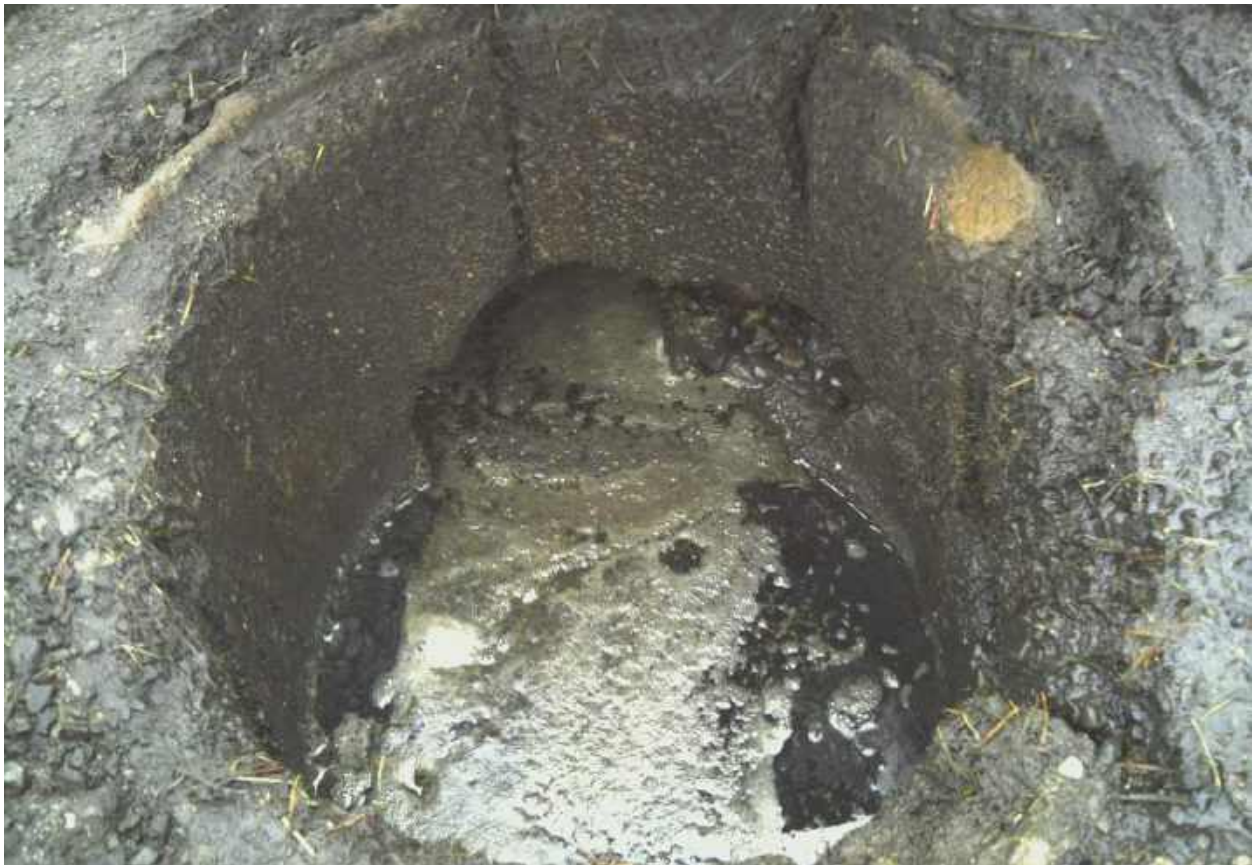
*Figure 4-3. Catch Basin with Oil Sheen and Odors (photo by Wilson Engineering)*

Urban stormwater quality is highly variable, depending on factors such as land use, the level of development, the age of the developed area, and the density of construction. The quality of stormwater runoff has historically been degraded by changes from natural to urbanized conditions (Figure 4-3). Fecal coliform and trash have been identified as water quality problems in the Central South Subwatershed.

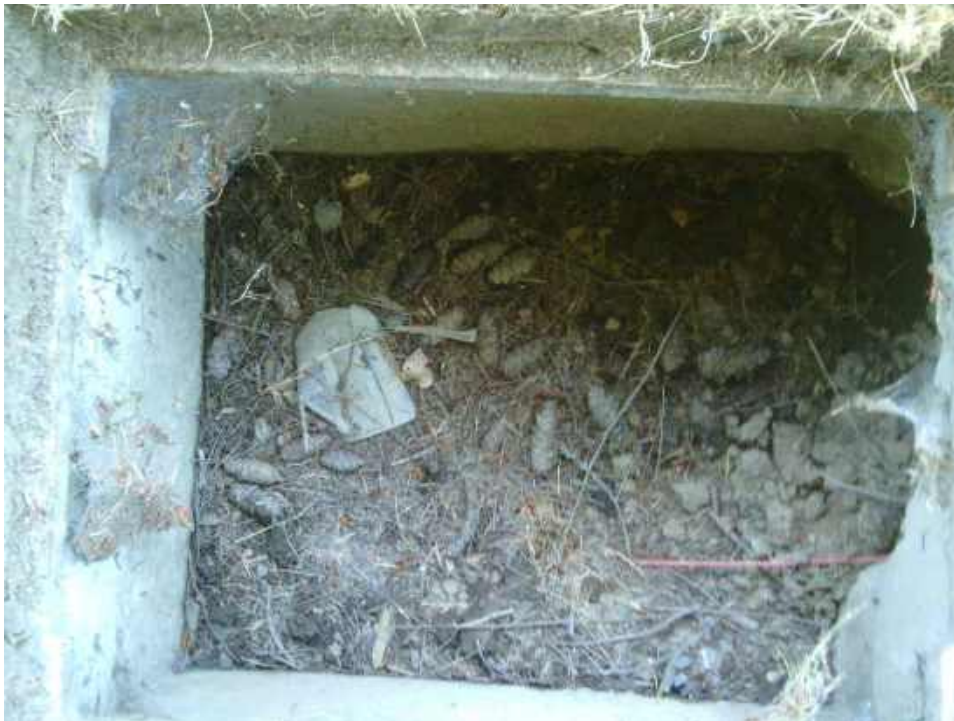
*Figure 4-4. Catch Basin with Sediment and Debris Accumulation (photo by Wilson Engineering)*

Drainage structures fill with sediment over time in the absence of regular cleaning (see Figure 4-4). When structures become blocked, stormwater may overflow during rainfall events, causing damage to surrounding public and private property. Drainage structures in the Central South Subwatershed are especially prone to siltation and blockage due to backwater in low-gradient drainage systems which allows sediment to settle into the pipe and ditch systems. Sediments from developed areas have been shown to contain high levels of pollutants. Also, stormwater outfalls to Birch Bay are susceptible to blockage due to tidal fluctuation that washes sand and mud into outfall pipes and offshore currents that float debris over the opening.

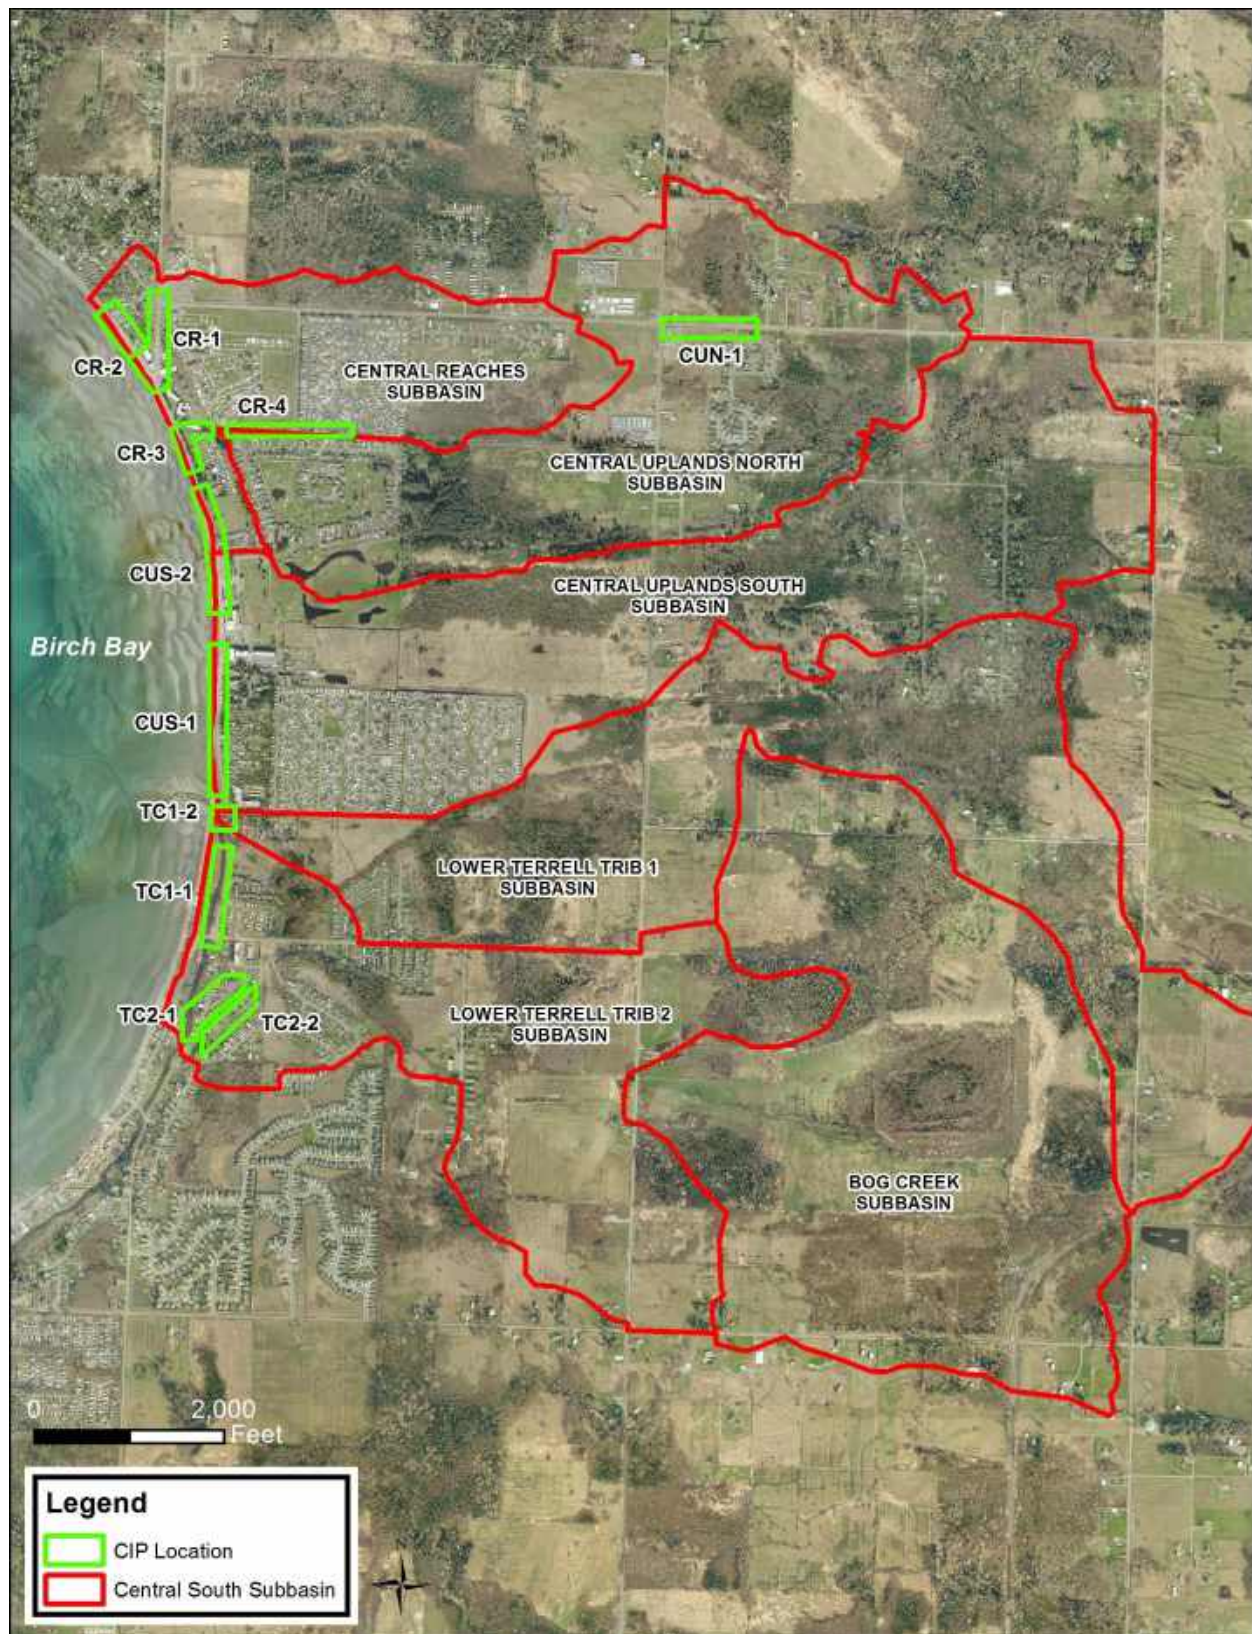
Figure 5-2. Capital Projects

Twelve capital projects were developed to address 33 drainage problems, as listed in Table 5-5. In some locations, a single project addresses more than one problem. The proposed projects include a total of over 11,300 feet of new or replacement storm drain pipeline, 265 feet of roadside ditch, 115 new or replacement catch basins, 290 feet of water quality swale, two new tide valves, and 6 new or replaced outfalls. Figure 5-2 shows the project locations. Detailed project descriptions are provided in Appendix C. Table 5-6 shows a breakdown of estimated project costs.

a. See Figure 5-2 for project location.

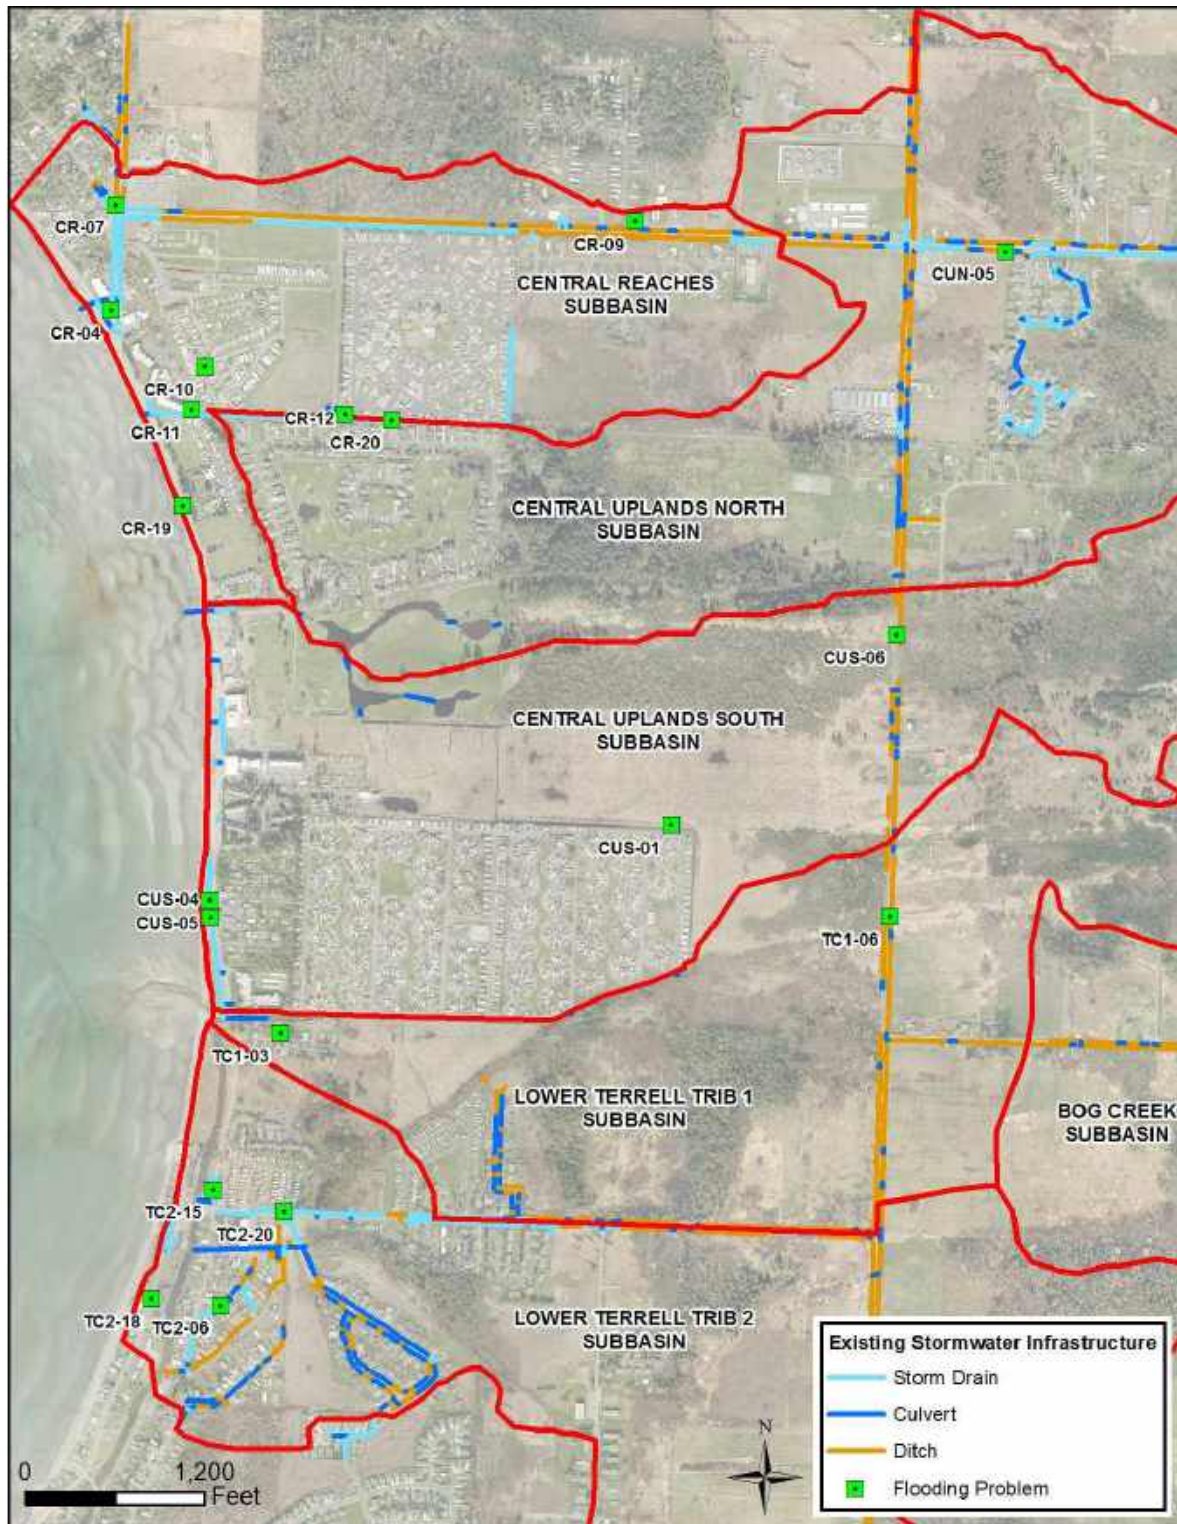
Figure 6. Flooding Problem Areas

Subbasin	Location	Pipe Size (in)	Predicted Peak Flow (cfs)		Max Flow Before Flooding (cfs)
			25-Year	100-Year	
Central Reaches	Harborview Rd.	18	14.9	17.8	3.7
Central Uplands North	Mariners Cove	30	23.8	26.4	24.3
Central Uplands North	Club House Dr.	36	20.4	27.2	> 100-Year
Terrell Creek Trib. 1	Lora Lane	48	32.7	49.7	44.2
Terrell Creek Trib. 2	Birch Creek	48	53.1	105	>100 Year
Terrell Creek Trib. 2	Wooldridge Ave.	36	7.8	9	6.9

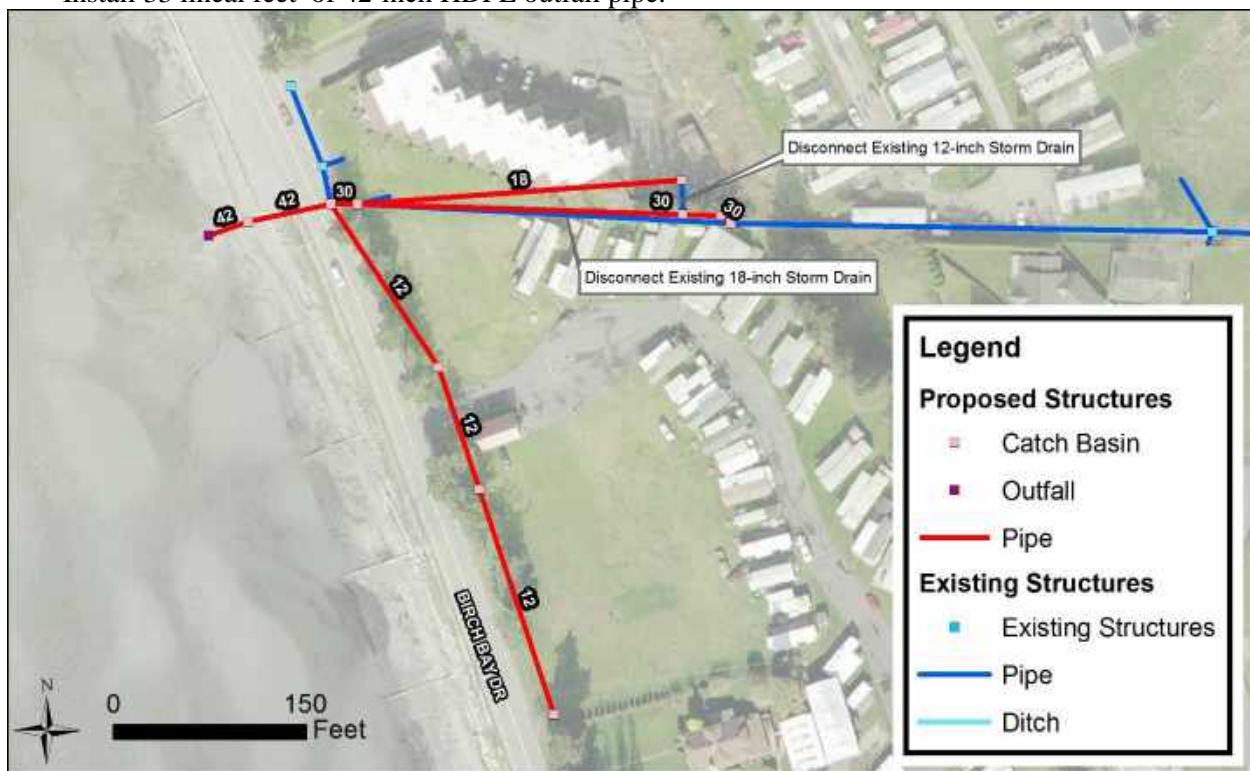
- Replace 315 lineal feet of 12-, 24-, and 30-inch diameter pipe with 30-inch CPE.
- Replace 66 lineal feet of 30-inch diameter pipe with 42-inch CPE.
- Replace 5 CB Type 2 structures and 1 CB Type 1 structure.
- Install 438 lineal feet of 12-inch diameter and 254 lineal feet of 18-inch diameter CPE pipe
- Install 1 CB Type 2 structure 3 CB Type 1 structures.
- Install 33 lineal feet of 42-inch HDPE outfall pipe.

**PROJECT:** CR-3  
**DESCRIPTION:** Birch Bay Drive at Mariners Cove SD Imp. and Outfall Repl.  
**SUBBASIN:** Central Reaches

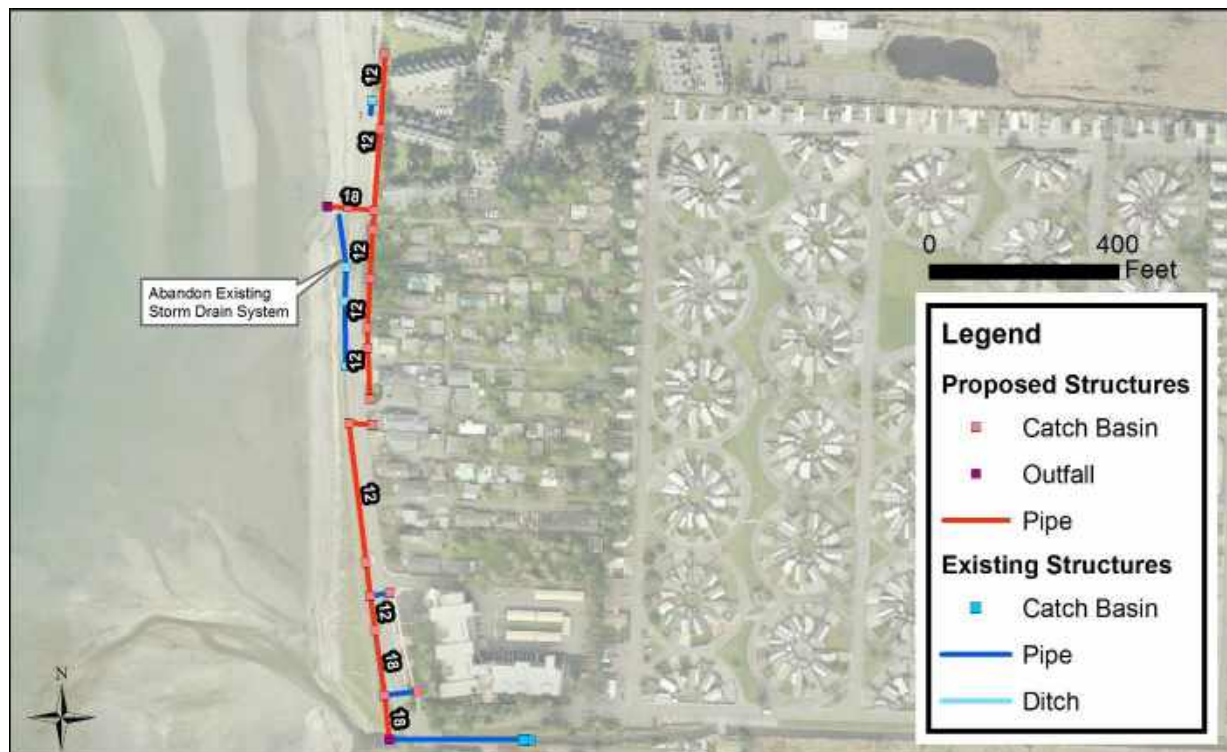
- Abandon existing storm drain line.
- Replace 679 lineal feet of 8-inch diameter storm drain with 445 lineal feet of 12-inch CPE and 234 lineal feet of 18-inch CPE.
- Replace 2 CB Type 1 structures with CB Type 2 Structures
- Replace 5 CB Type 1 structures.
- Install 788 lineal feet of 12-inch diameter CPE pipe and 55 lineal feet of 18-inch diameter CPE pipe
- Install 9 CB Type 1 structures and 2 CB Type 2 structures.
- Install one 18-inch HDPE outfall to Birch Bay (30 lineal feet).

**PROJECT:** CUS--1  
**DESCRIPTION:** Birch Bay Drive Storm Drain Improvements North of Lora Lane  
**SUBBASIN:** Central Uplands South

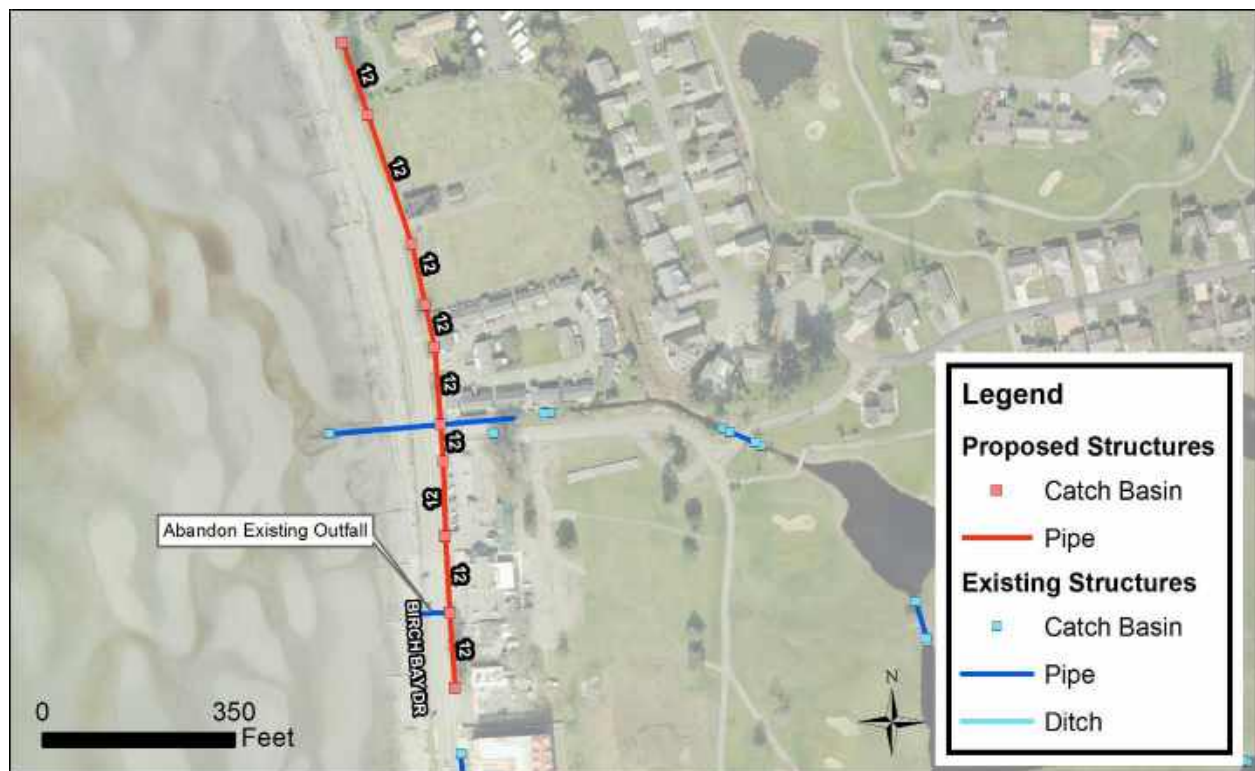
- Install 1,200 linear feet of 12-inch CPE pipe.
- Install 9 CB Type 1 structures.
- Replace 1 CB Type 2 structure.

**PROJECT:** CUS-2  
**DESCRIPTION:** Birch Bay Drive at Club House Drive Storm Drain Improvements  
**SUBBASIN:** Central Reaches / Central Uplands South

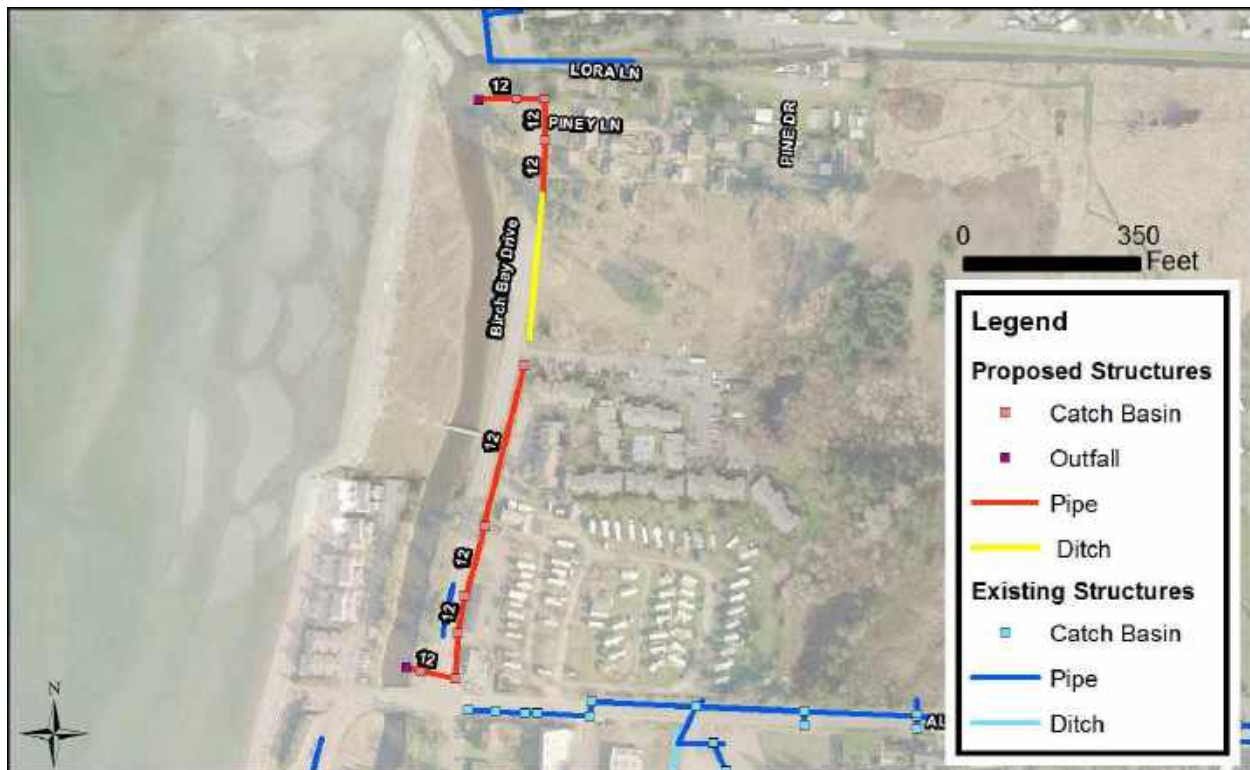
- Replace 194 lineal feet of 8- and 10-inch diameter storm drain with 12-inch diameter CPE.
- Install 719 lineal feet of 12-inch diameter CPE pipe.
- Construct 294 lineal feet of water quality swale.
- Replace 3 CB Type 1 structures and install 6 CB Type 1 structures.
- Install two 12-inch diameter HDPE pipe outfalls (145 total lineal feet).

**PROJECT:** TC1-1  
**DESCRIPTION:** Birch Bay Dr. Storm Drain Improvements North of Alderson Rd.  
**SUBBASIN:** Terrell Creek Tributary 1

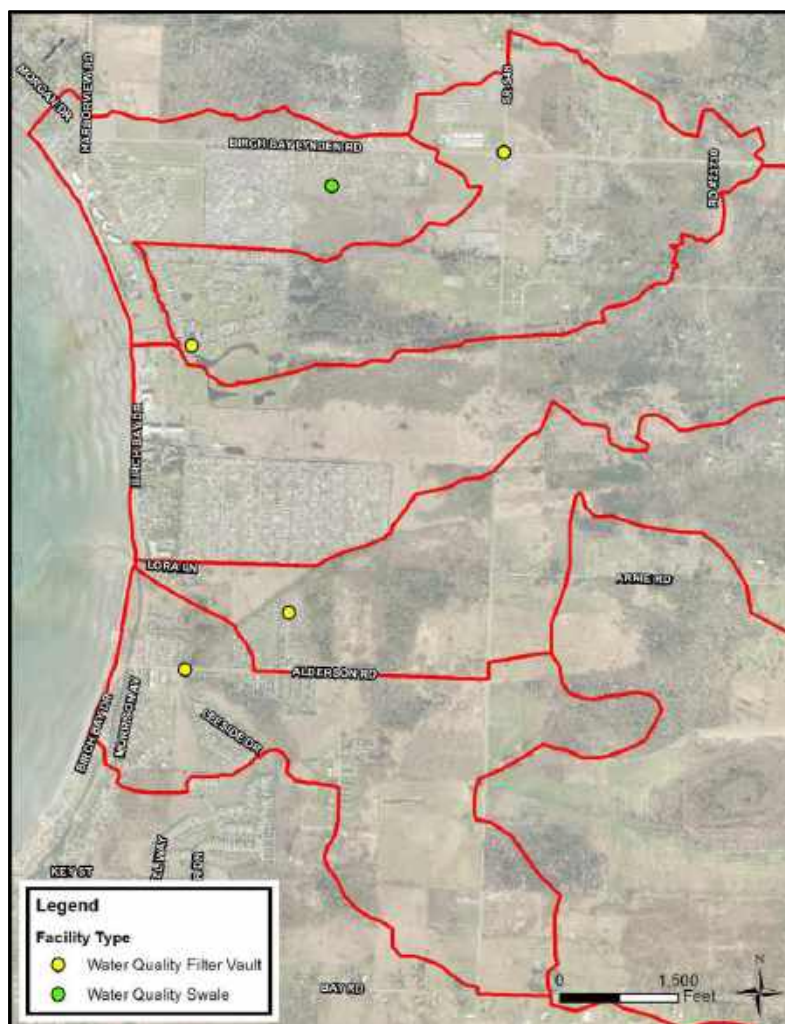
- 5 locations have been identified for water quality facility installations. Facility types will be evaluated and selected based on individual opportunity and may include water quality filter vaults and swales.

<b>PROJECT:</b> <u>BBCS-1</u> <b>DESCRIPTION:</b> <u>Subwatershed Water Quality Retrofit</u> <b>Subwatershed</b> <u>Birch Bay Central South</u>	<b>BY:</b> <u>GW</u> <b>CHECKED BY:</b> _____ <b>DATE:</b> <u>12/20/2014</u>
---	--

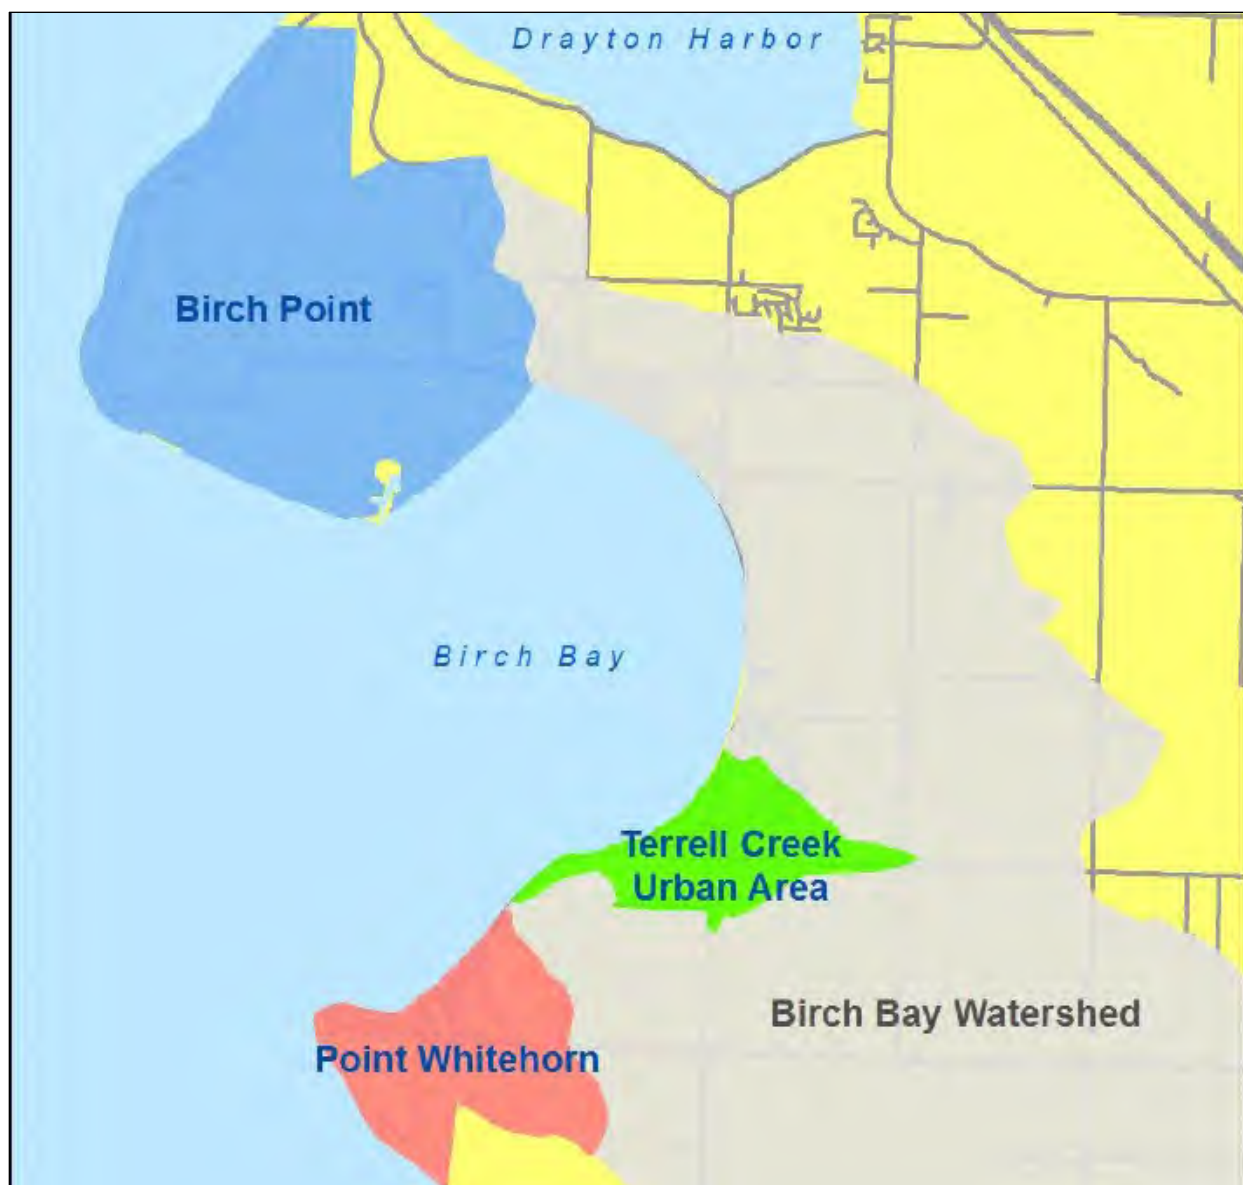
*Figure 1-1. Location of Subwatershed Master Plan Study Areas*

The Birch Bay watershed covers 27 square miles in the northwest corner of Whatcom County along the Georgia Straight, 18 miles northwest of Bellingham and just south of Blaine. The BP-TC-PW Subwatersheds cover about 2,700 acres along the Birch Bay shoreline (see Figure 1-1). The subwatersheds do not share any boundaries. Each is divided into multiple subbasins. Together they extend from south of Grandview Road to Drayton Harbor Road. Subwatershed areas near the shore generally consist of single-family residential housing, trailer parks and condominiums. The upland areas are rural and agricultural.

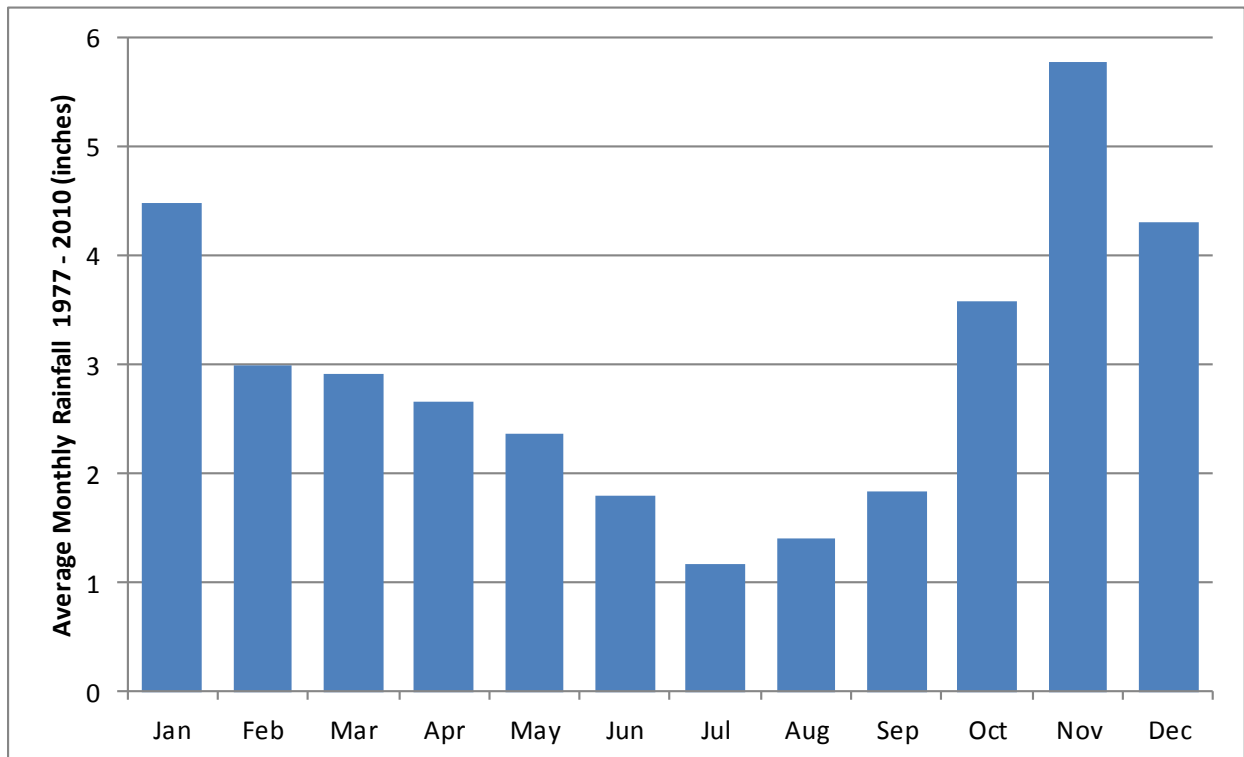
*Figure 2-1. Average Monthly Rainfall—Birch Bay*

Birch Bay experiences a mild marine climate with cool, dry summers and mild, wet winters. Average monthly temperatures range from about 37°F in January to 62°F in August. However, extreme temperatures can occur, with temperatures falling below freezing an average of about 70 days per year. Temperatures rarely get above 90°F (WRCC, 2011). The Birch Bay area receives an average of about 35 inches of rain annually. Approximately 14 inches of precipitation occurs as snow in an average year. Figure 2-1 shows the average monthly rainfall measured by the Birch Bay Water and Sewer District (BBWSD) near Birch Bay State Park. Typically, winter rainfall occurs as long-duration, low-intensity events over a day or more.

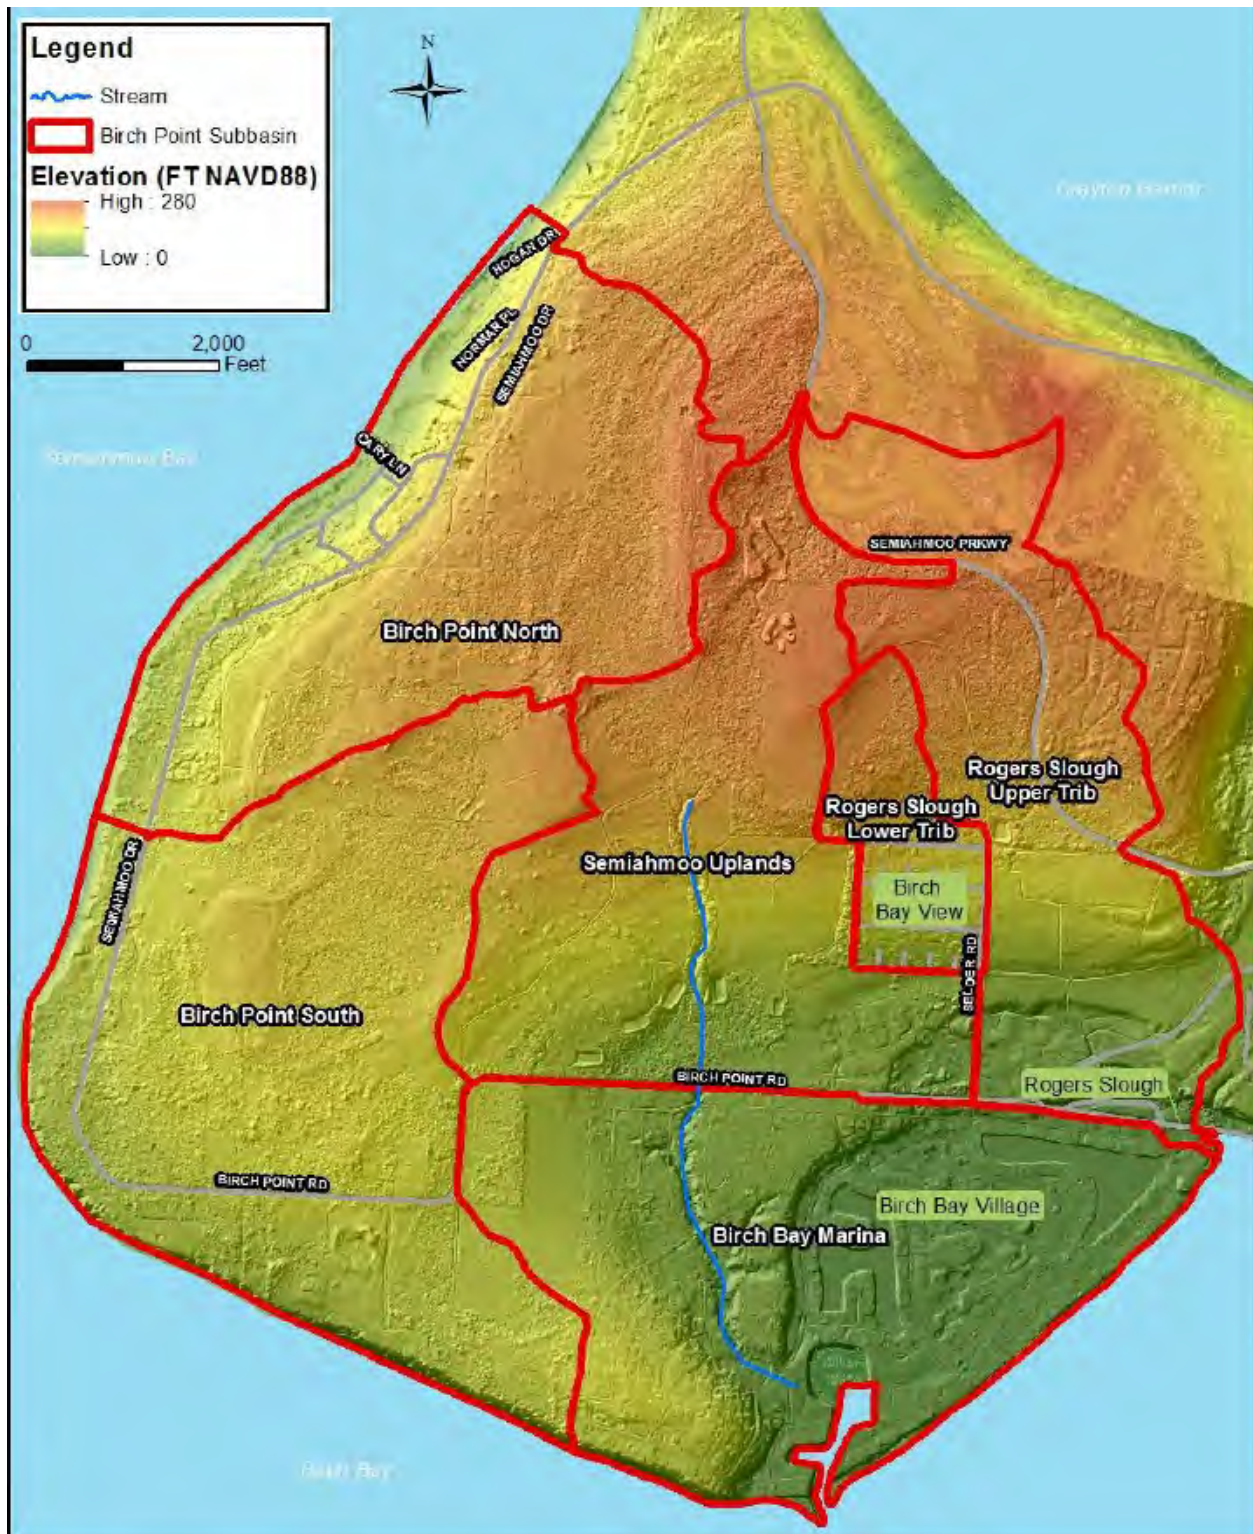
Figure 2-2. Topography of the Birch Point Subwatershed

The Birch Point Subwatershed (Figure 2-2) is a tear-drop shaped basin covering approximately 4 square miles and has been subdivided into six distinct subbasins. Surface runoff for the east side of the subwatershed generally flows south to Birch Bay.. The land falls steadily to the south toward Birch Bay and the west to the Semiahmoo Bay. A steep ridge drops to the water along the basin perimeter. A low-lying area surrounds the golf course and marina in the southeast portion of the subwatershed. Ground elevation ranges from 10 feet NAVD88 (North American Vertical Datum 1988) at the south end of the subwatershed to 260 feet NAVD88 in the northeast.

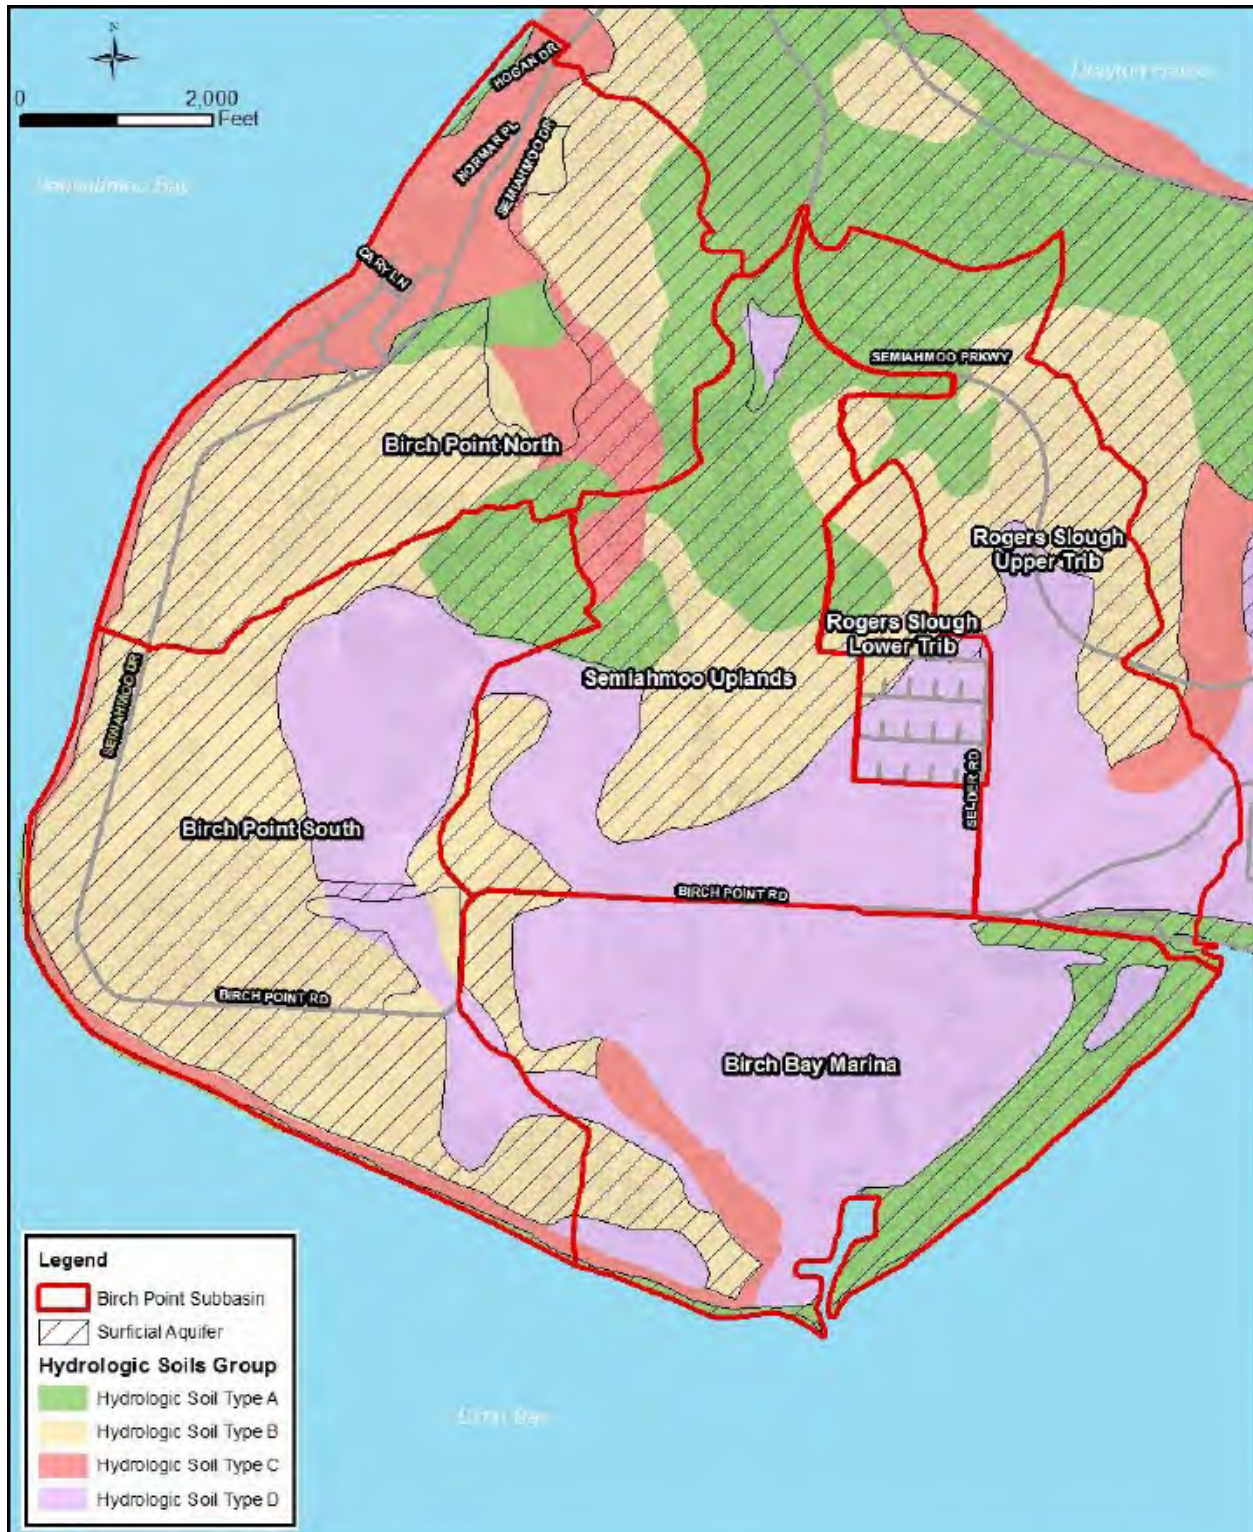
Figure 2-3. Hydrologic Soil Group and Surficial Aquifers in the Birch Point Subwatershed

Geologic conditions of the Birch Point Subwatershed are primarily the result of continental glaciation and intervening non-glacial periods. Figure 2-3 shows hydrologic soil groups and surficial aquifers.

- Type A and B soils are generally outwash soils made of loosely consolidated sand and gravel material. They are deep, well-drained soils with low runoff potential. Type A and B soils cover about 45 percent of the subwatershed.
- Type C soils are till soils made of fine-textured silts with shallow depths, low permeability, and high runoff potential. Type C soils cover the smallest area of the subwatershed at about 18 percent.
- Type D soils are wetland soils made of saturated silts and clays with a high water table. They are very shallow and have a confining clay or hardpan layer near the surface. Type D soils cover about 37 percent of the subwatershed.

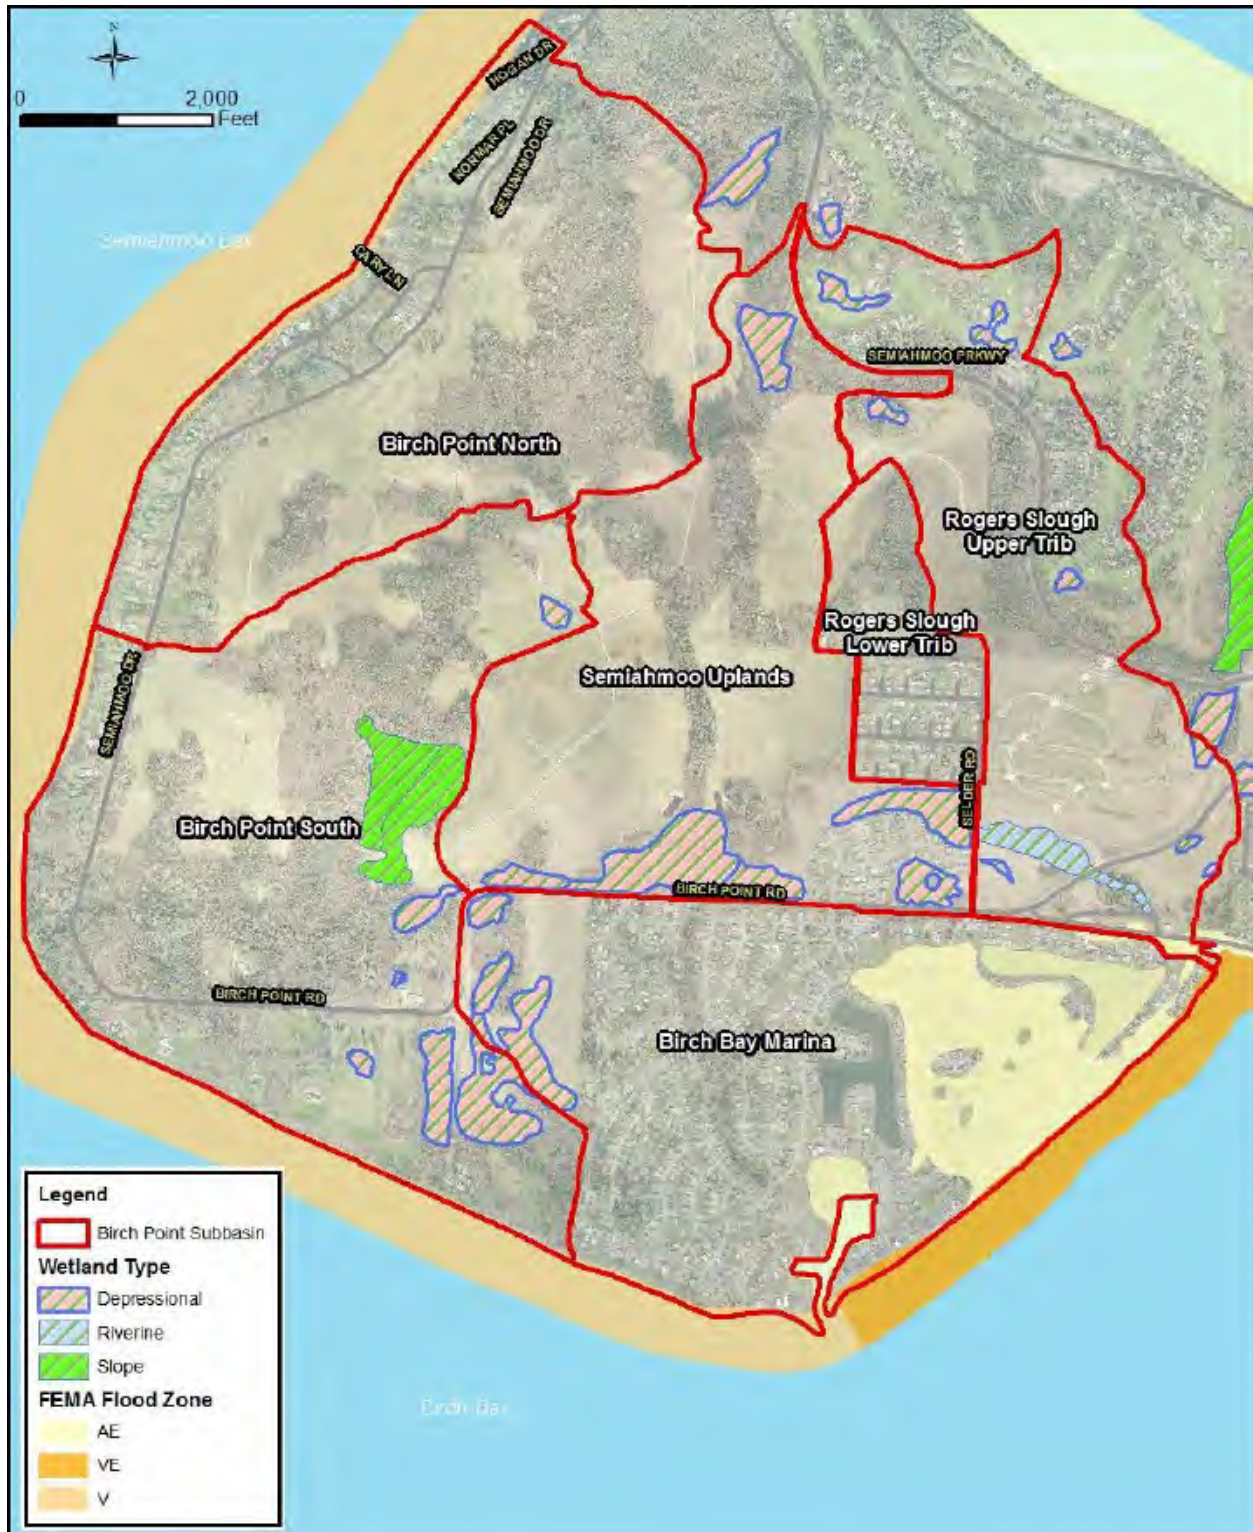
Figure 2-4. Wetlands and FEMA Flood Zones within the Birch Point Subwatershed

Flood hazard mapping (see Figure 2-4) by the Federal Emergency Management Agency (FEMA) has identified the coastal areas of the Birch Point Subwatershed as Flood Zone Type AE, VE, and V.

Wetlands are located in lowland areas of the subwatershed near Birch Point Road (see Figure 2-4) due to the flat topography, potentially high groundwater and relatively pervious surface soils. Table 2-1 summarizes the wetland area in each subbasin. Wetland locations were generated using approximate methods based on information from county sources; they may not represent actual wetland areas in the subwatershed.
