Resolution amending the 2006 Birch Bay Comprehensive Stormwater Plan to include four Subwatershed Master Plans (Council acting as the Whatcom County Flood Control Zone District Board of Supervisors)

# BIRCH BAY

## COMPREHENSIVE STORMWATER PLAN

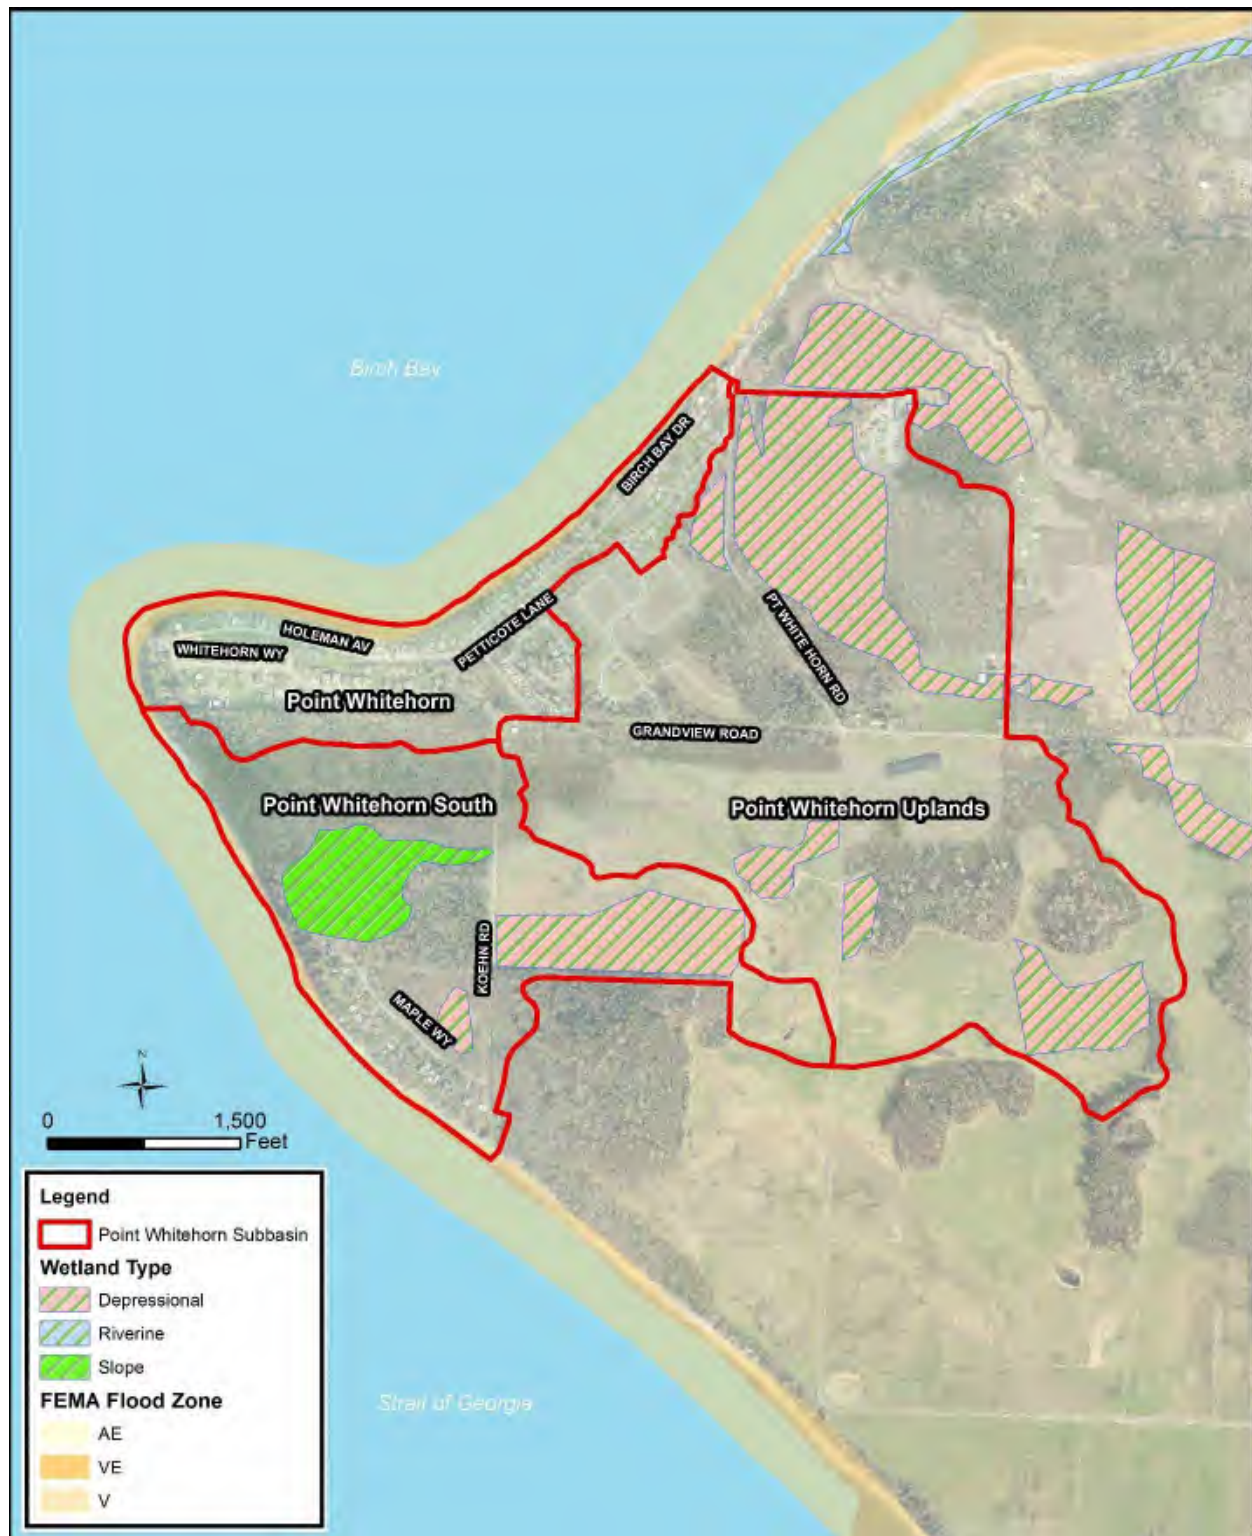
Figure 2-12. Wetlands and FEMA Flood Zones within the Point Whitehorn Subwatershed

A Type V flood zone is located along the shoreline through the entire length of the Point Whitehorn Subwatershed (Figure 2-12). No other flood zones were identified within the subwatershed. Flood zones are described on page 12.

Wetlands in the Point Whitehorn Subwatershed are shown in Figure 2-12 and cover approximately 20 percent of the subwatershed. The most extensive coverage is in the Point Whitehorn Uplands Subbasin, where wetlands cover 30 percent of the subbasin. Depressional wetland are found throughout the subwatershed and a slope wetland is located at the western edge. Table 2-9 summarizes wetland coverage in the Point Whitehorn Subwatershed. Wetland types are described on page 12.

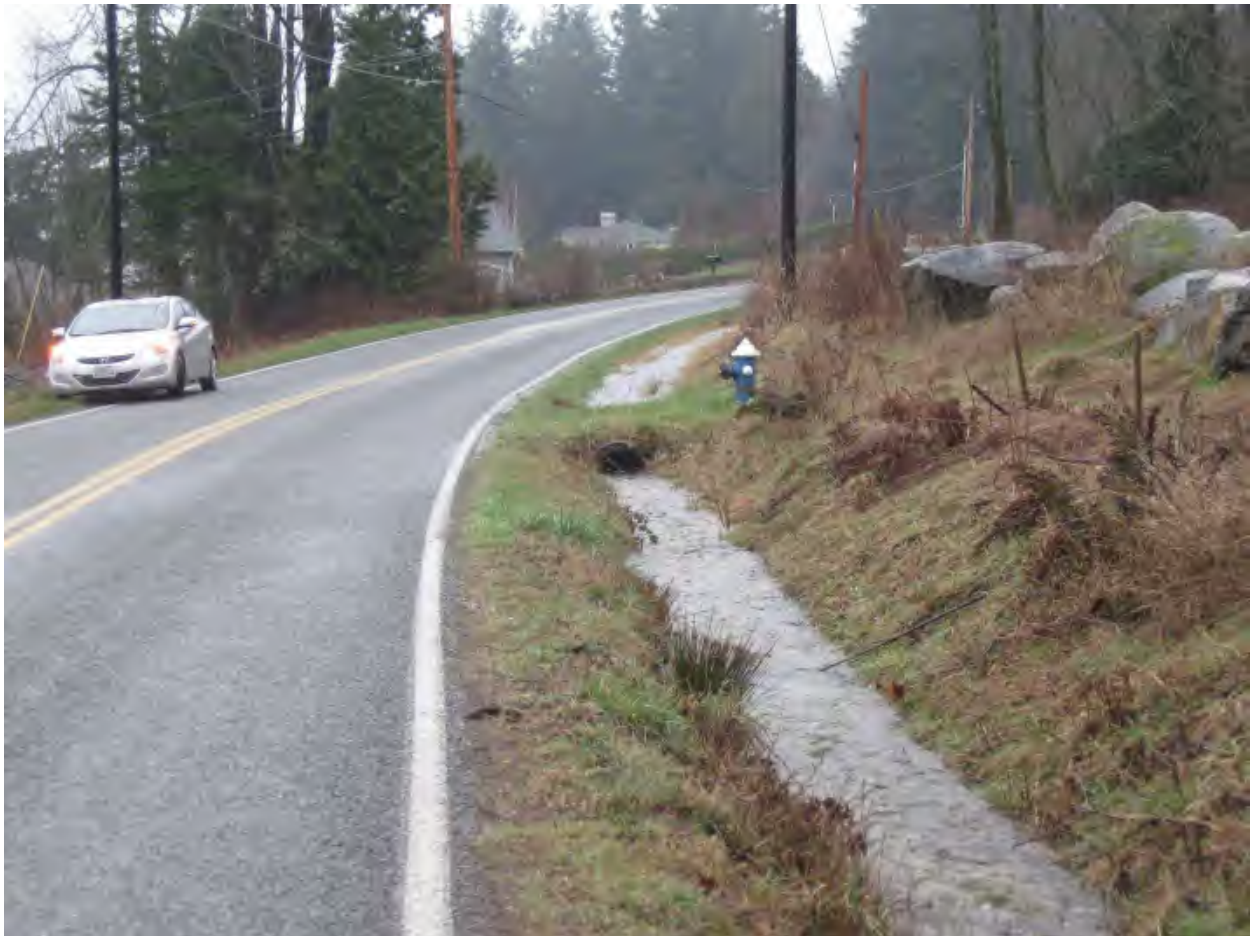
*Figure 4-1. Roadside Ditches on Semiahmoo Drive, Undersized for Large Storms*

Drainage structures are considered inadequate when they are too small to accommodate stormwater flows, whether by original design or because land use changes increased flows to levels beyond the system's capacity. It is not economical to design systems with capacity for every possible storm, but systems that are inadequate for a reasonable design storm (see Figure 4-1) must be improved by performing a hydraulic analysis and designing improvements to meet local design criteria. Within the study area, many of the existing drainage structures were installed fairly recently and are of adequate size. Inadequate infrastructure also includes structures in poor condition and in need of replacement, as shown in Figure 4-2.

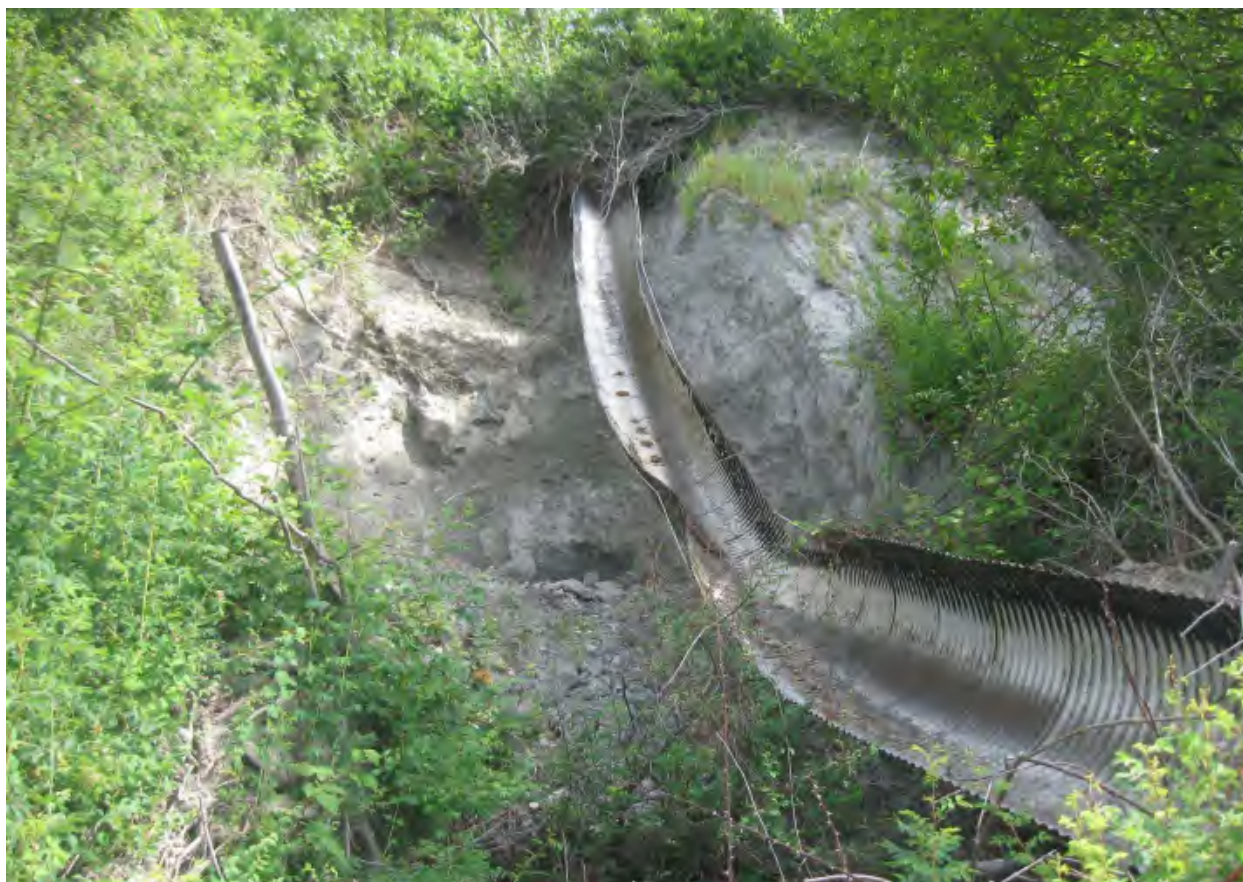
*Figure 4-2. Erosion-Undermined Storm Drain Outfall to Birch Bay*

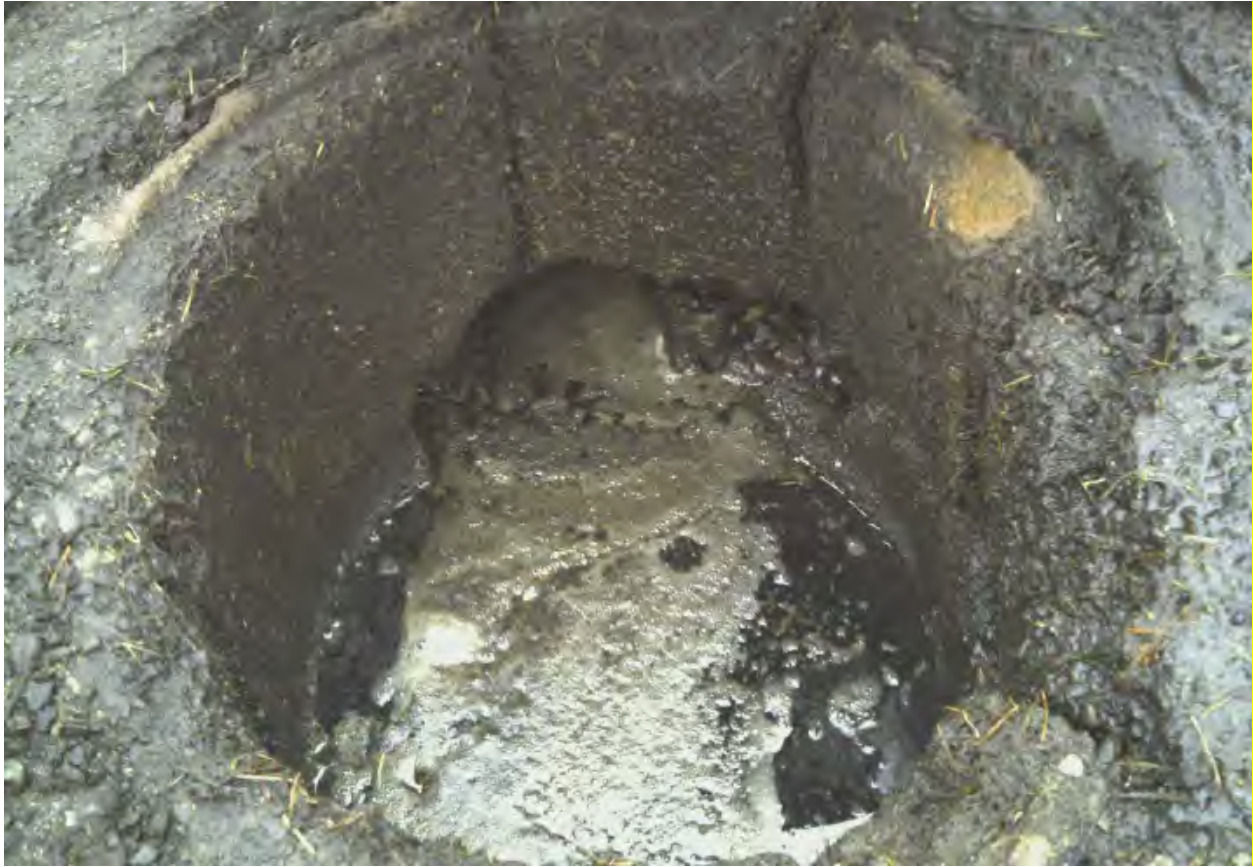
*Figure 4-3. Catch Basin with Oil Sheen and Odors*

*Figure 4-3. Catch Basin with Oil Sheen and Odors (photo by Wilson Engineering)*

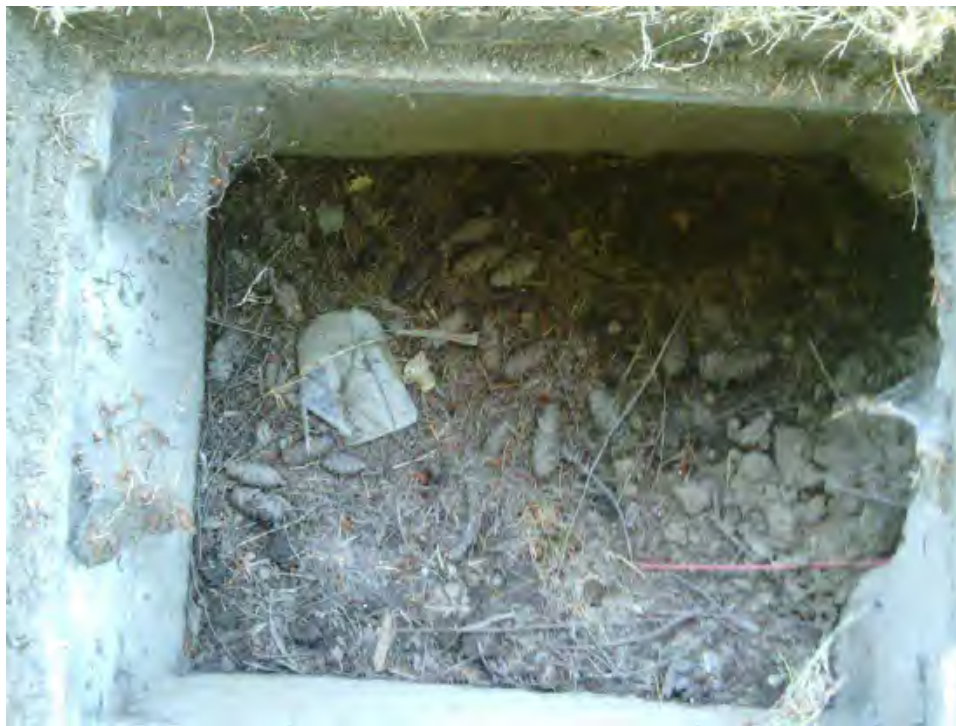
*Figure 4-4. Catch Basin with Sediment and Debris Accumulation (photo by Wilson Engineering)*

*Figure 4-4. Catch Basin with Sediment and Debris Accumulation (photo by Wilson Engineering)*

Drainage structures fill with sediment over time in the absence of regular cleaning (see Figure 4-4). When structures become blocked, stormwater may overflow during rainfall events, causing damage to surrounding public and private property. Drainage structures in the BP-TC-PW Subwatersheds are especially prone to siltation and blockage due to backwater in low-gradient systems, which allows sediment to settle into pipes and ditches. Sediments from developed areas have been shown to contain high levels of pollutants. Also, stormwater outfalls near sea level are susceptible to blockage due to tidal fluctuation that washes sand and mud into outfall pipes and offshore currents that float debris over the opening. Lack of access may also prevent adequate maintenance of the storm drain system. Proper storm drain design requires an access structure, usually a catch basin or manhole, at each point where a pipeline changes grade or alignment direction. Without this access, pipeline inspection and cleaning is difficult or impossible.

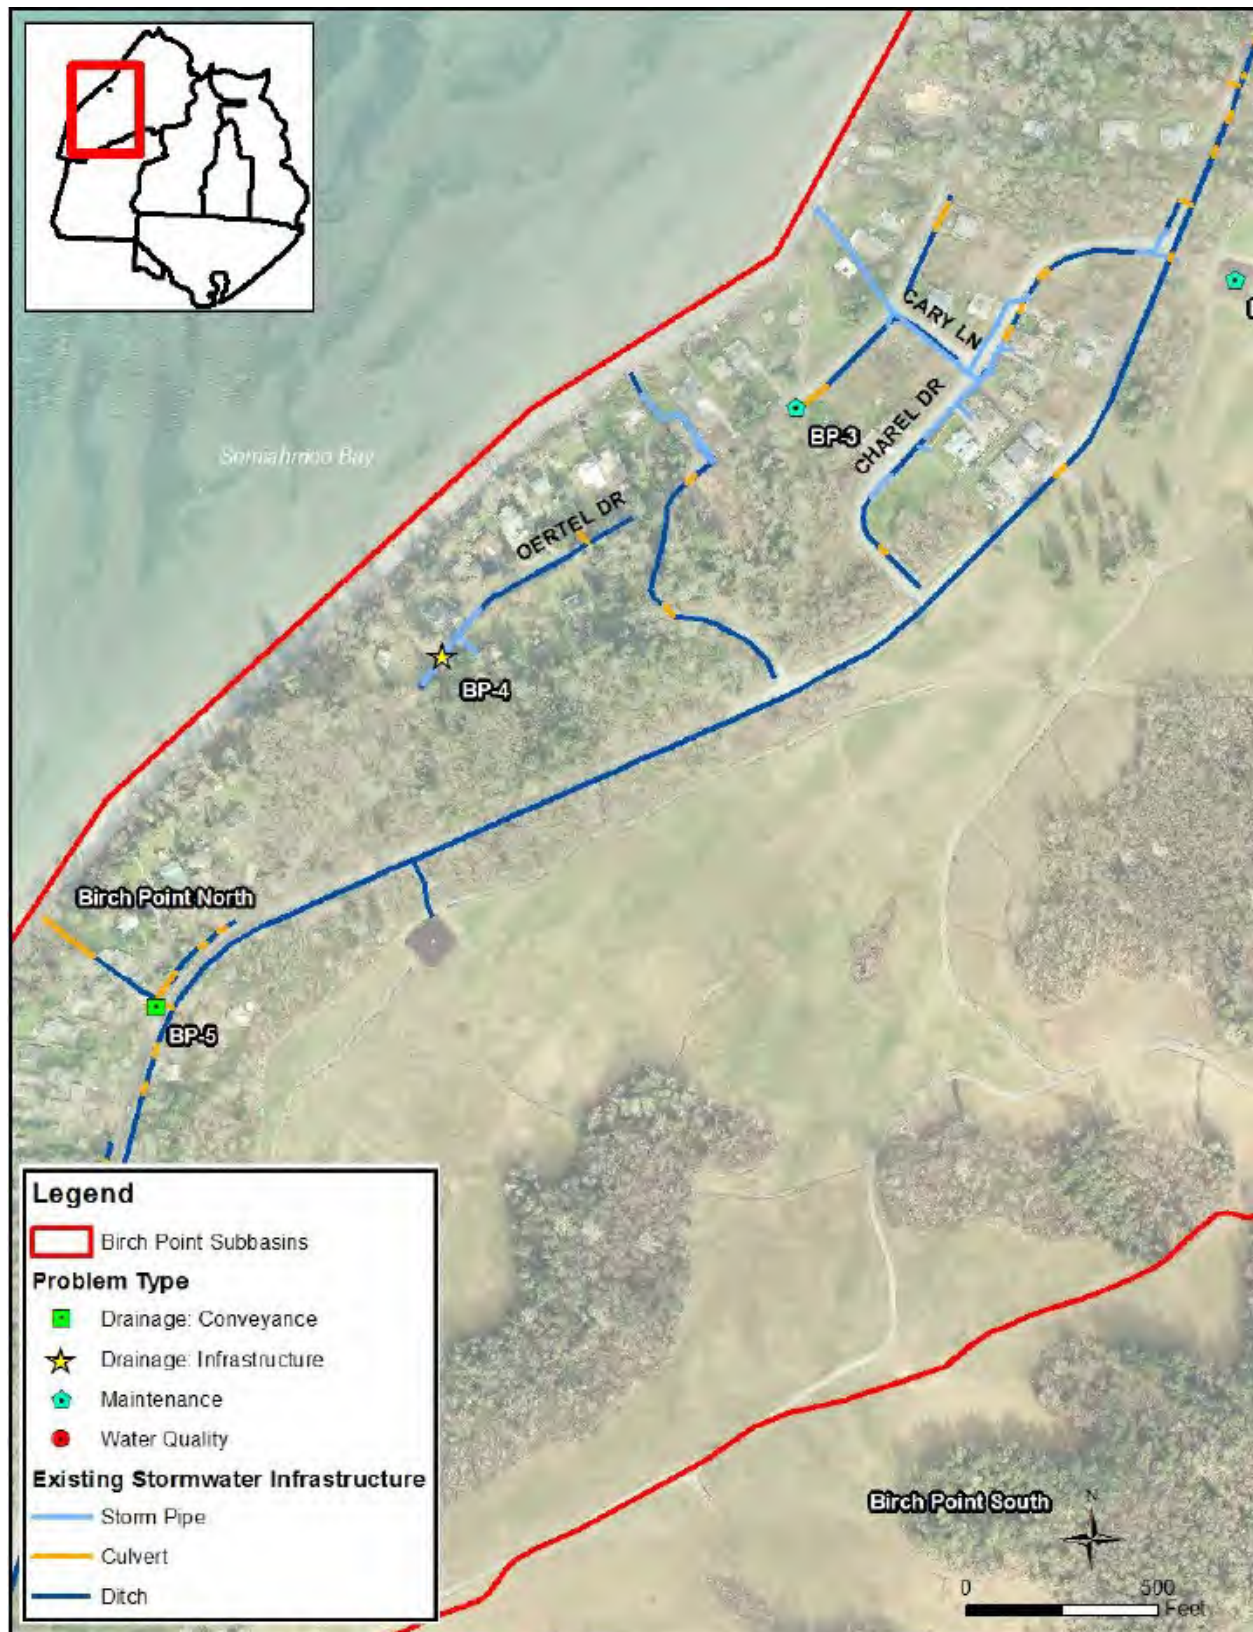
Figure 4-5A. Identified Problem Areas in the Birch Point Subwatershed

Figure 4-5B. Identified Problem Areas in the Birch Point Subwatershed

Figure 4-5C. Identified Problem Areas in the Birch Point Subwatershed

Figure 4-5D. Identified Problem Areas in the Birch Point Subwatershed

a. See Figures 4-5 for problem locations. b. Inventory = Whatcom County Stormwater Infrastructure Geodatabase, ACM = Advisory Committee Meeting, ID = Incident Database, BBCSP = Birch Bay Comprehensive Stormwater Plan, CDM = Conceptual Design Memorandum, HH Analysis = Hydrologic and Hydraulic Analysis, BB/TC WQMP = Birch Bay/Terrell Creek Water Quality Monitoring Project, County = County Staff, WDFW = Washington State Department of Fish and Wildlife (2016)

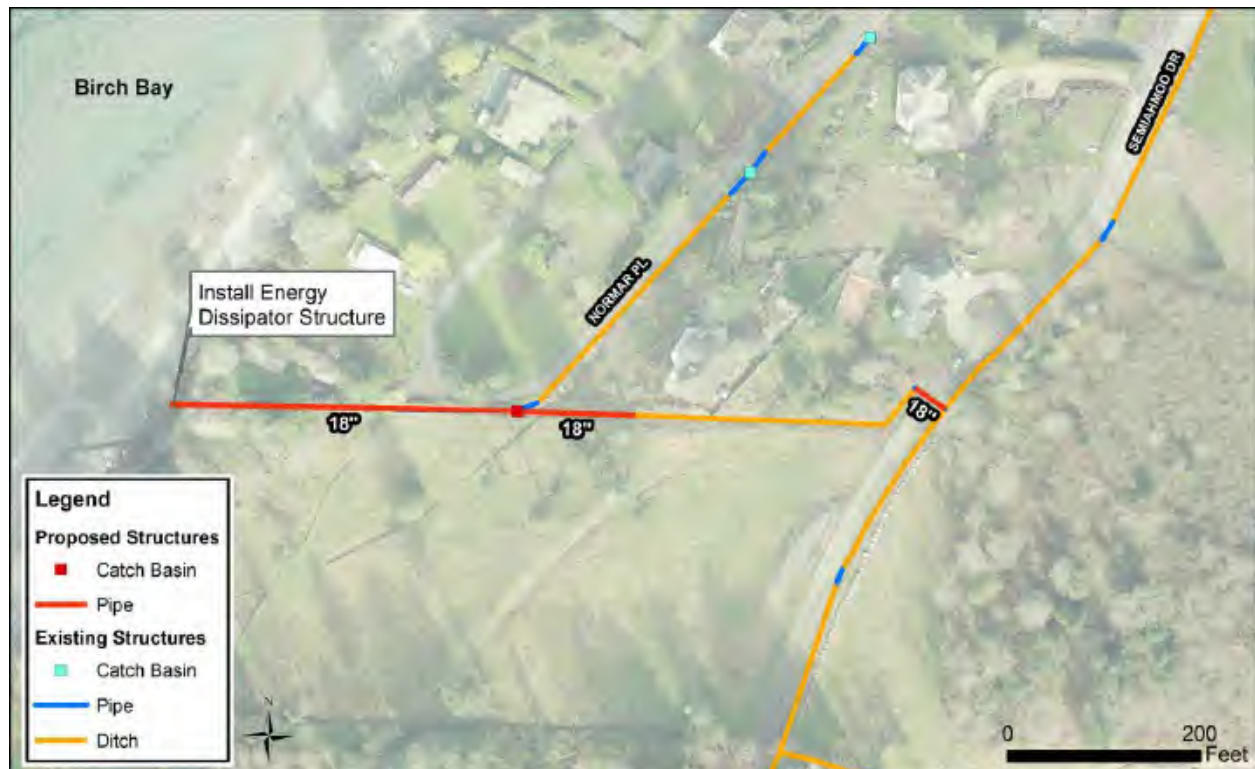
- Replace 415 lineal feet of 12-inch diameter pipe with 18-inch diameter CPE.
- Replace 30 lineal feet of 12-inch diameter concrete culvert with 18-inch CPE.
- Replace 1 CB Type 1 structure with 1 CB Type 2 structure.
- Install energy dissipater at pipe outfall.

Description: Culvert crossing under Semiahmoo Drive is undersized and causing roadway flooding during the 2-year and larger storm event under existing and future conditions. A flume conveys stormwater from Semiahmoo Drive to Normar Place (private) and overflows during the 25-year and larger storm event for existing and future conditions. High flow velocity in the roadside ditches is causing scour, sediment is transported to the downstream catch basin and obstructs flow.

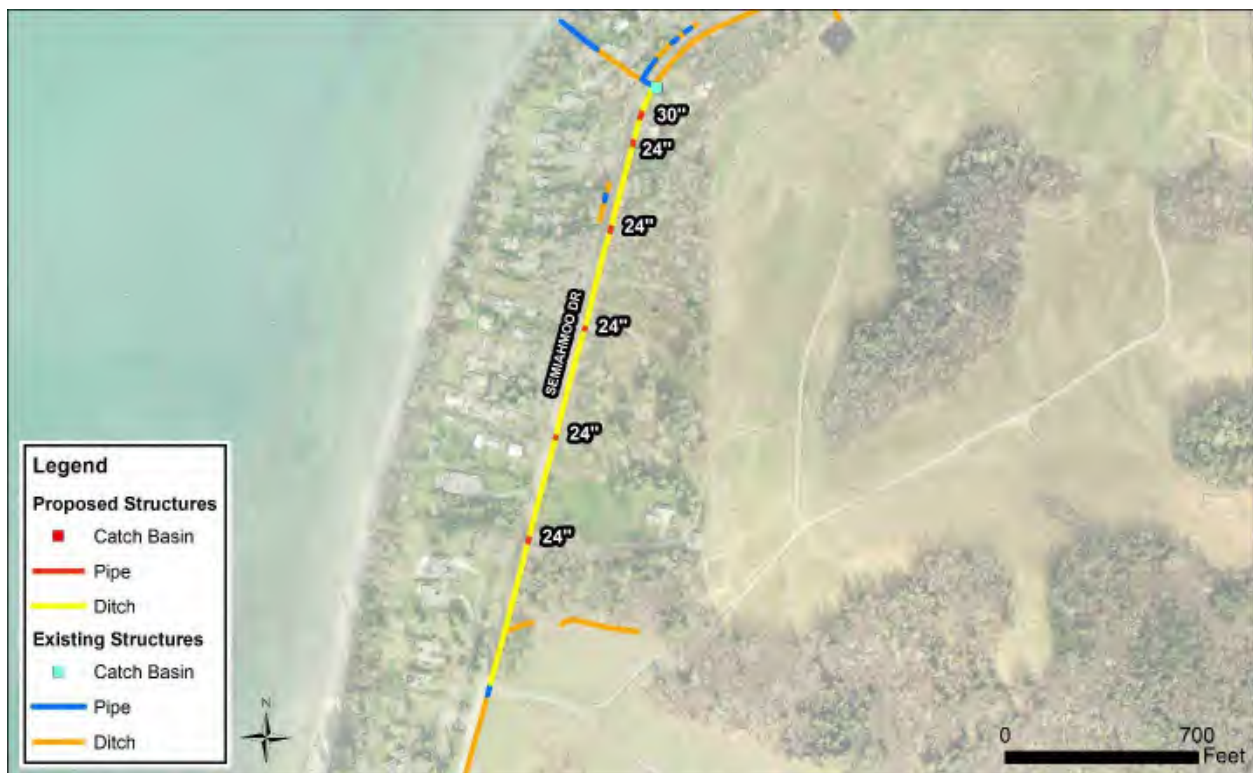
- Replace 165-linear feet of 15-, 18-, & 24- inch diameter pipe with 30-inch & 24-inch diameter CPE pipe.
- Re-establish 2,090 linear feet of roadside ditch.

Description: Driveway culverts and roadside ditches on the east side of Semiahmoo Drive have insufficient capacity and overflow during the 25-year and larger future conditions storm event.

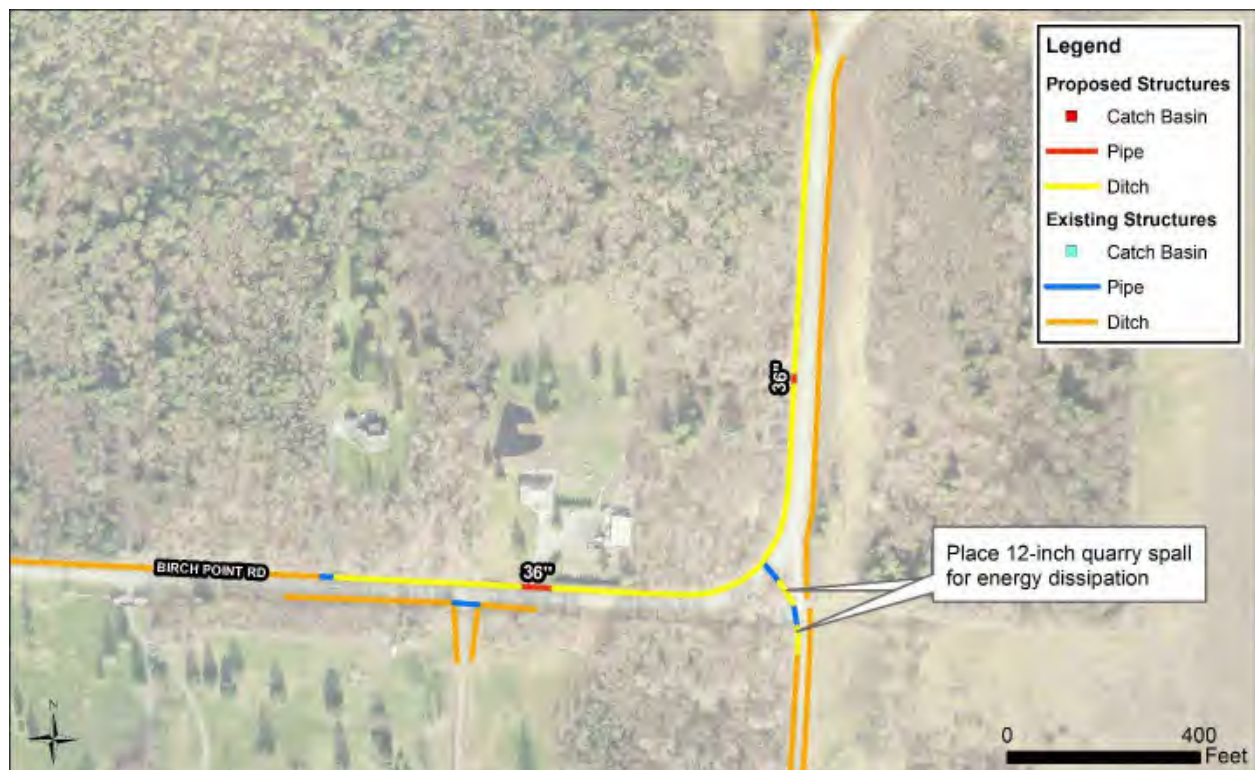
- Replace 70 lineal feet of 18-inch diameter PE culvert with 36-inch CPE.
- Replace 30 lineal feet of 24-inch diameter PE culvert with 36-inch CPE.
- Re-establish 2,000 lineal feet of roadside ditch.
- Place 12-inch quarry spall at culvert outlets adjacent to private driveway.

Description: Driveway culverts and roadside ditches along Birch Point Road are undersized and flooding for the 25-year and larger storm existing conditions storm event and 25-year and larger future conditions storm event. High flow velocity is causing erosion at the outlet of both driveway culverts on the south side of Birch Point Road adjacent to the private driveway.

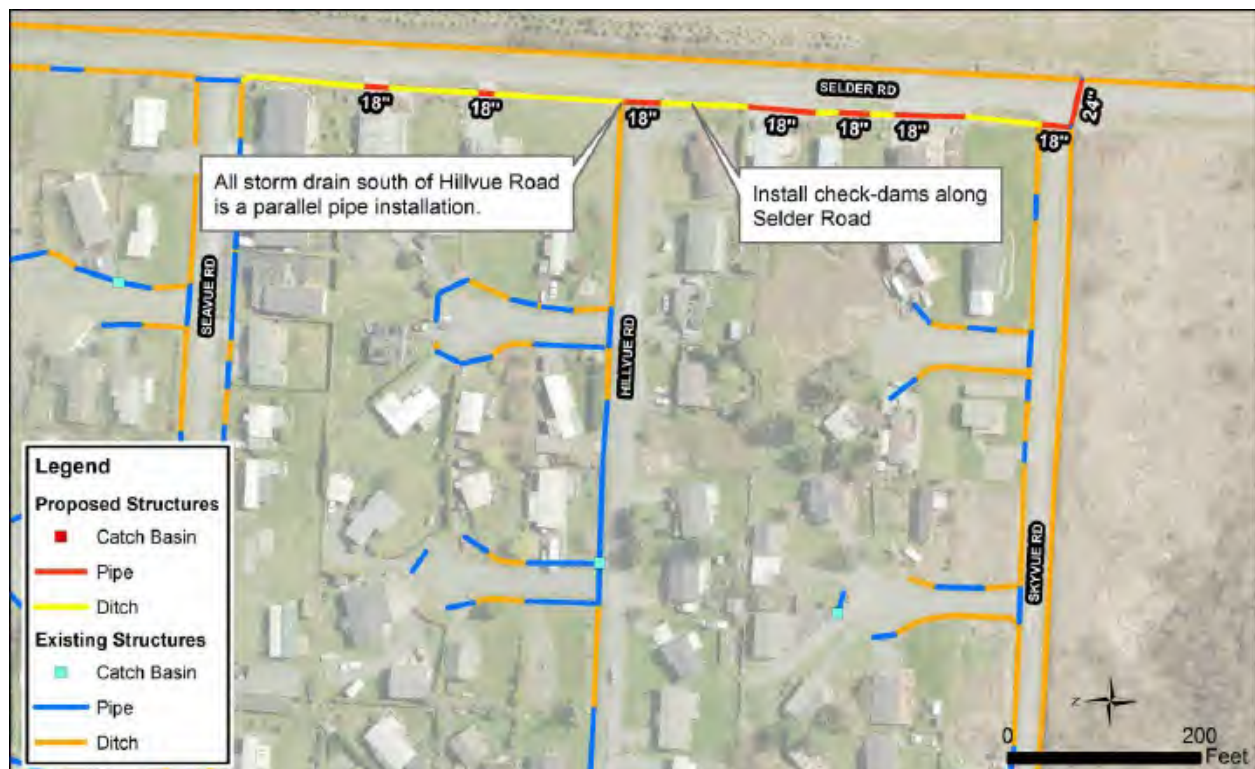
- Replace 50 feet of 18-inch diameter pipe with twin 24-inch diameter CPE pipes.
- Replace 30 feet of 18-inch diameter pipe with twin 18-inch diameter CPE pipes.
- Replace 265 feet of 12-inch diameter pipe with twin 18-inch diameter CPE pipes.
- Replace 50 feet of 12-inch diameter pipe with 18-inch diameter CPE.
- Re-establish 550 lineal feet of roadside ditch.
- Install check dams in roadside ditches along both sides of Selder Road.

Description: Roadway flooding predicted at multiple driveway culverts along the west side of Selder Road for the 25-year and larger existing conditions storm event and the 2-year and larger future conditions storm event. Scour caused by high flow velocity in the roadside ditches occurs at multiple locations.

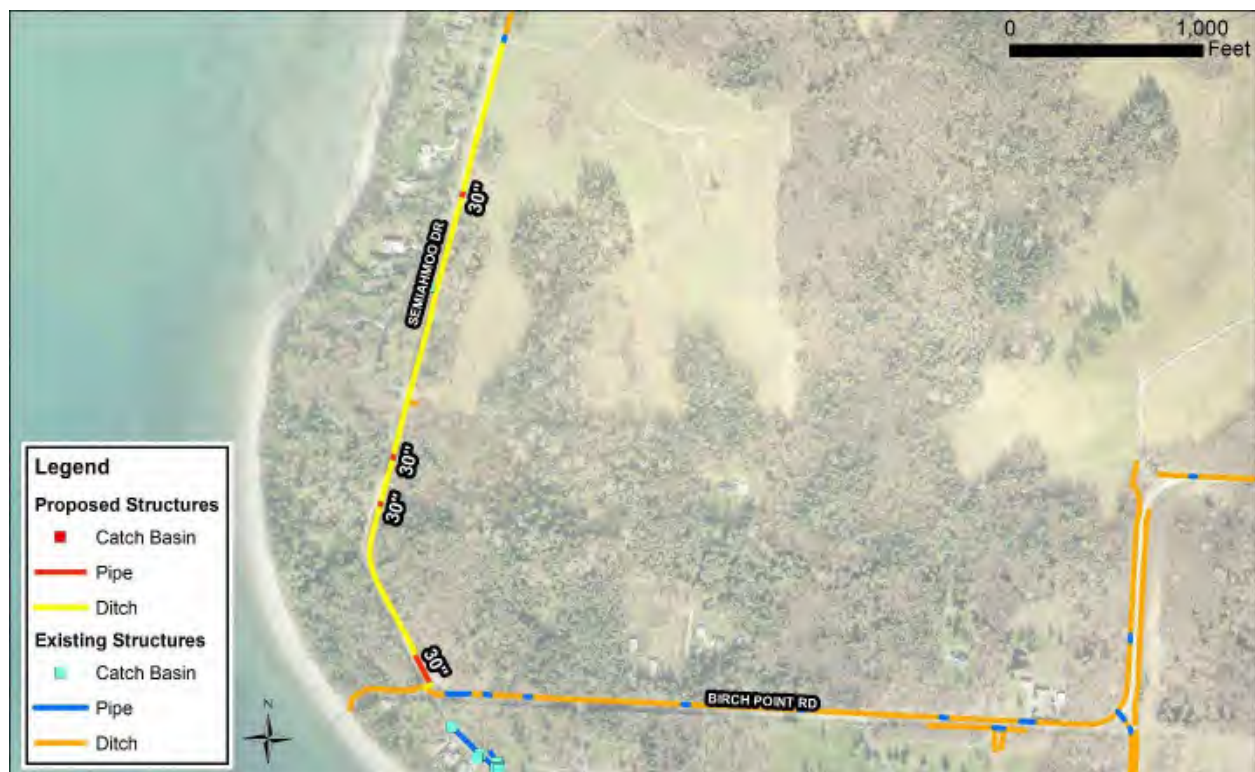
- Replace 265 lineal feet of 12-inch diameter concrete pipe with 30-inch CPE.
- Deepen 3,260 feet of existing ditches

Description: Ditches and driveway culverts on the east side of Semiahmoo Drive overflow during the 25-year and larger existing conditions storm event and the 2-year and larger future conditions storm event.

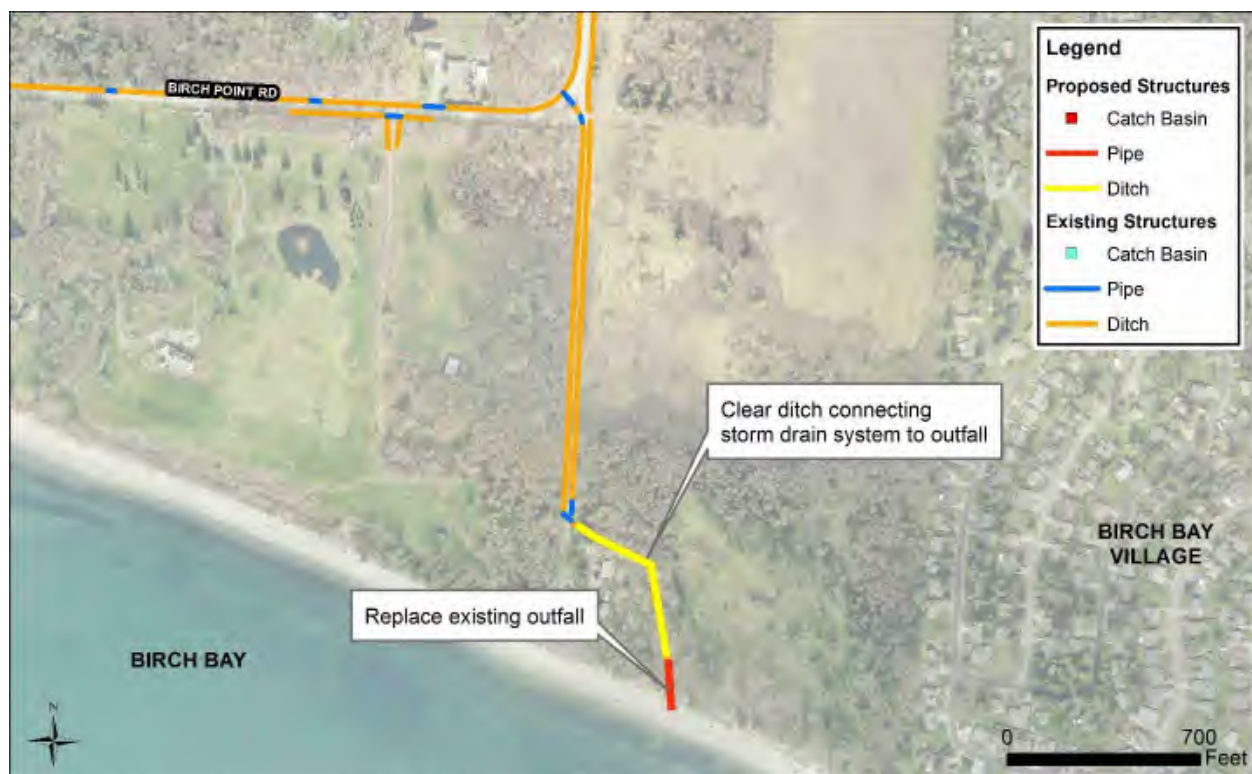
- Replace approximately 100 lineal feet of 48" diameter CMP half-pipe with 48-inch diameter HDPE tightline and anchor.
- Inspect and repair ditch connecting outfall and upstream storm drain system.
- Install energy dissipater.

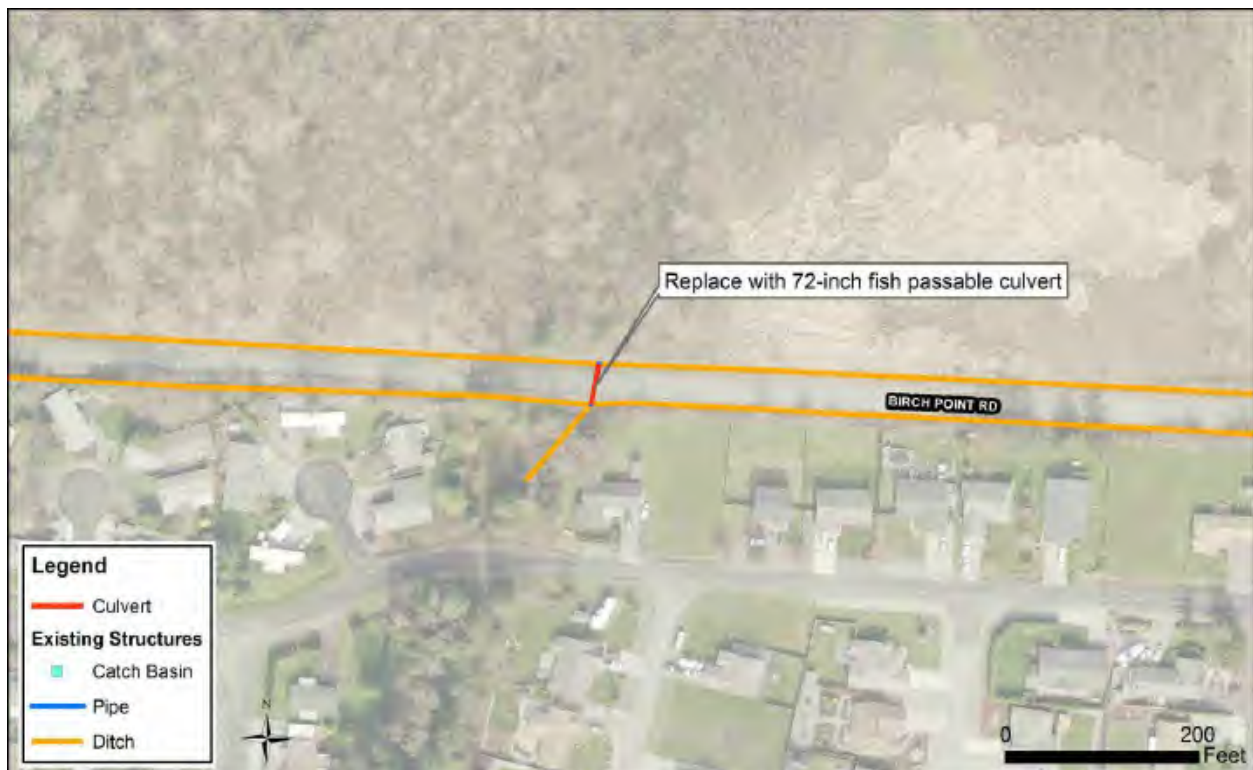
- Replace existing 24-inch diameter concrete culvert with 72-inch diameter fish passage culvert structure (50 lineal feet).

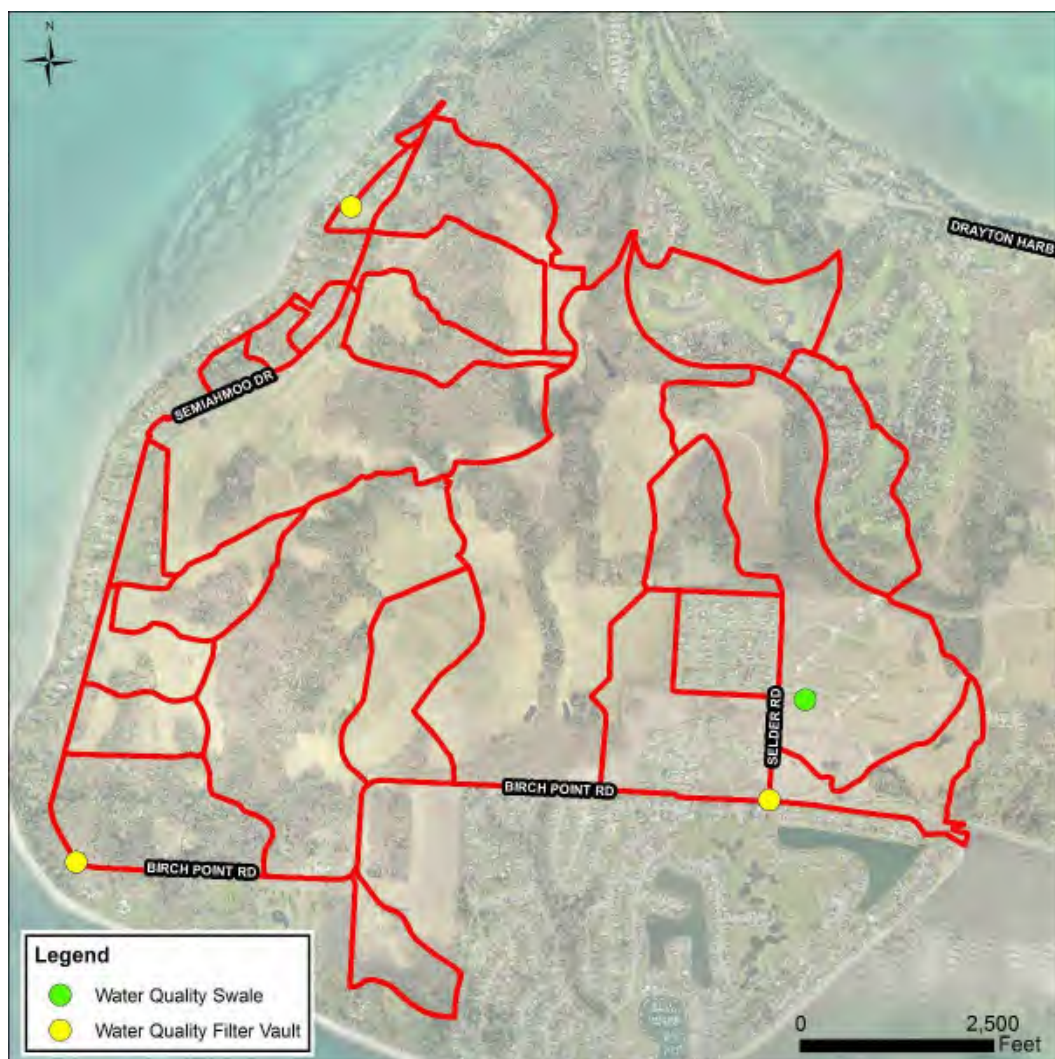
- 4 locations have been identified for water quality facility installations. Facility types will be evaluated and selected based on individual opportunity and may include water quality filter vaults and swales

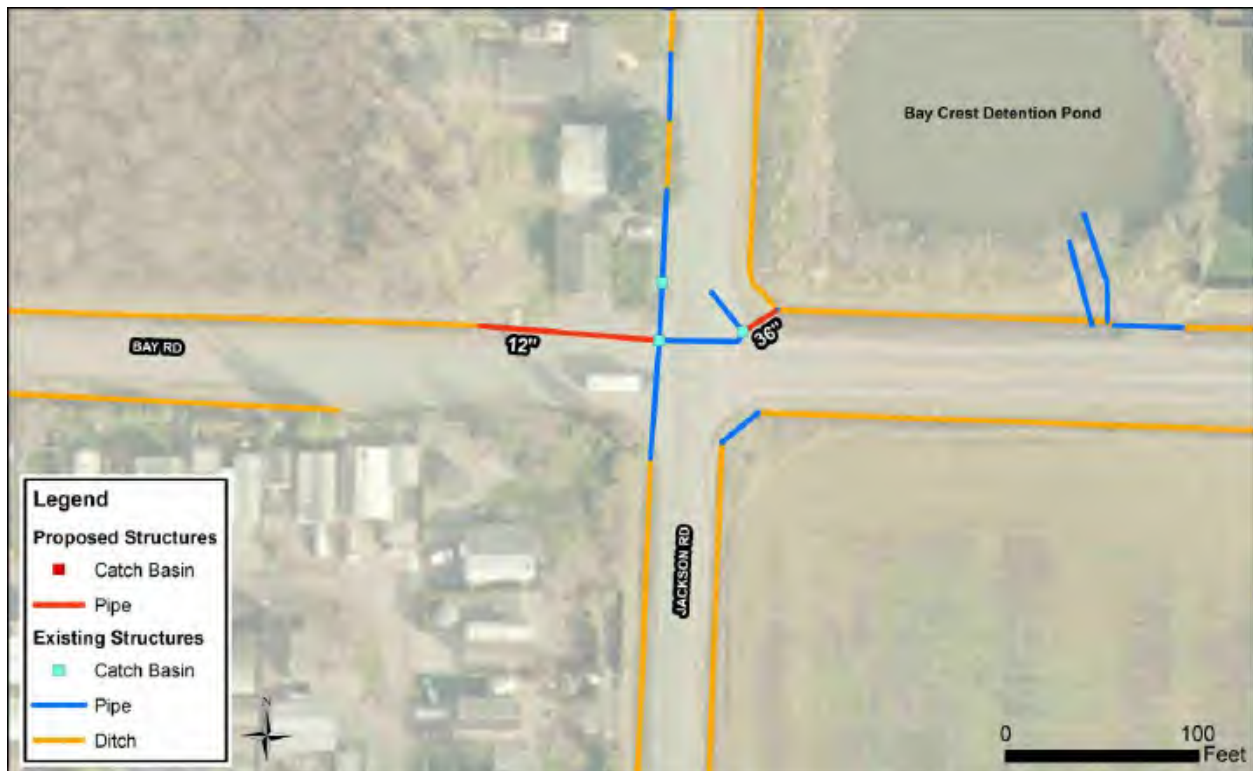
- Replace 90 lineal feet of 8-inch diameter pipe with 12-inch CPE.
- Replace 25 lineal feet of 24-inch diameter pipe with 36-inch CPE.

Description: Roadside storm drainage at the intersection of Bay Road and Jackson road is undersized and causing roadway flooding for the 25-year and larger storm event. High flow depth along Birch Bay Road causes a backwater condition at the culvert outlet and contributes to reduced pipe capacity.

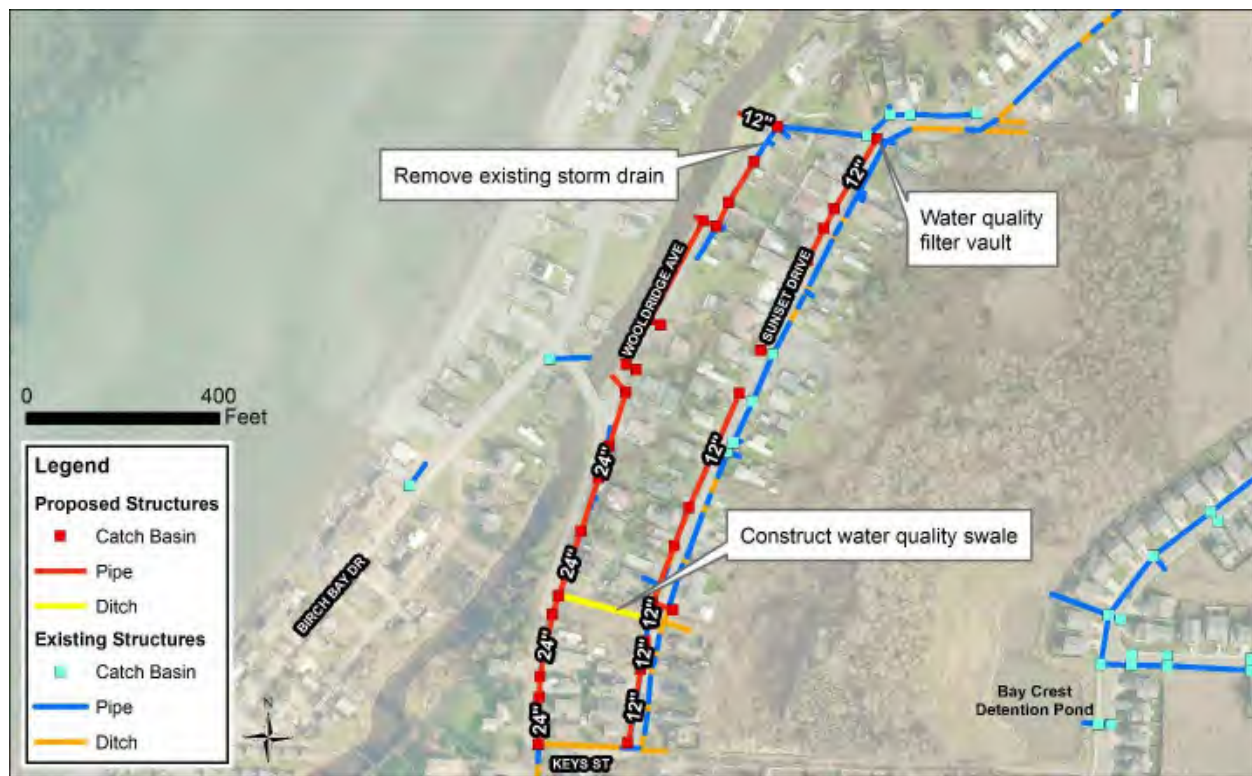
- Replace roadside ditches and culvert and install 1,750 lineal feet of 12-inch diameter CPE.
- Replace roadside ditches and culvert and install 865 lineal feet of 12-inch diameter CPE.
- Install 25 Type 1 CB structures and 9 Type 2 CB structures.
- Install 72-inch water quality filter vault.
- Install 100 lineal feet of water quality treatment swale.
- Remove 1,300 lineal feet of existing storm pipe.

Description: Storm drain system is undersized causing roadway flooding along Wooldridge Avenue, Jackson Road, and Sunrise Drive for the 2-year and larger storm event. Outfall to Terrell Creek is in poor condition and requires replacement. Water quality monitoring in Birch Bay has shown that state water quality standards for fecal coliform is frequently exceeded at the Terrell Creek outfalls.

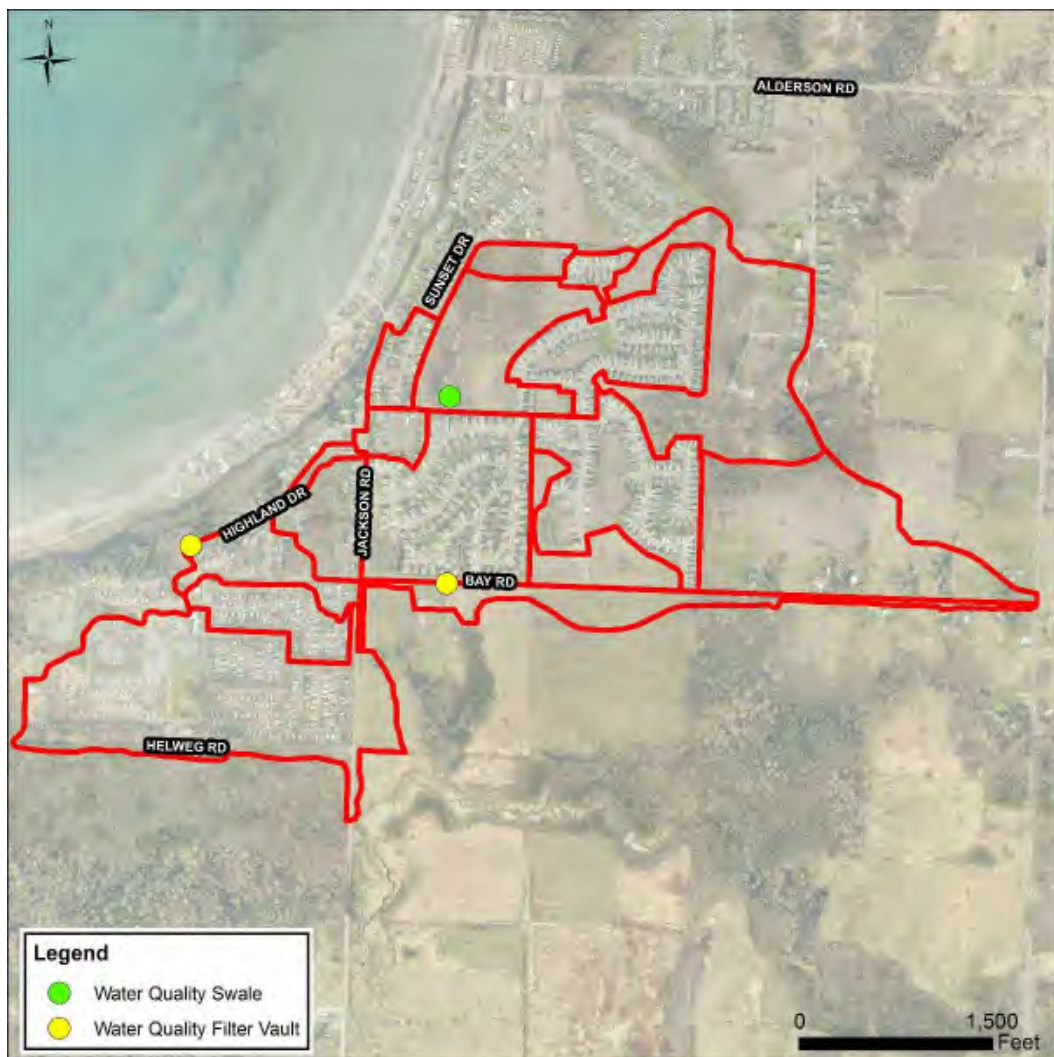
- 3 locations have been identified for water quality facility installations. Facility types will be evaluated and selected based on individual opportunity and may include water quality filter vaults and swales

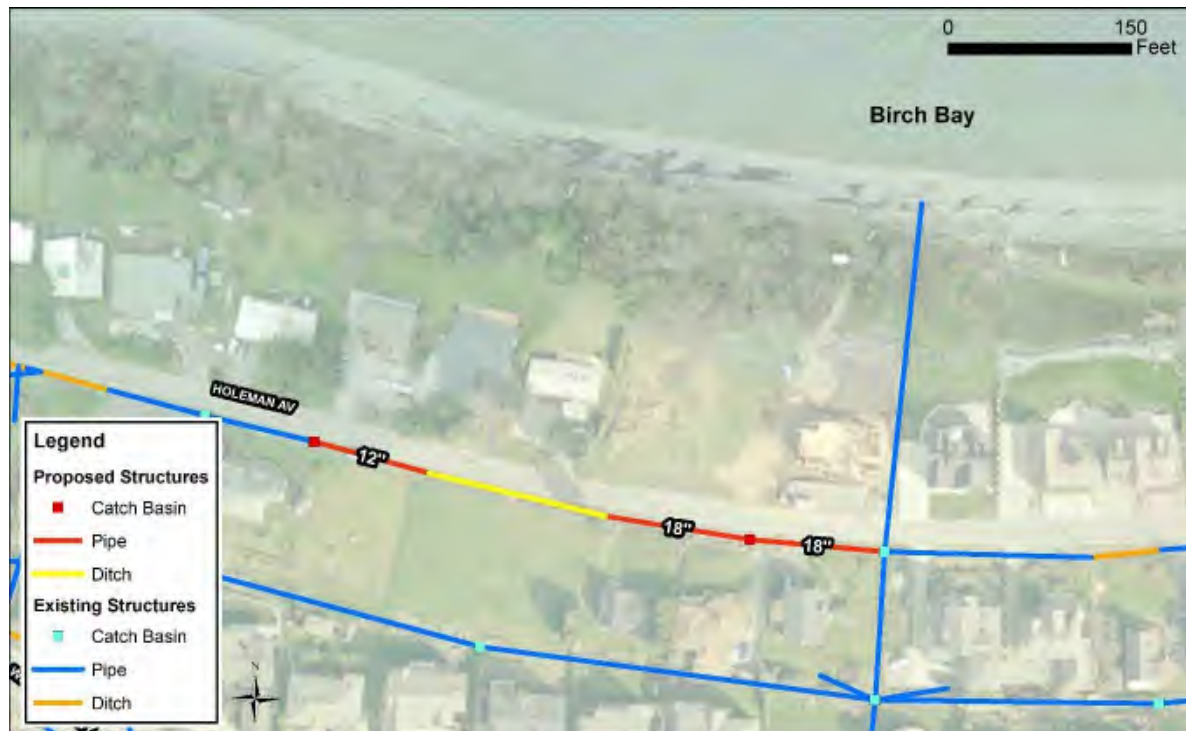
- Replace 235 lineal feet of 12-inch diameter pipe with 18-inch CPE.
- Replace 100 lineal feet of 12-inch diameter pipe with 12-inch CPE.
- Replace 1 CB Type 1 structure.
- Replace 1 CB Type 1 structure with 1 CB Type 2 structure.
- Re-establish 160 lineal feet of existing ditch to match pipe invert elevations.
