Resolution amending the 2006 Birch Bay Comprehensive Stormwater Plan to include four Subwatershed Master Plans (Council acting as the Whatcom County Flood Control Zone District Board of Supervisors)

# BIRCH BAY

## COMPREHENSIVE STORMWATER PLAN

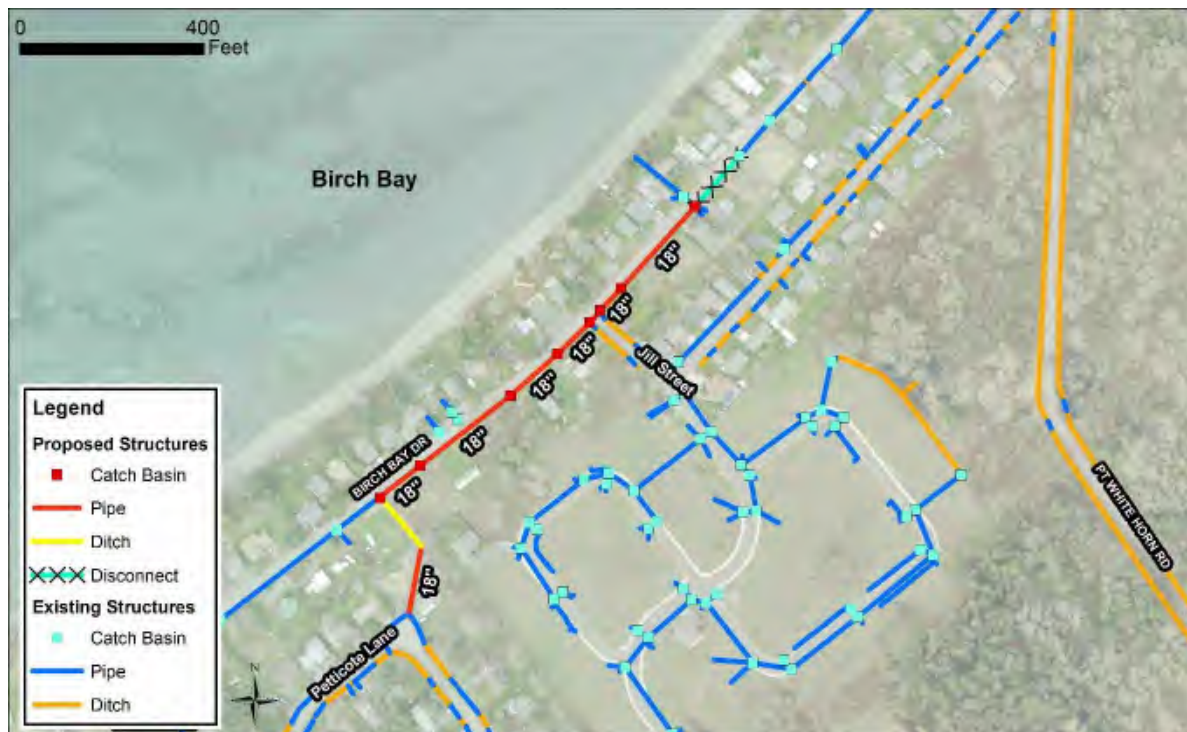
- Replace 950 lineal feet of 12-inch diameter pipe with 18-inch CPE along Birch Bay Road.
- Replace 8 Type 1 CB structures with 8 CB Type 2 structures.
- Disconnect existing 12-inch diameter storm drain on Birch Bay Road.
- Replace 110 lineal feet of 12-inch diameter CMP culvert with 18-inch CPE at Petticote Lane.
- Clean roadside ditches and culverts within Petticote Lane.
- Re-establish 190 lineal feet of ditch connecting Petticote Lane and Birch Bay Road.

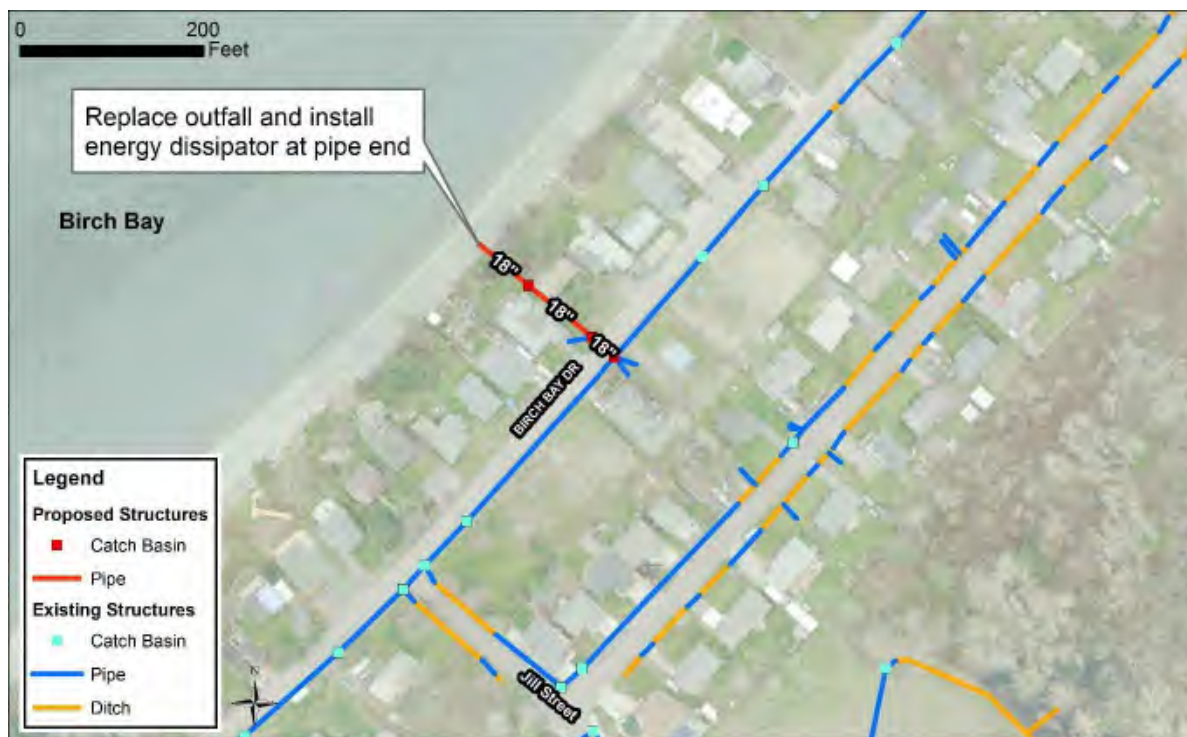
#### Project Description:

- Replace 1 Type 2 CB structure and install 1 Type 2 CB structure.
- Replace 18-inch diameter outfall with 18-inch diameter HDPE pipe (80 lineal feet).
- Replace 35 feet of 18-inch diameter concrete pipe with 18-inch CPE.
- Replace 55 feet of 12-inch diameter concrete pipe with 18-inch CPE.
- Install energy dissipater.

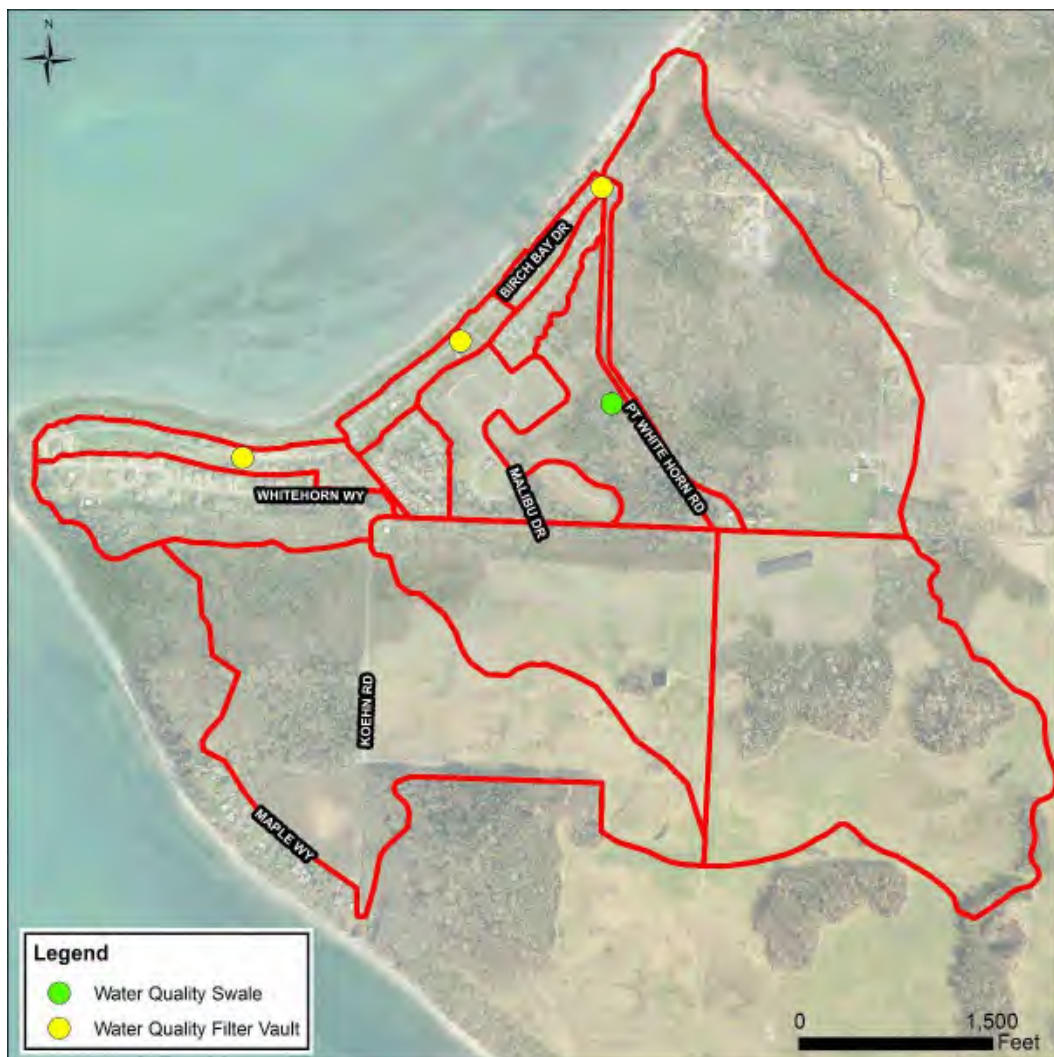
#### Project Description:

- 4 locations have been identified for water quality facility installations. Facility types will be evaluated and selected based on individual opportunity and may include water quality filter vaults and swales

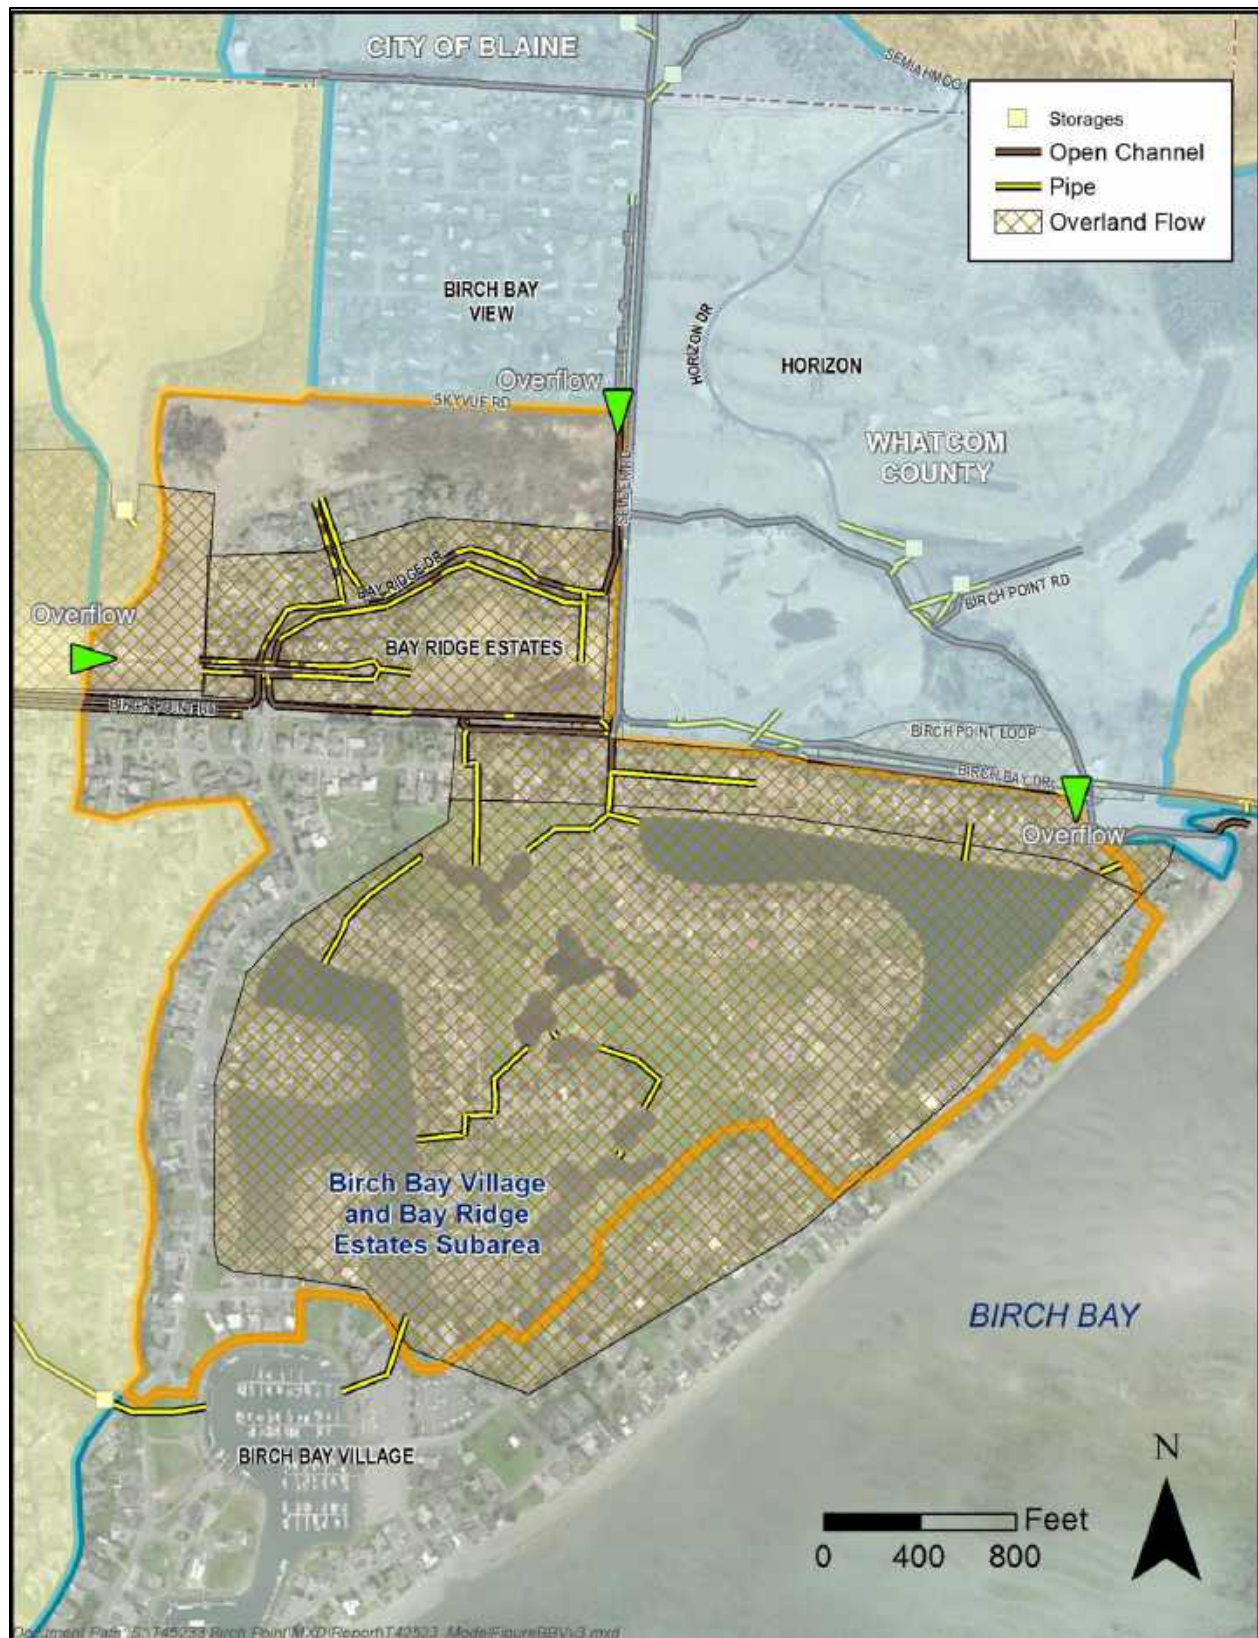
Figure 3. Birch Bay Village and Bay Ridge Estates Subarea

The Birch Bay Village and Bay Ridge Estates Subarea covers 246 acres and generally includes the Bay Ridge Estates neighborhood and is bounded by Skyvue Road on the north, Chehalis Road on the west side, and Selder Road and Birch Bay to the south and east (see Figure 3). The subarea is mostly medium-density residential in Birch Bay Village and Bay Ridge Estates neighborhoods. The remaining area is undeveloped vacant land (north of Bay Ridge Estates) and open space/golf course in Birch Bay Village.

Bay Ridge Estates is served by a piped storm drain system within the development and discharges to a pond at the northwest corner of Selder Road and Birch Point Road. The Bay Ridge Estates system combines with the Birch Point Road and Selder Road drainage system and crosses under Birch Point Road at two locations: at the entrance to Birch Bay Village and at Selder Road. From this point, the drainageway enters the Birch Bay Village drainage system and is combined with the golf course ponds and is conveyed to Thunderbird Lake and then to the Birch Bay Marina.

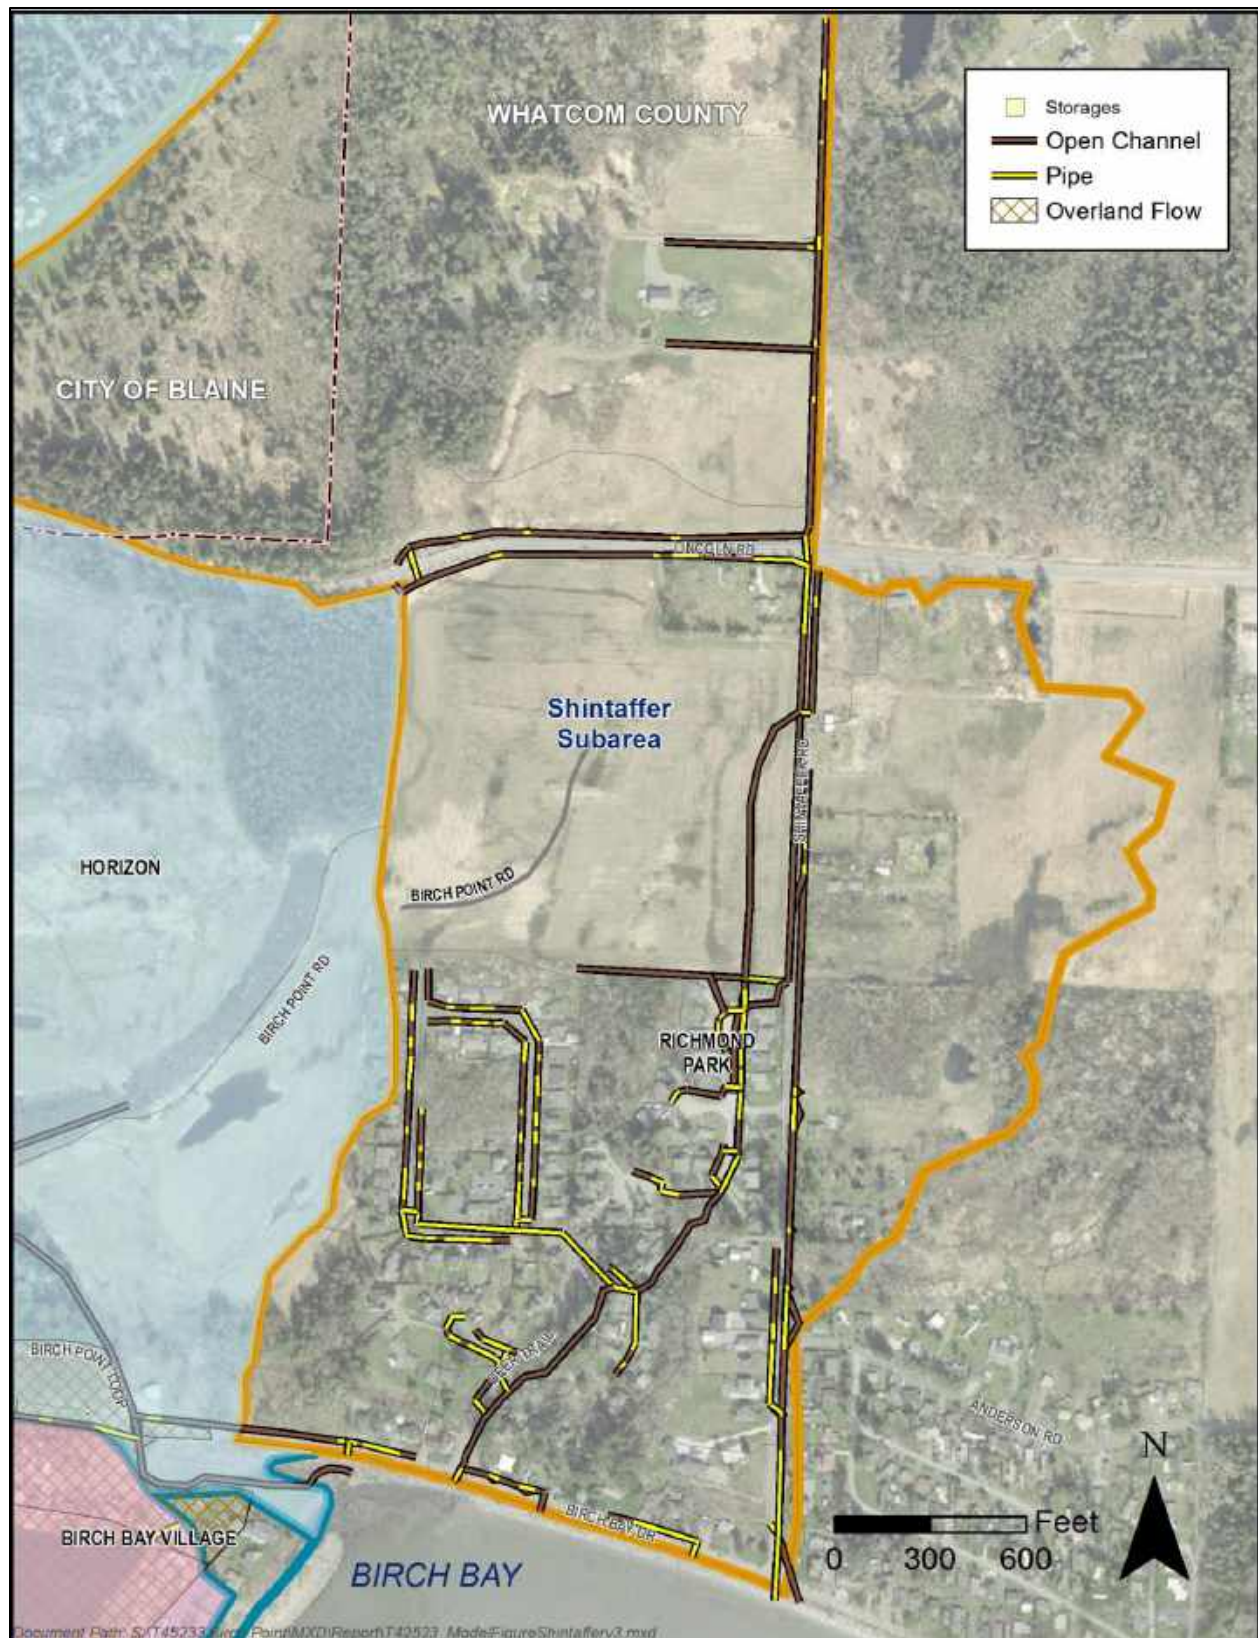
Figure 5. Shintaffer Subarea

The Shintaffer subarea is 256 acres on the west side of the Central North subwatershed (see Figure 5). The subbasin is west of Shintaffer Road except for a moderately sized area immediately south of Lincoln Road. The Shintaffer subbasin is bisected by Lincoln Road. Land use in the subbasin is primarily agricultural north of Richmond Park and residential to the south. An undeveloped area is located north of Semiahmoo Parkway and west of Shintaffer Road. The subarea crosses into the City of Blaine in the northwest corner. The area north of Richmond Park is zoned Urban Residential, Neighborhood Commercial, and Rural Residential.

Surface water in the Shintaffer subarea flows south to Birch Bay from headwaters north of Semiahmoo Parkway and west of Shintaffer Road. Drainage from the Semiahmoo residential area discharges to a wetland area east of Shintaffer Road and north of Lincoln Road. A network of field ditches drains the wetland area to roadside ditches along the north side of Lincoln Road and the west side of Shintaffer Road. The main conveyance pathway continues south along Shintaffer Road where it becomes a storm drain pipeline at Richmond Park Road. This 24-inch concrete pipe conveys flow through the Richmond Park subdivision and outfalls to a steep ravine. Ultimately, stormwater is discharged to Birch Bay through an ungated outfall near Deer Trail. A small local system along the north side of Birch Bay Drive is also served by the outfall.

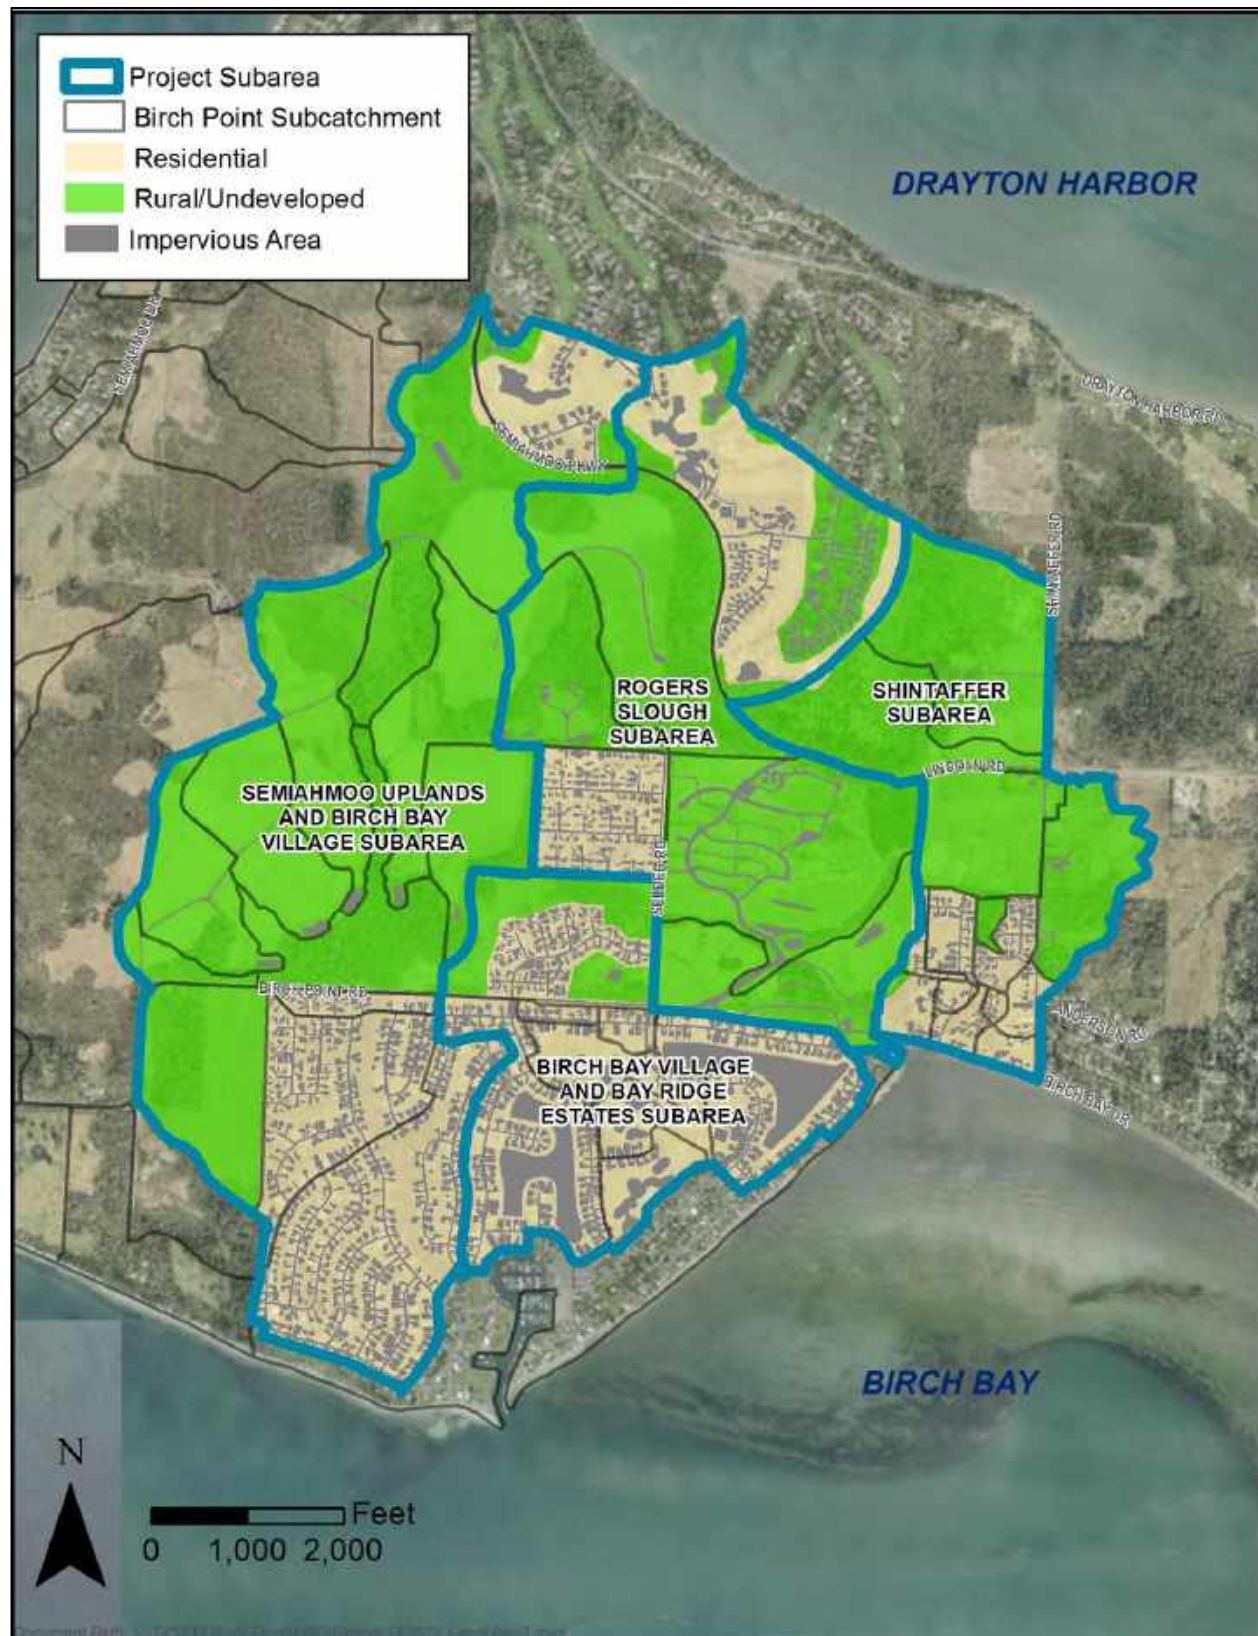
Figure 6. Existing Land Use Condition

Flow characteristics were computed for existing land use conditions at the 40 subcatchments in the study area. Existing land use conditions were updated based on 2019 aerial photography provided by Whatcom County. Existing land use conditions and impervious area are shown in Figure 6. Impervious area estimates developed for the watershed characterization study (ESA Adolfson, 2007) were used as the

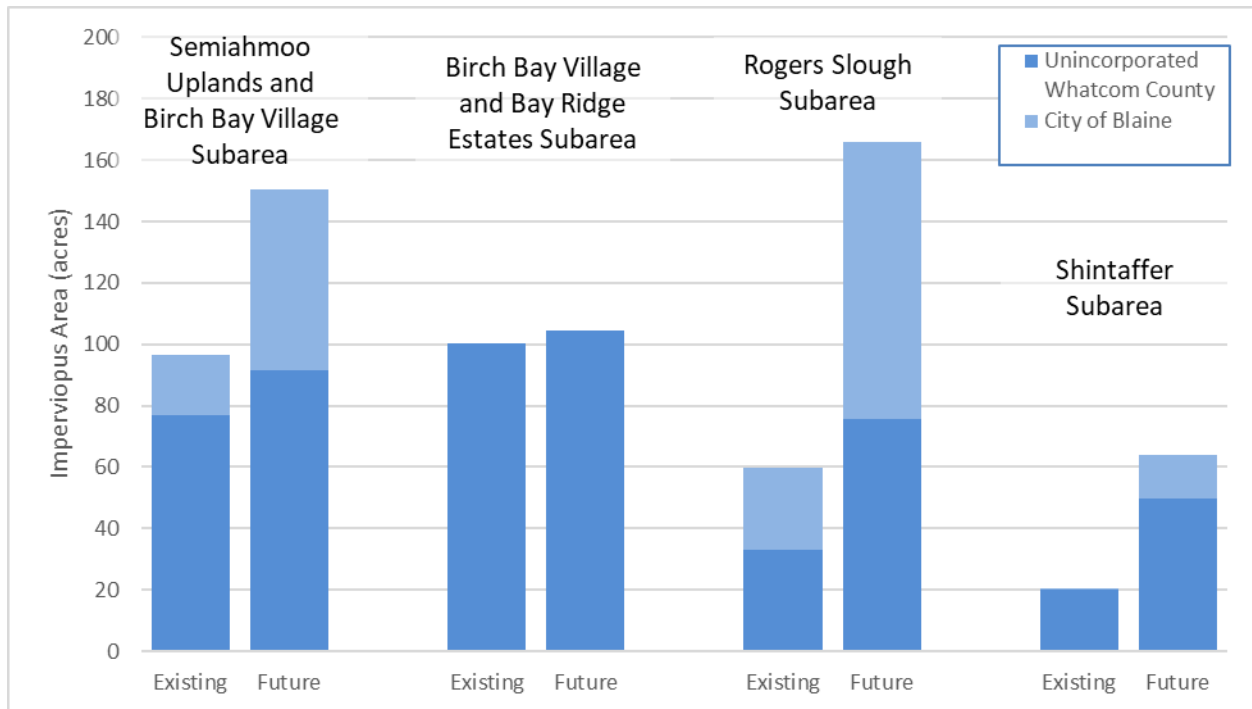
Figure 7. Impervious Area Distribution by Jurisdiction

Currently, impervious area in the Birch Point study area is found mostly in unincorporated Whatcom County with a small amount in the City of Blaine, primarily in the residential neighborhoods east of Semiahmoo Parkway. Figure 7 illustrates the distribution of impervious area in the study area.

Table 1 shows that total impervious area under future conditions is expected to increase by over 200 acres, or a 75% increase in impervious area in the study area. Figure 7 shows that the impervious area will increase disproportionality in the City of Blaine for the Semiahmoo Uplands and Birch Bay Village subarea and the Rogers Slough subarea. The increase in impervious area in the Shintaffer subarea will occur mostly in Whatcom County but is also expected to increase in the City of Blaine where currently there is very little impervious surface in the study area.

Semiahmoo Uplands and Birch Bay Village subarea rather than an increase in impervious area (less than 5%, see Table 1 and Figure 7). Increased overflow also occurs from the Rogers Slough subarea to the Birch Bay View neighborhood and the drainageway adjacent to Birch Point Loop at Nootka Loop.

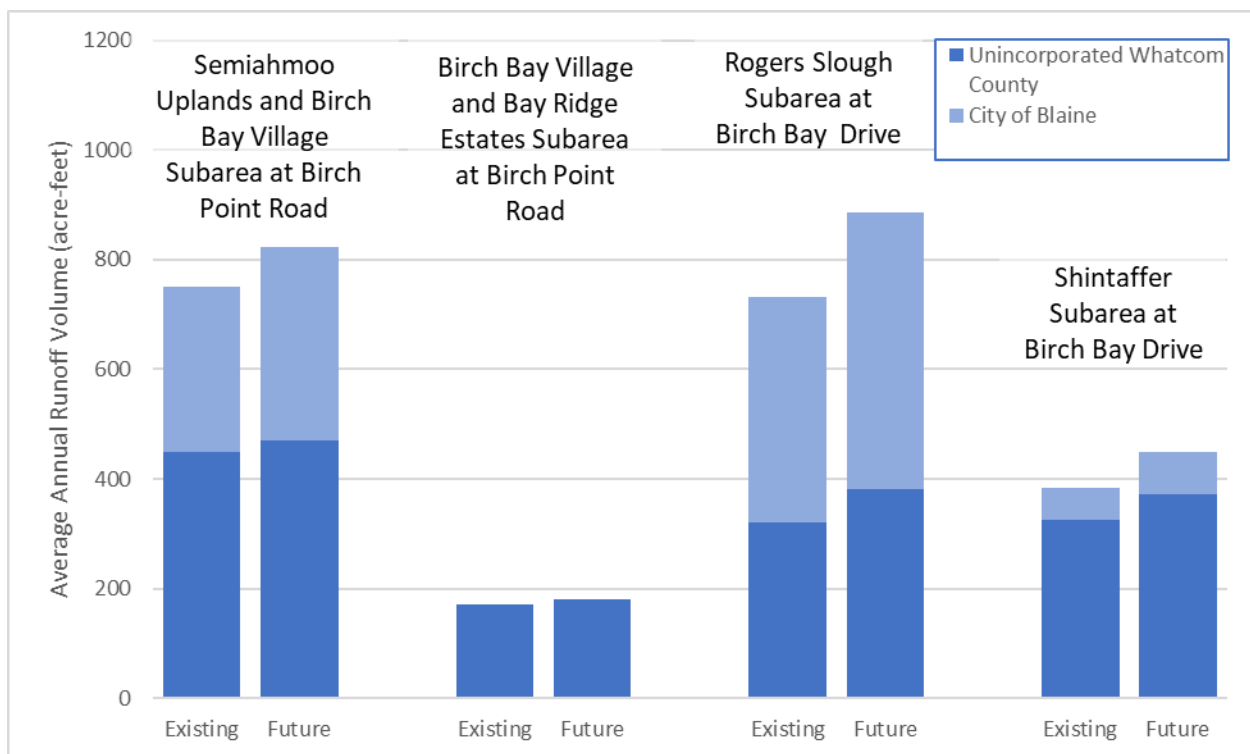
Figure 10. Existing Conditions Runoff Contribution from City of Blaine and Unincorporated Whatcom County

For three of the four subareas a significant portion of stormwater runoff is generated in the City of Blaine and flows downhill to unincorporated Whatcom County. Figure 10 shows the average annual volume of stormwater runoff contribution from the City of Blaine and Whatcom County. This figure shows that approximately 40 percent of stormwater runoff is generated in the City of Blaine for the Semiahmoo Uplands and Birch Bay Village subarea (measured at Birch Point Road) and over 50 percent of stormwater runoff comes from the City in the Rogers Slough subarea. Only about 15 percent of stormwater runoff is generated in the City of Blaine in the Shintaffer subarea. Stormwater runoff in the Birch Bay Village and Bay Ridge Estates subarea is generated entirely in the County however the evaluation of runoff volume does not consider the overflows from adjacent subareas described later in this section.

One acre-foot = 1 foot of flooding over 1 acre of land (43,560 cubic feet or 326,000 gallons)

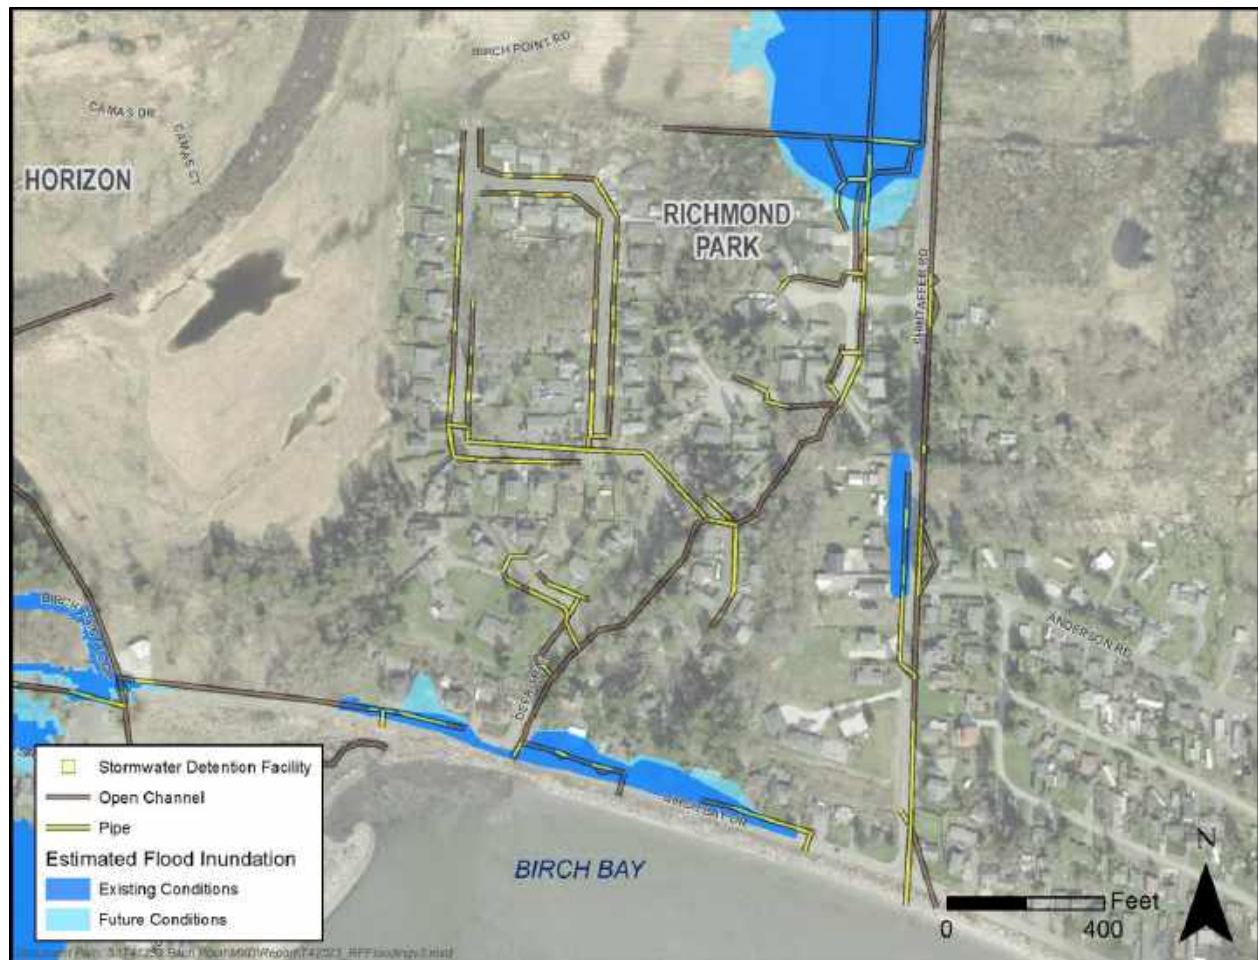
Figure 15. Simulated Flooding in Shintaffer Sub Area - Existing and Future Conditions, 100-year Event

The hydraulic analysis predicted flooding at three locations under existing conditions in the Shintaffer subarea. Table 11 and Table 12 show predicted peak stage and flow at selected locations in this sub area. Figure 15 and Figure 16 show the estimated flood inundation extents for the 100-year and November 2021 events.

The hydraulic analysis of future conditions showed that flood depth will increase up to 0.5 feet in the Richmond Park area (S-B) if flow control is not provided with upstream development. Peak flow rates would increase for all events along Shintaffer Road, but the increase would be mitigated with the depression storage on the farm field north of Richmond Park. The peak flow attenuation of this storage is demonstrated by the peak flow reduction that occurs between the farm field (S-1) and Richmond Park (S-2) for all events analyzed. For example, Table 12 shows peak flow for the 100-year event is about 34 cfs in the roadside ditch west of Shintaffer Road (S-1) but is reduced to about 18 cfs downstream of Richmond Park (S-2).

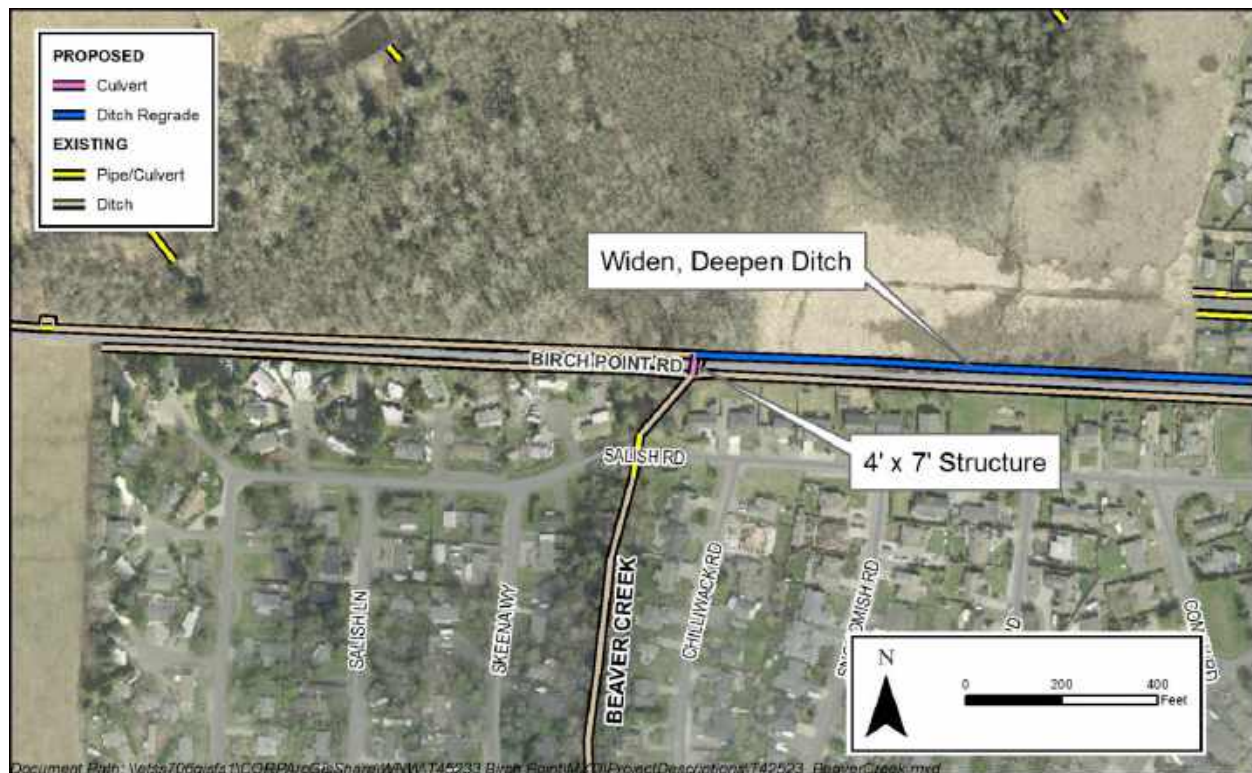
### Project Description:

- Replace existing culvert along Birch Point Road with a 4' high by 7' wide fish passable culvert.
- Regrade 1,170 lineal feet of existing ditch along Birch Point Road.

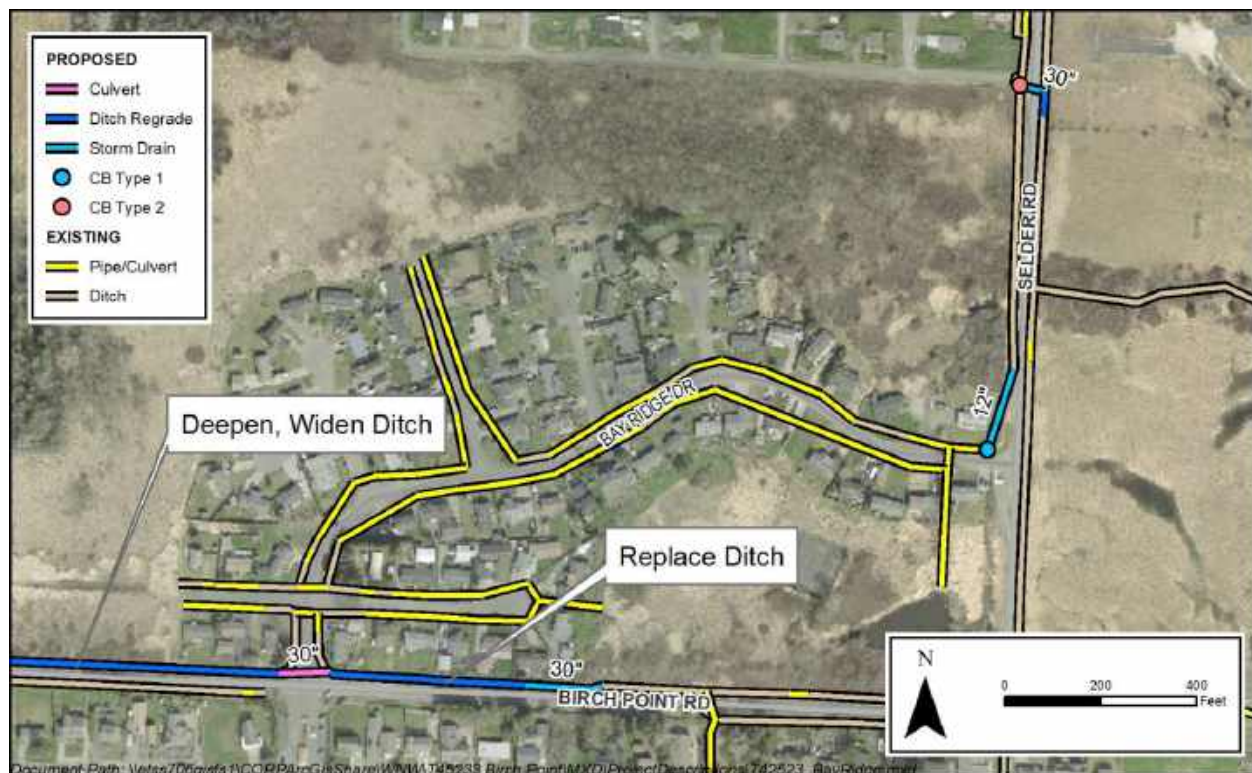
#### Project Description:

- Replace 52 lineal feet of 18-inch diameter pipe with 30-inch diameter PVC pipe on Selder Road at Skyvue Road.
- Install 200 lineal feet of new 12-inch diameter ductile iron pipe along Selder Road.
- Install 108 lineal feet of new 30-inch diameter PVC pipe on Birch Point Road.
- Install 1 new CB Type 1 structures on Selder Road and 1 new CB Type 2 structure on Birch Point Road.
- Regrade 50 lineal feet of existing ditch on Selder Road to lower an invert.
- Regrade 960 feet of existing ditch on Birch Point.
- Install 135 lineal feet of new 30-inch diameter PVC pipe along Birch Point Road

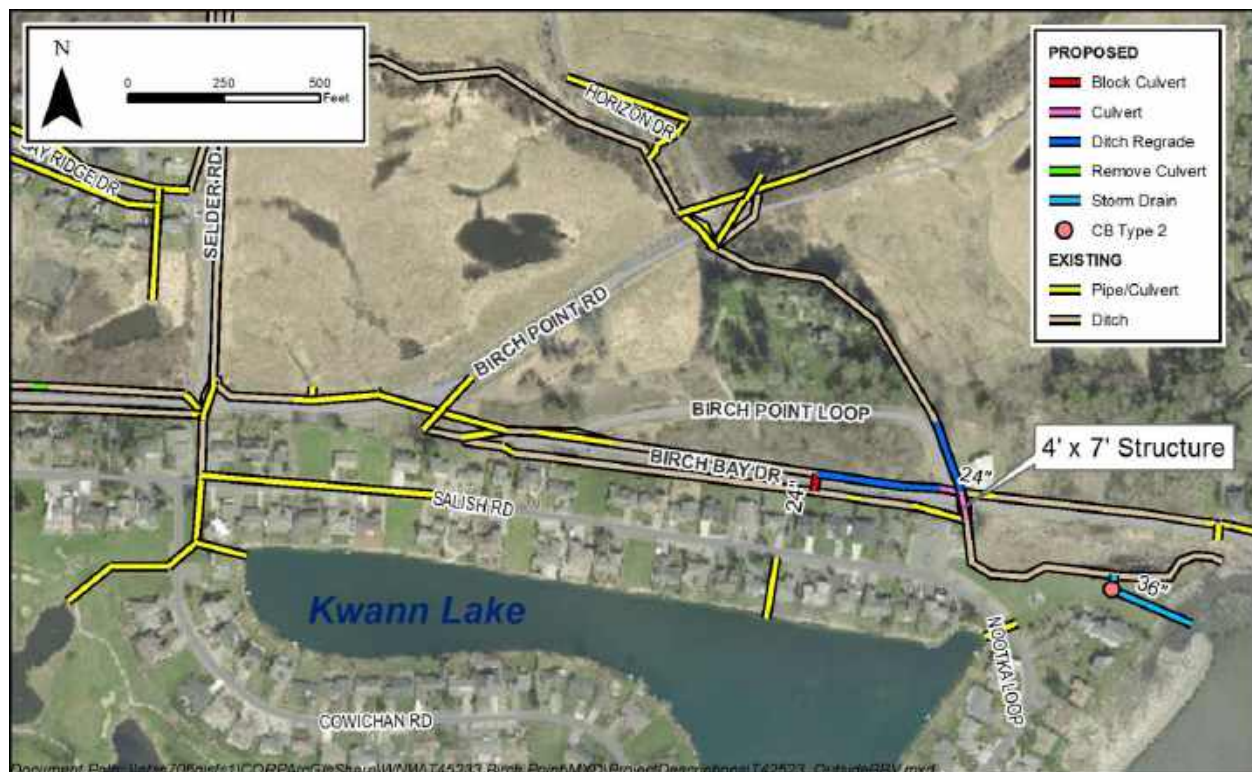
### Project: Rogers Slough Drainage Improvements – Existing Conditions

Description: Driveway culverts and roadside ditches along Birch Point Road are undersized and flooding for the 2-year and larger storm existing and future conditions storm events.

- Block an existing 24-inch diameter culvert with CDF.
- Install 55 lineal feet of 24-inch diameter PVC pipe under Birch Point Loop.
- Replace 144 lineal feet of existing twin 30-inch diameter culvert with a 4-foot by 7-foot rectangular concrete culvert.
- Remove existing 18-inch culvert under Birch Bay Drive between east and west intersection of Birch Point Loop.
- Regrade 319 feet of existing roadside ditch along Birch Point Road.
- Regrade 185 feet of channel along Birch Point Loop to establish positive drainage over entire length roadside ditch along north side of Birch Bay Drive.
- Install one new Type 2 CB near Nootka Loop.
- Install 230 lineal feet of new 36-inch diameter PVC pipe.

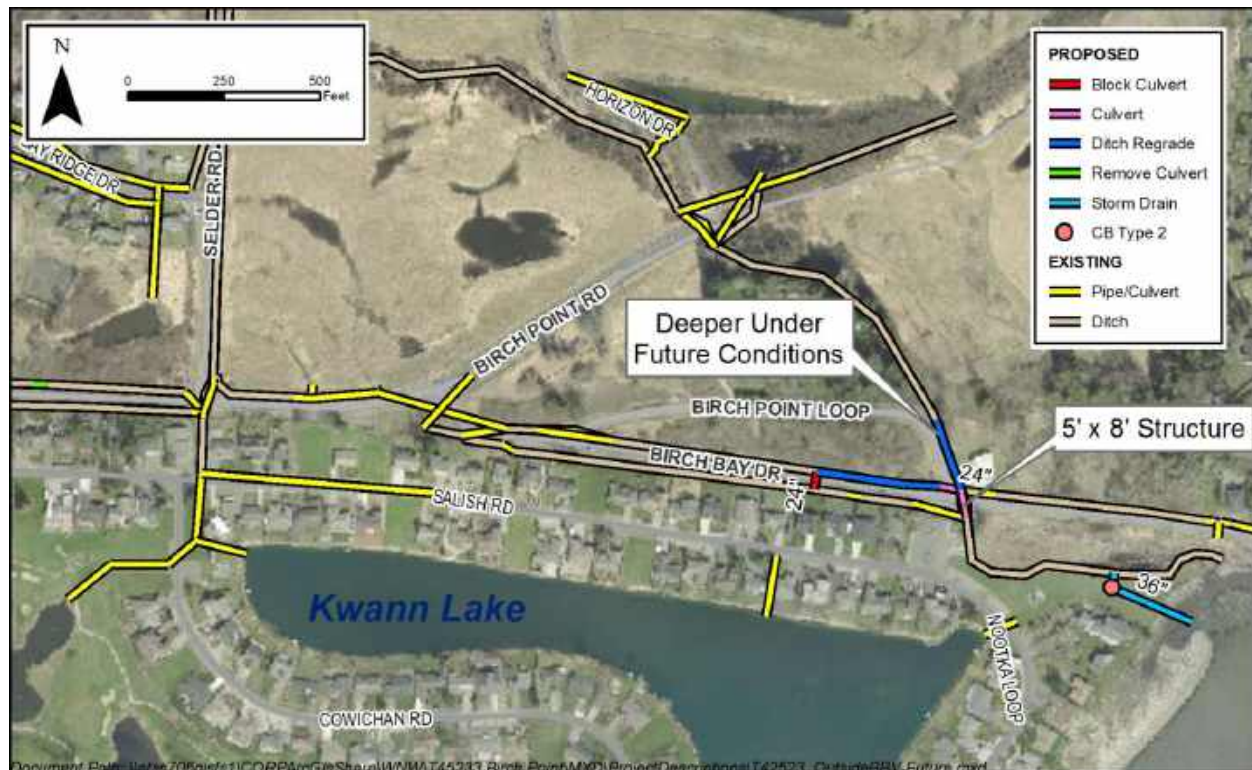
### Project: Rogers Slough Drainage Improvements – Future Conditions

Description: Driveway culverts and roadside ditches along Birch Point Road are undersized and flooding for the 2-year and larger storm existing and future conditions storm events.

- Block an existing 24-inch diameter culvert with CDF.
- Install 55 lineal feet of 24-inch diameter PVC pipe on Birch Point Loop.
- Replace 144 lineal feet of existing twin 30-inch diameter culvert with a 5-foot by 8-foot rectangular concrete culvert.
- Remove existing 18-inch culvert under Birch Bay Drive between east and west intersection of Birch Point Loop.
- Regrade 319 feet of existing roadside ditch along Birch Point Road.
- Regrade 185 feet of channel along Birch Point Loop to establish positive drainage over entire length roadside ditch along north side of Birch Bay Drive.
- Install one new Type 2 CB near Nootka Loop
- Install 230 lineal feet of new 36-inch diameter PVC pipe near Nootka Loop

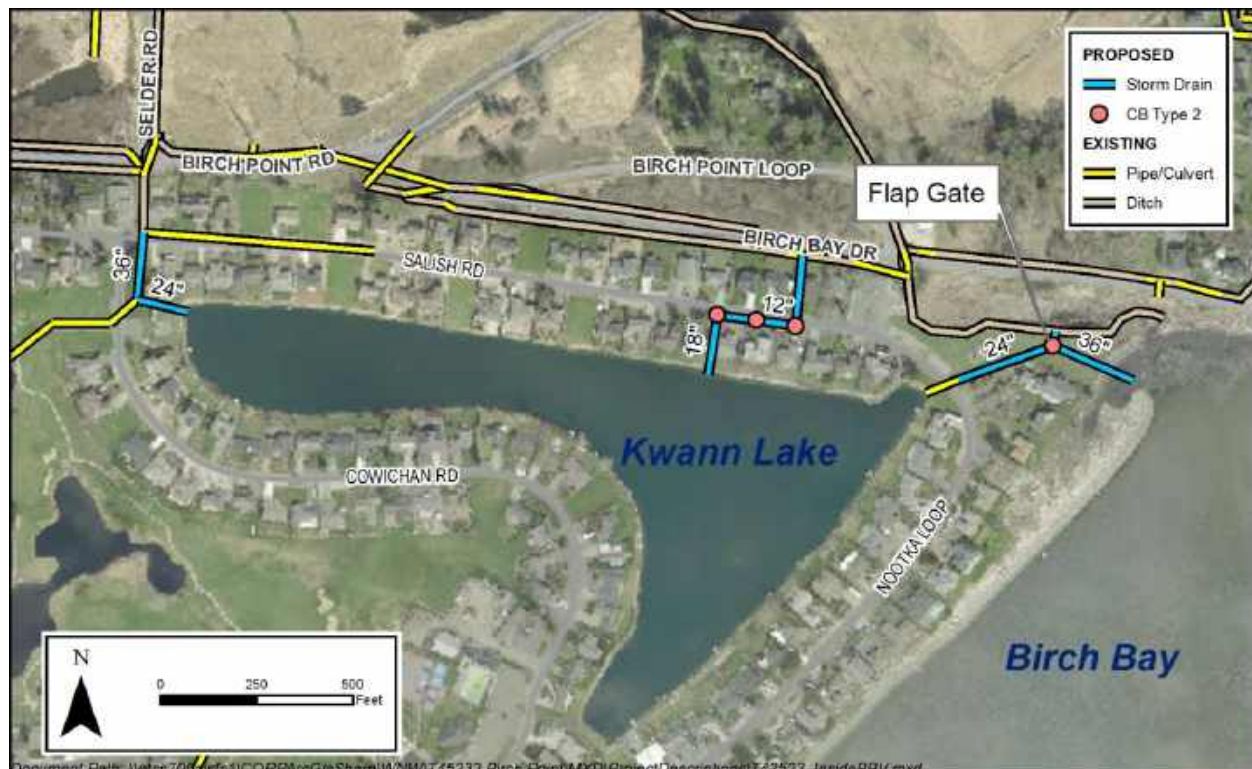
Description: Roadway flooding predicted at multiple areas in the vicinity of Kwann Lake at the 10-year and larger existing conditions storm event.

- Replace 140 lineal feet of 12-inch diameter pipe with 24-inch diameter corrugated polyethylene pipe from Cowichan Road to Kwann Lake.
- Replace 160 lineal feet of 12-inch diameter pipe with 18-inch diameter PVC pipe from Salish Road to Kwann Lake.
- Replace 176 lineal feet of 24-inch diameter pipe with 36-inch diameter PVC pipe along Cowichan Road.
- Install 390 lineal feet of new 12-inch diameter PVC pipe along Salish Road.
- Install 3 new CB Type 2, 48-inch diameter structures along Salish Road.
- Install one new CB Type 2, 54-inch diameter structure near Nootka Loop.
- Install new 36-inch diameter flap gate near Nootka Loop
- Install 290 lineal feet of 24-inch diameter PVC pipe near Nootka Loop
- Install 230 lineal feet of new 36-inch diameter PVC pipe near Nootka Loop

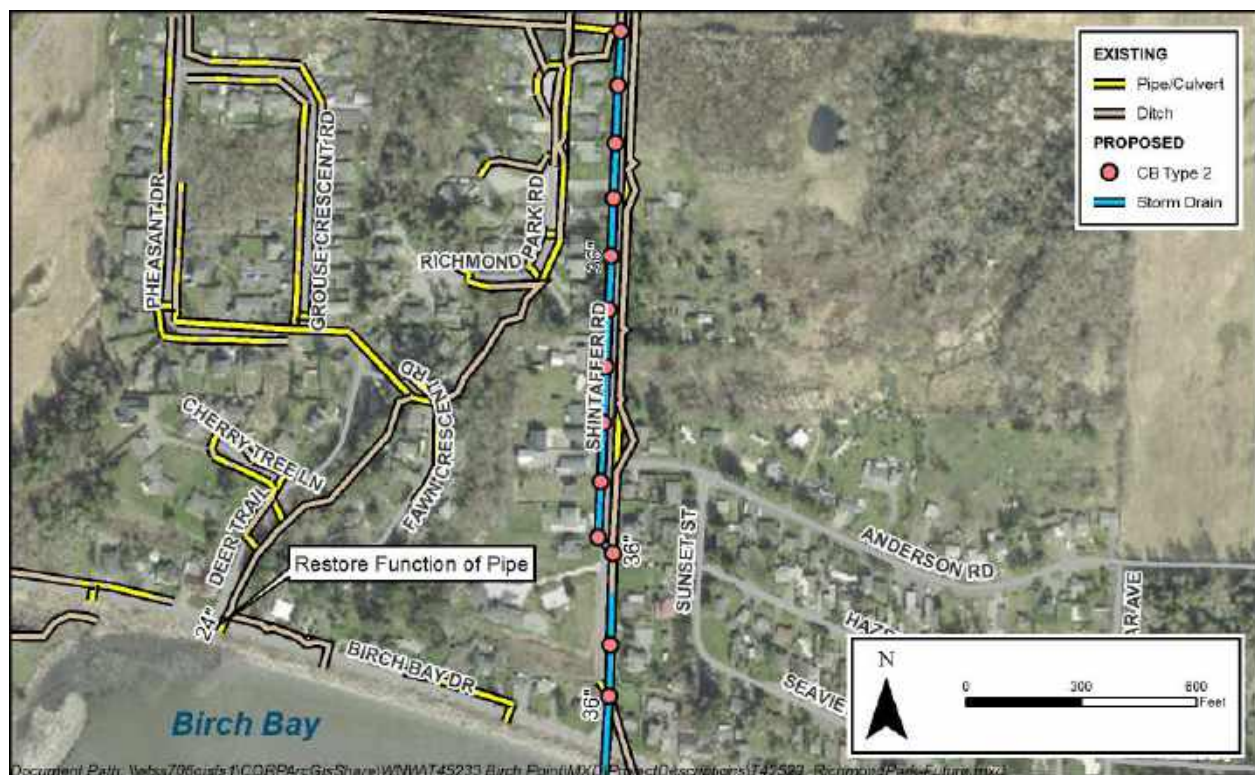
### Project: Richmond Park Stormwater Improvements Project – Future Conditions

Description: Ditches and existing culverts and pipe network in Richmond Park and along Shintaffer Road overflow during the 25-year and larger existing and future conditions storm events.

- Replace 1640 lineal feet of 12-inch diameter pipe with 36-inch diameter PVC pipe, and 36-inch diameter corrugated polyethylene pipe along Shintaffer Road.
- Replace 24 lineal feet of 24-inch diameter pipe at Deer Trail and Birch Bay to restore conveyance function.
- Install 11 new CB Type 2, 48-inch diameter structures and 2 new CB Type 2, 54-inch diameter structures along Shintaffer Road.
