**AMENDING THE 2006 BIRCH BAY COMPREHENSIVE STORMWATER PLAN TO
INCLUDE FOUR SUBWATERSHED MASTER PLANS**

BIRCH BAY

COMPREHENSIVE STORMWATER PLAN

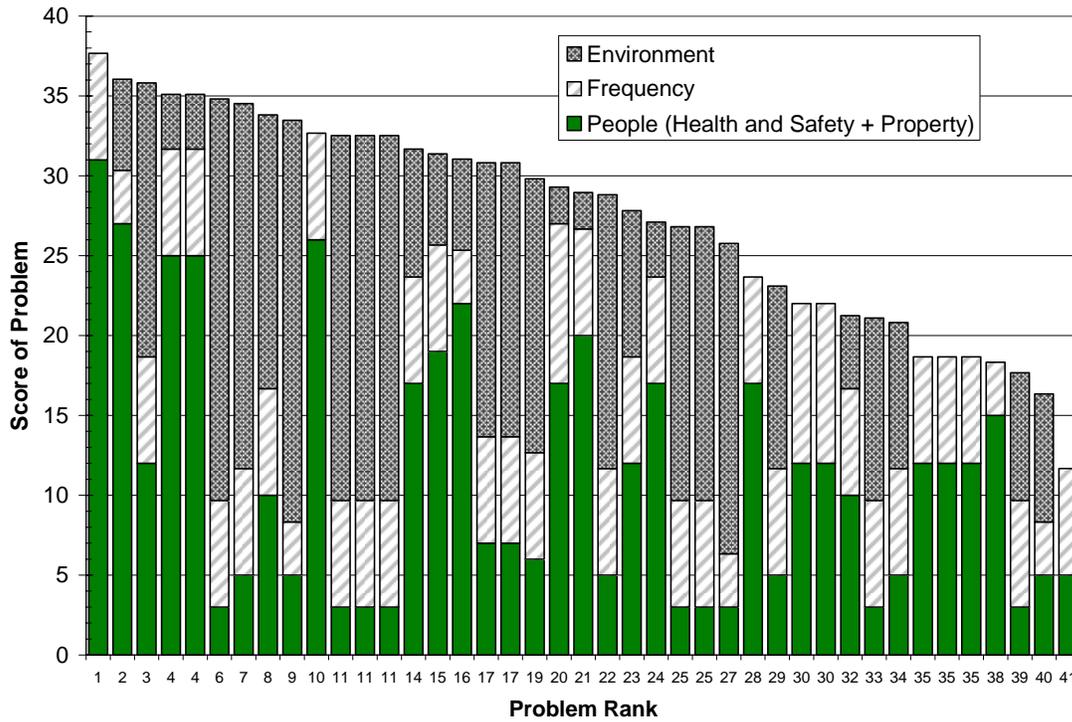
FIGURE 4-2. RANKED SCORES, SUMMARY BY CONTRIBUTING FACTOR

Figure 4-2 shows the portion of the score for each problem that is attributed to people, the environment, or frequency of occurrence. This allows for a comparison between problems that are priorities because of the potential effect(s) on people versus problems that are priorities for their effect(s) on the environment. The frequency of occurrence indicates how often a problem occurs and how that metric influenced the rating and ranking of the problem.

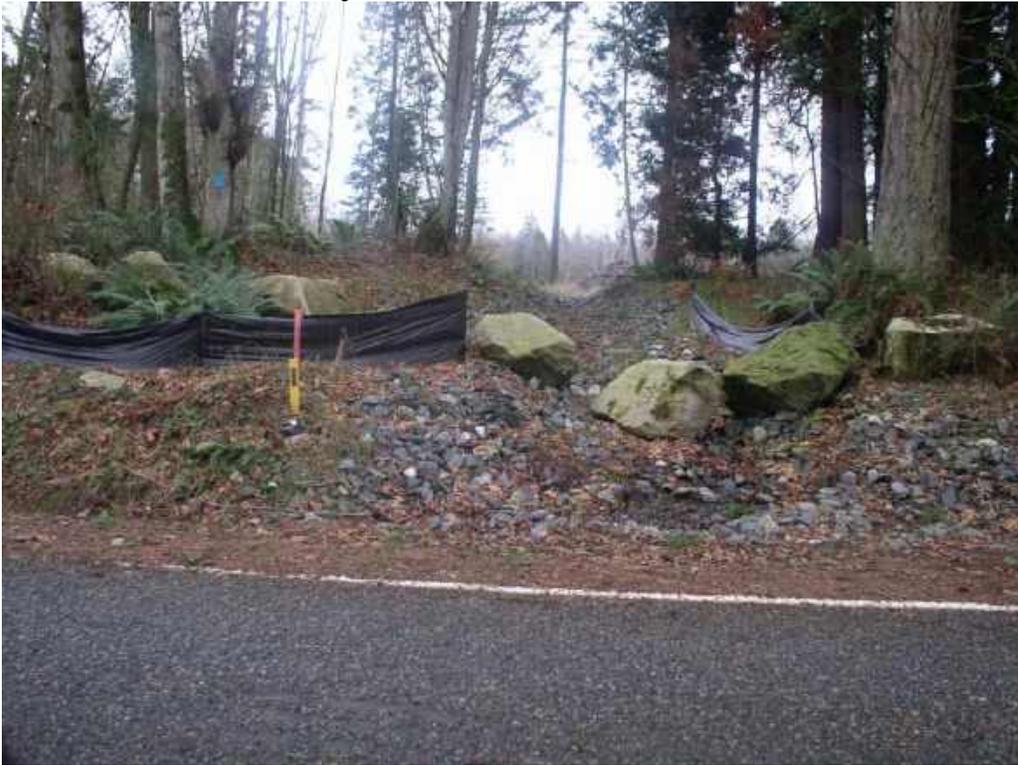
FIGURE 1
Channelized Stormwater Flow along Semiahmoo Drive in Birch Point Area

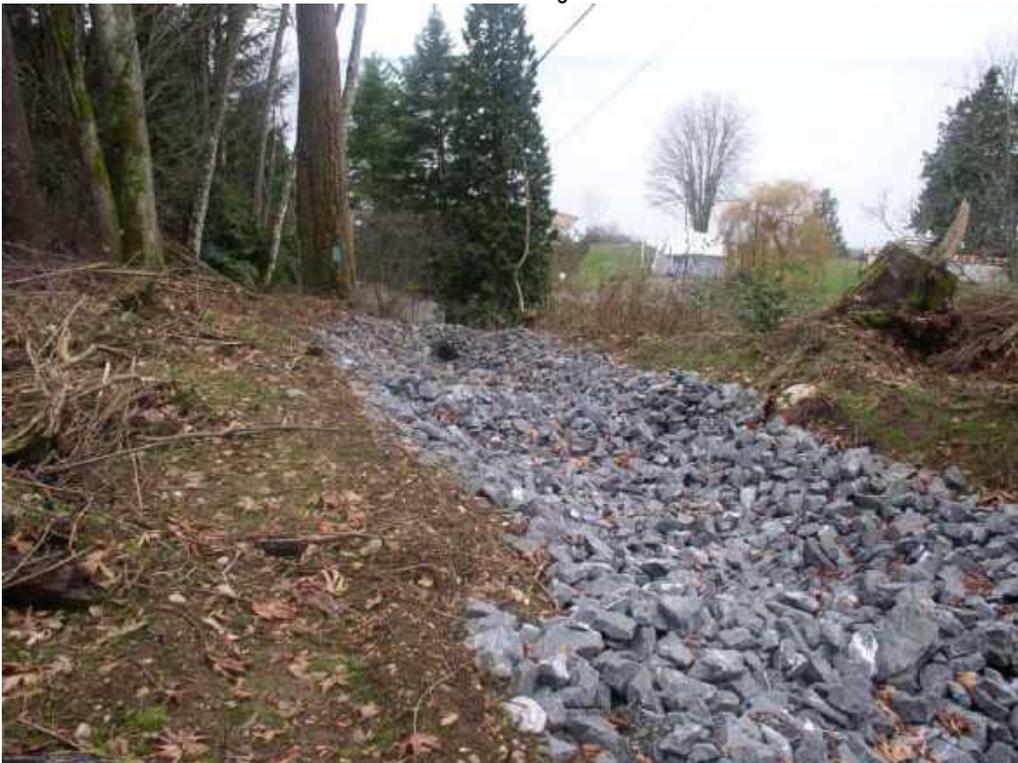
FIGURE 2
Modifications made to Channelized Stormwater Flow along Semiahmoo Drive in Birch Point Area

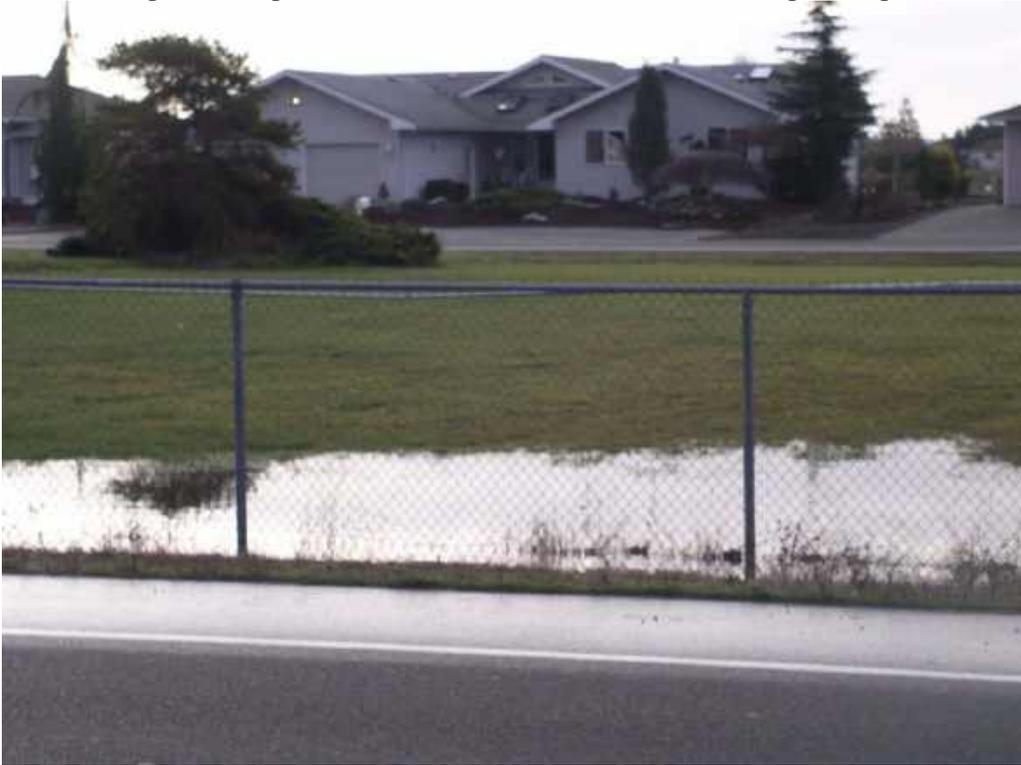
FIGURE 3

Flooded drainage ditch along the south side of Birch Point Road to the west of Rogers Slough

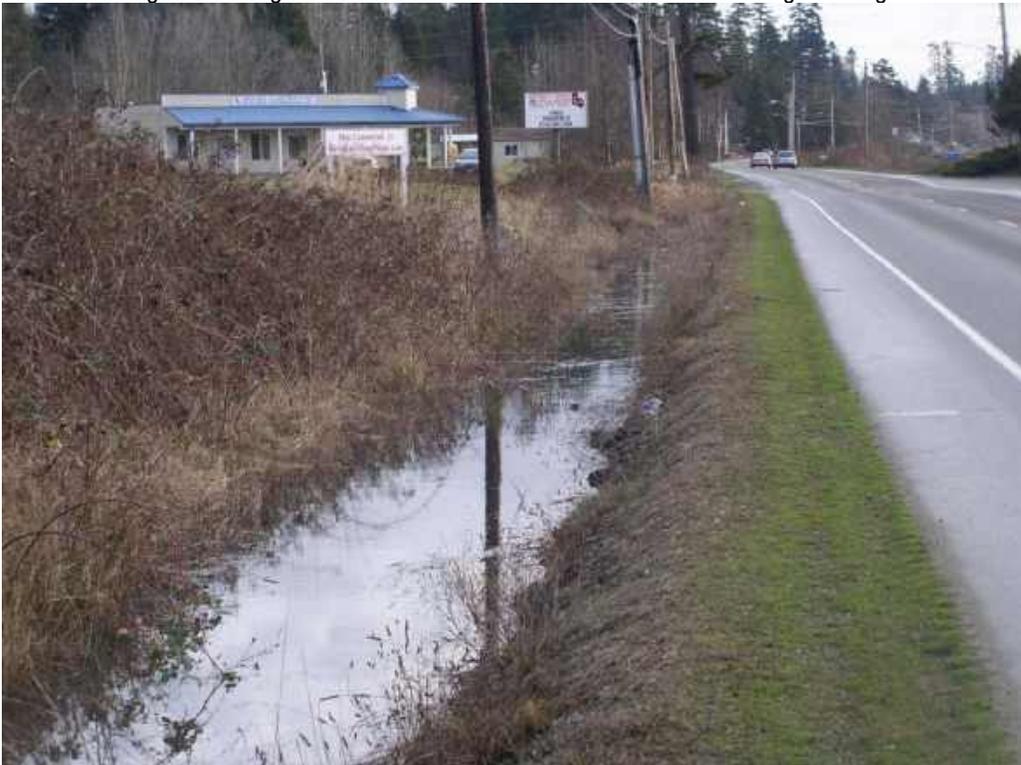
FIGURE 4

Flooded drainage ditch along the north side of Birch Point Road to the west of Rogers Slough

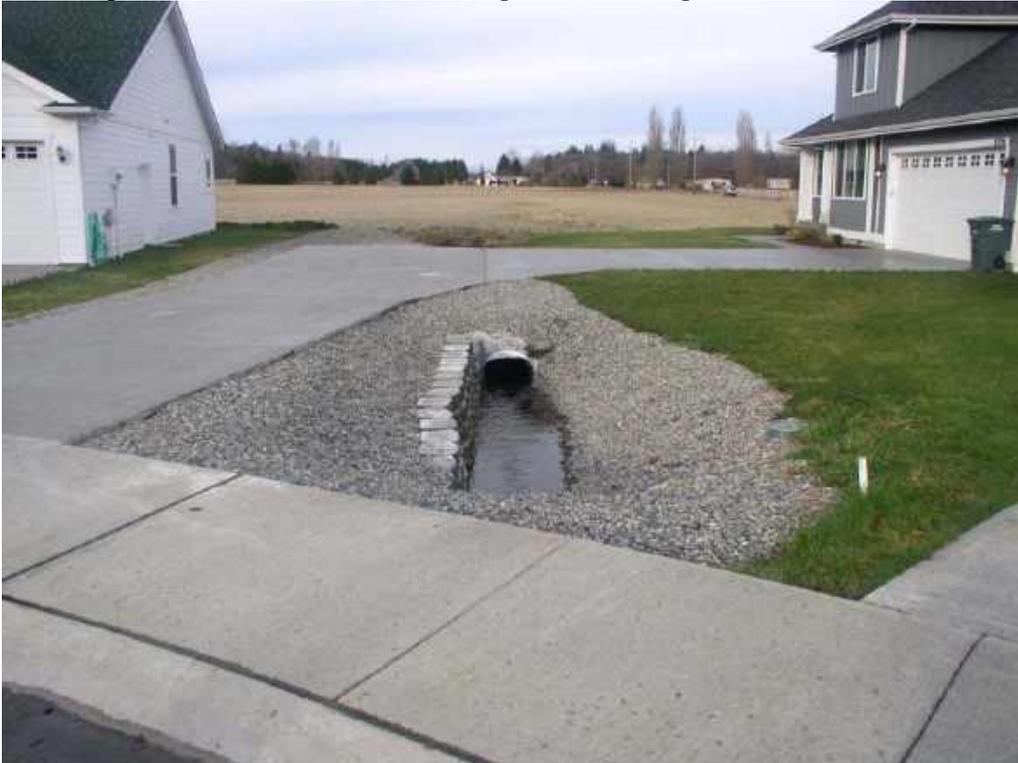
FIGURE 5

The drainage channel downstream of the two 90-degree bends entering the Richmond Park Subdivision, looking north

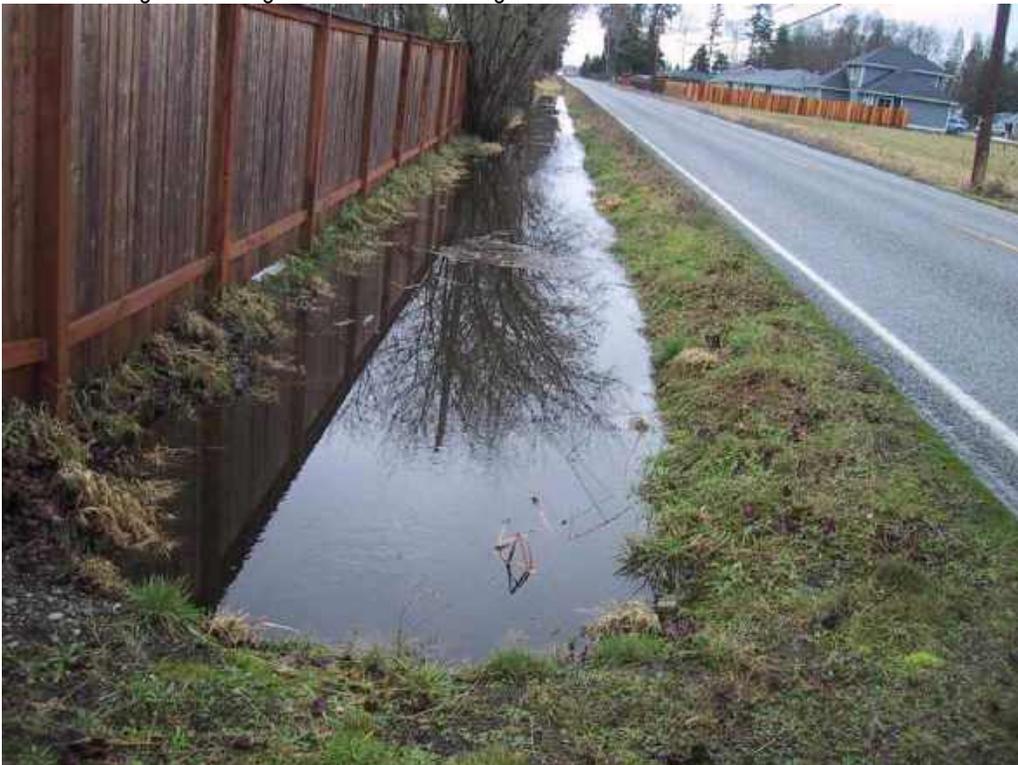
FIGURE 6

The full drainage ditch along Shintaffer Drive looking south

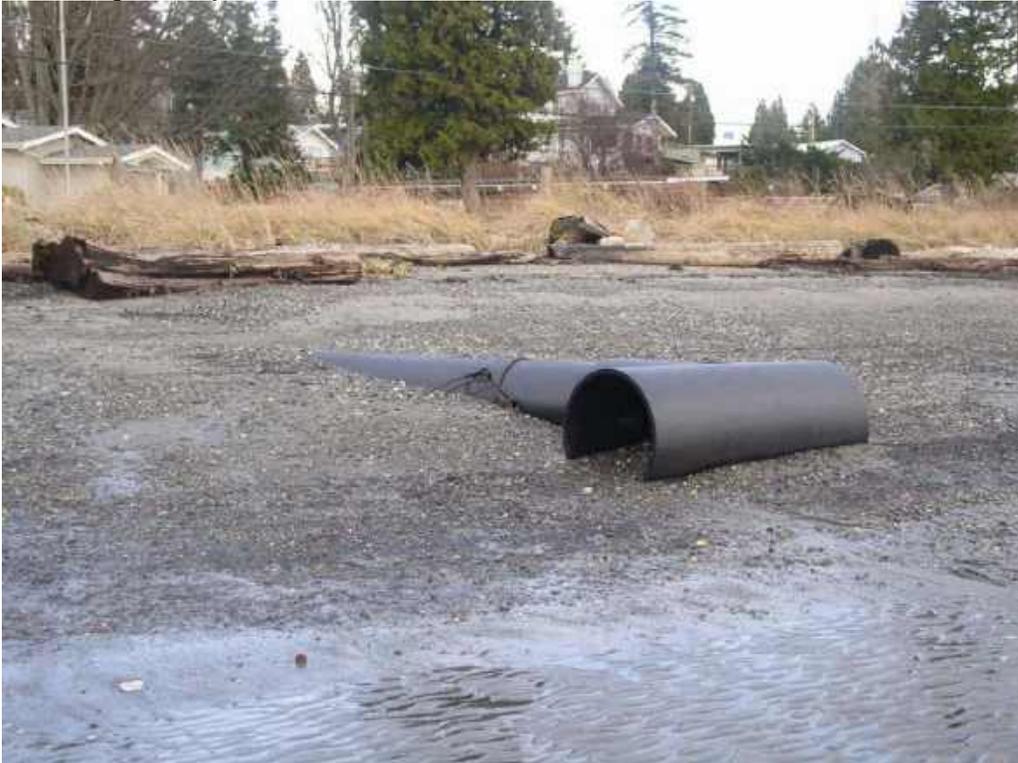
FIGURE 7
Outfall along Birch Bay Drive near Cedar

When the outfall pipe(s) are clogged or otherwise blocked or under extreme high tide conditions, the hydraulic head builds up and may create a backwater condition in the closed-pipe system. Figure 7 shows the hammerhead-type outlet structure of the northern outfall, and Figure 8 shows flooding that has occurred in the area. According to local residents, the lack of regular maintenance may lead to periodic flooding emergencies throughout Birch Bay. In both the January 2006 cases, the outfall had been obstructed by accumulated material that contributed to the drainage issues.

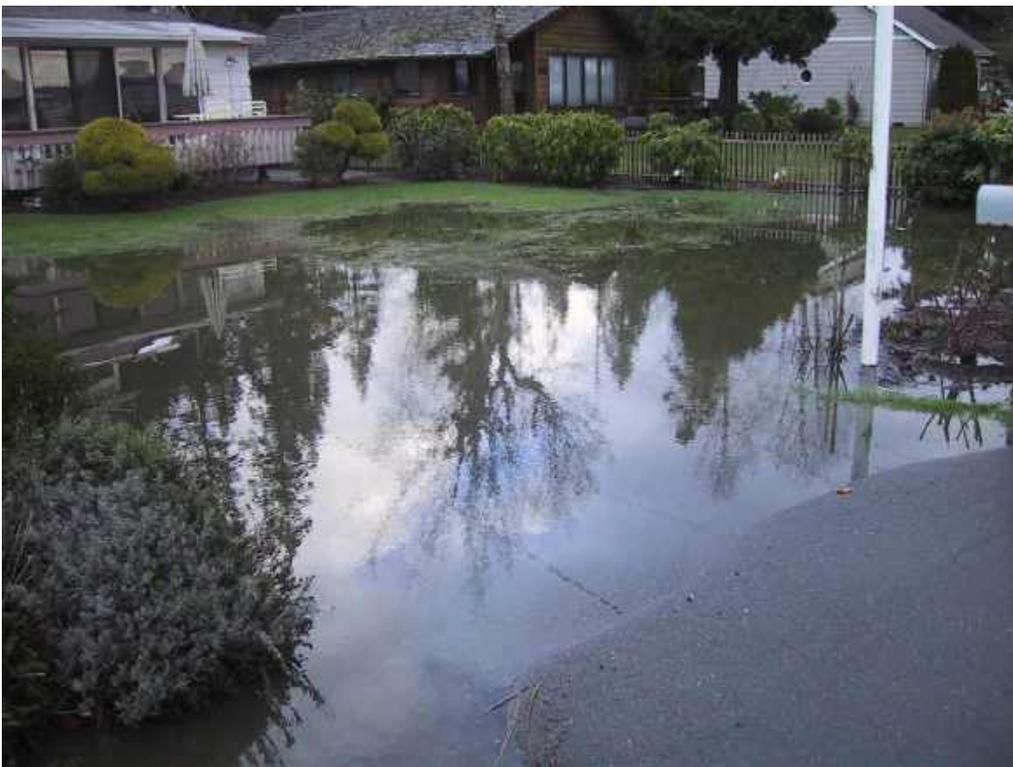
FIGURE 8
Flooding that occurred in January, 2006 along the 8200 block of Birch Bay Drive

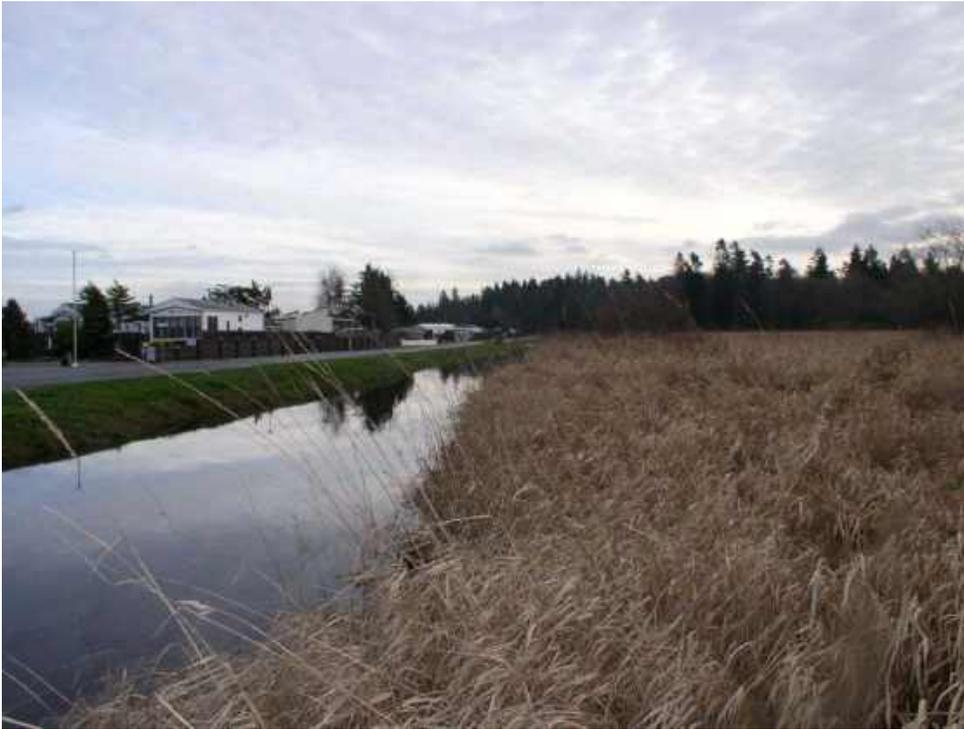
FIGURE 9

Looking east along the drainage ditch behind the tide gate at Lora Lane discharging to the mouth of Terrell Creek. The Leisure Park is shown on the left of the picture. Portions of the area to the right of the drainage ditch are classified as wetlands.

The area to the south and east of the Leisure Park is low-lying and flat and is part of the sub-basin draining to the ditch along Lora Lane. This ditch then discharges through the tide gate to Terrell Creek and on to Birch Bay. The yards of homes along Pine Drive are routinely full of runoff. Figure 9 shows the view looking east along the ditch along Lora Lane, with the Leisure Park on the left side of the picture. The tide gate to the mouth of Terrell Creek is just west of where the picture was taken (behind the photographer). Figure 10 shows the general low-lying area draining to the drainage ditch and the proximity of several homes in relation to the low-lying area. Figure 11 shows the area to the east and upstream of the home in Figure 10, taken looking to the northwest towards the drainage ditch and tide gate to Terrell Creek. The Birch Bay Subarea Plan Update (Kask Consulting, 2004) indicates that a large portion of this low-lying area is classified as wetlands. Much of the development in this area most likely occurred in areas that were originally wetlands.

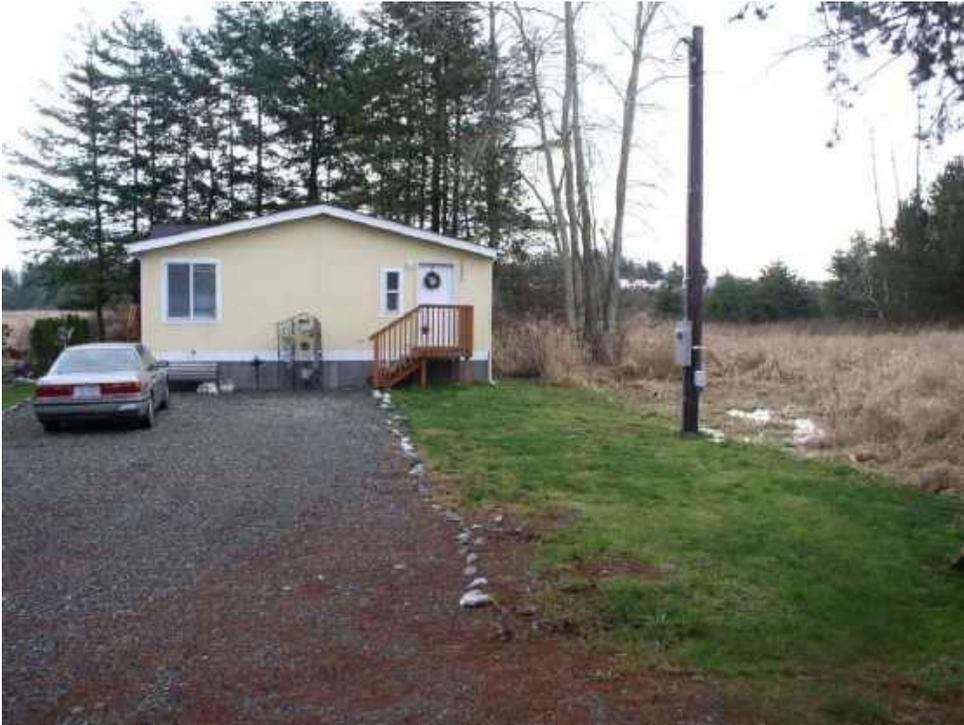
FIGURE 10

Low-lying area upstream of the drainage ditch shown in Figure 9. Note ponding water. Portions of this area are classified as a wetland.

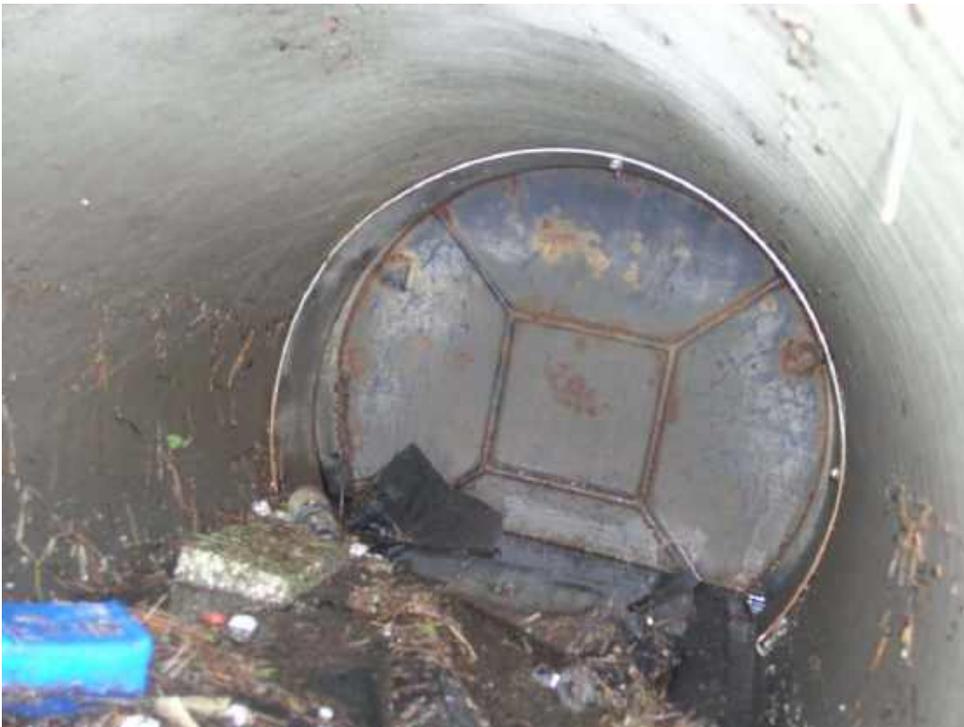
FIGURE 12

Material accumulated within the tide gate and culvert at the Corner of Wooldridge and Morrison, 01/04/06.

The culvert and tide gate at the corner of Wooldridge and Morrison often becomes blocked and causes road and yard flooding in the area. Water is often present over the roadway. Figure 12 shows the accumulated trash and other material propping open the tide gate during a site visit on 1/4/06. Figure 13 shows the culvert behind the tide gate under flooded conditions on 1/6/06. Because the tide gate was propped open and the picture was taken near the time of the high tide, the flooding shown may represent the approximate natural high tide level that day.

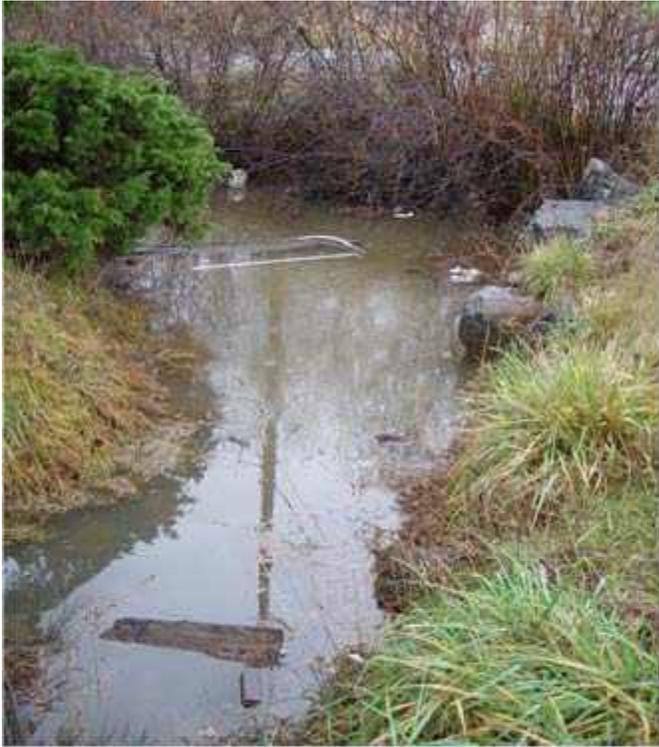
FIGURE 13

Flooded Ditch on the NE Corner of Wooldridge and Morrison behind tide gate, January 2006

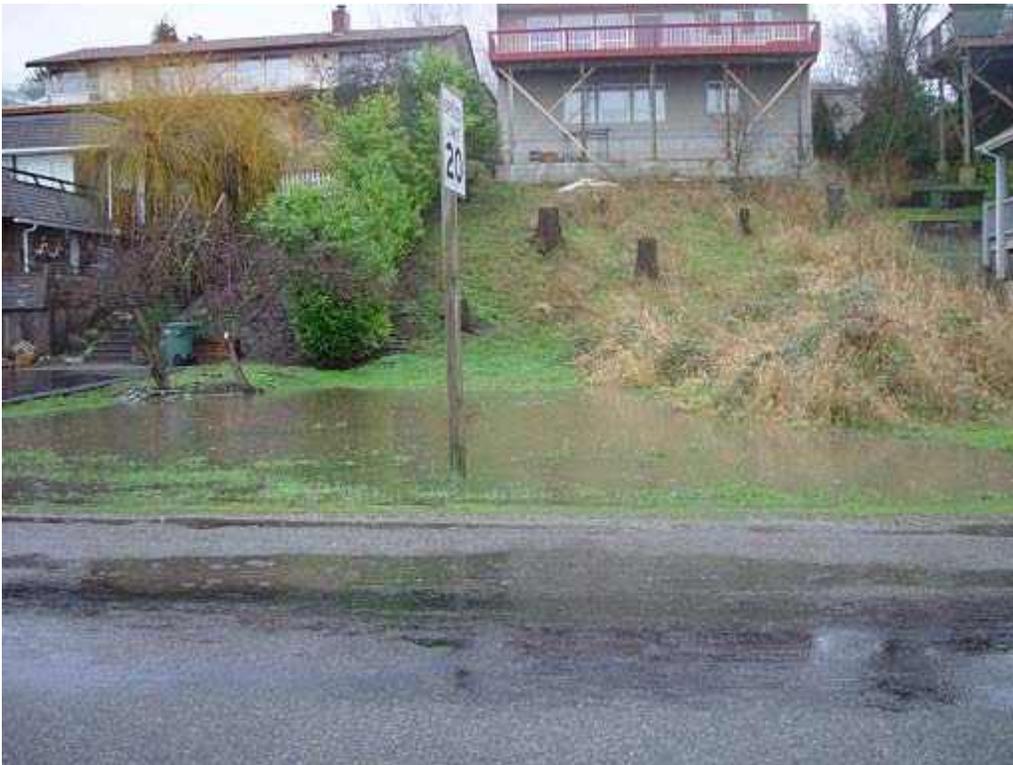
FIGURE 14

Flooding along Wooldridge just north of Jackson, January 2006

Yard flooding has been reported along Wooldridge just north of Jackson. This has been documented with photographs taken by local residents. Figure 14 shows an example of this flooding.

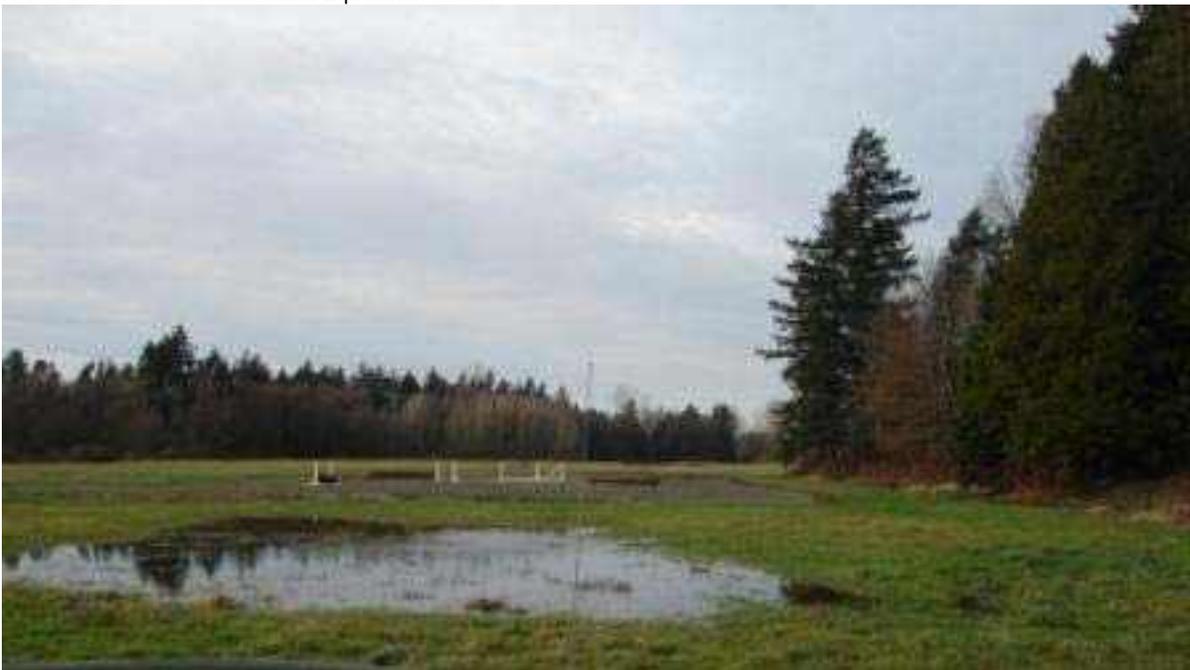
FIGURE 16
Horse use areas at Sunset Farm Equestrian Center

The Sunset Farm Equestrian Center along Birch Road may be a source of animal waste material. Posted rules require users to remove animal waste from graveled area. However, regulations may not be followed. This 70-acre park is managed by Whatcom County Parks and Recreation. Figure 16 shows the Sunset Farm Equestrian Center.

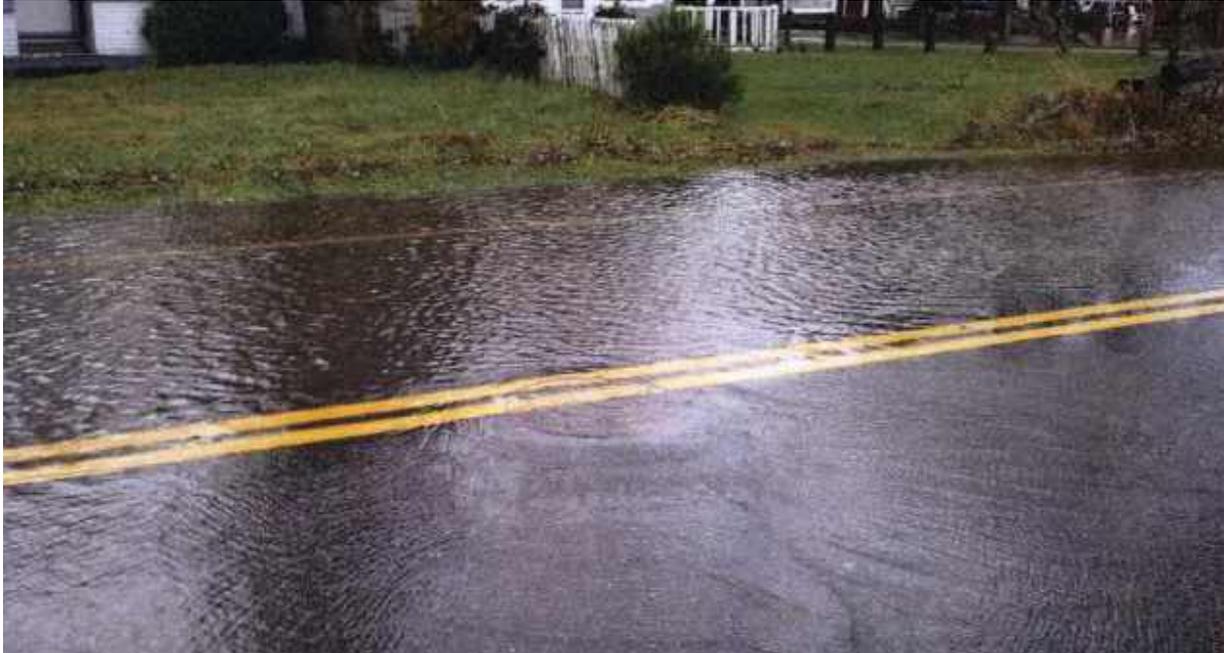
Figure 4-1. Street Ponding on Birch Bay Drive near Cottonwood Court

Naturally occurring ponding in an undisturbed system is beneficial because it slows the rate of runoff, thus reducing the likelihood of conveyance and erosion problems downstream. However, if ponding poses a safety concern or property damage risk (see Figure 4-1), then correction is required. Most ponding in the Central North subwatershed occurs because of high tide during storm events, lack of drainage infrastructure and low ground slopes.

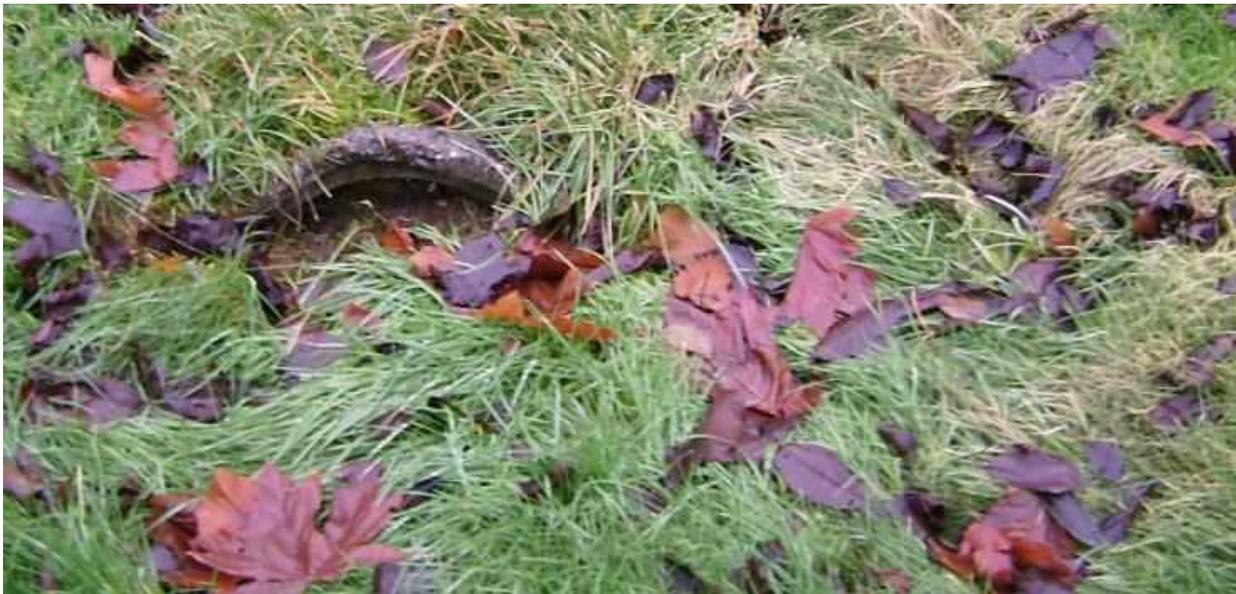
Figure 4-2. Blocked Culvert

Drainage structures fill with sediment over time in the absence of a regular cleaning program (see Figure 4-2). When structures become blocked, stormwater may overflow during rainfall events, causing damage to surrounding public and private property. Drainage structures in the Central North subwatershed are especially prone to siltation and blockage due to the ditch-and-culvert configuration, which brings sediment into the system. Sediments from developed areas have been shown to contain high levels of pollutants. Also, stormwater outfalls to Birch Bay are susceptible to blockage due to tidal fluctuation that washes sand and mud into outfall pipes and offshore currents that float debris over the opening.

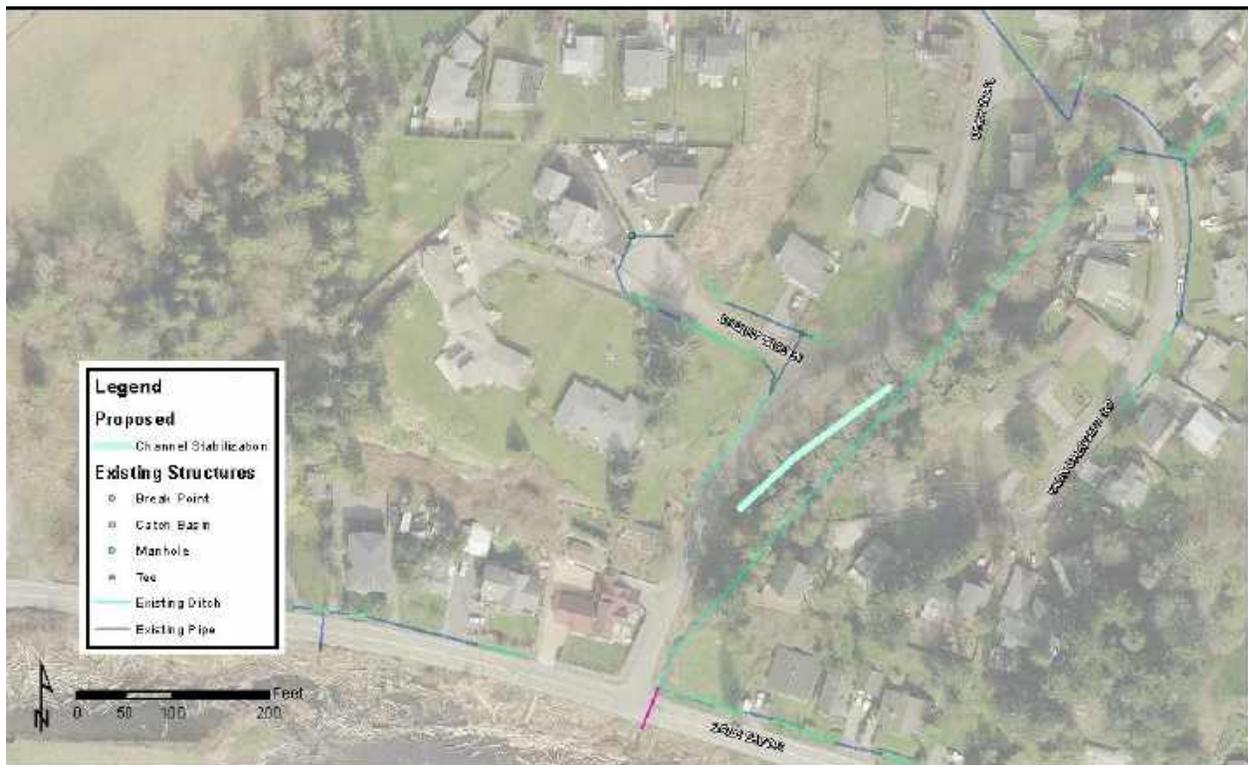
PROJECT: <u>SH-1 (Problem SH-13)</u>	BY: <u>GMS</u>
DESCRIPTION: <u>Streambank stabilization upstream of Birch Bay Drive</u>	CHECKED BY: _____
SUBBASIN: <u>Shintaffer</u>	DATE: <u>May 8, 2012</u>

- Stabilize and restore 200 feet of streambank.

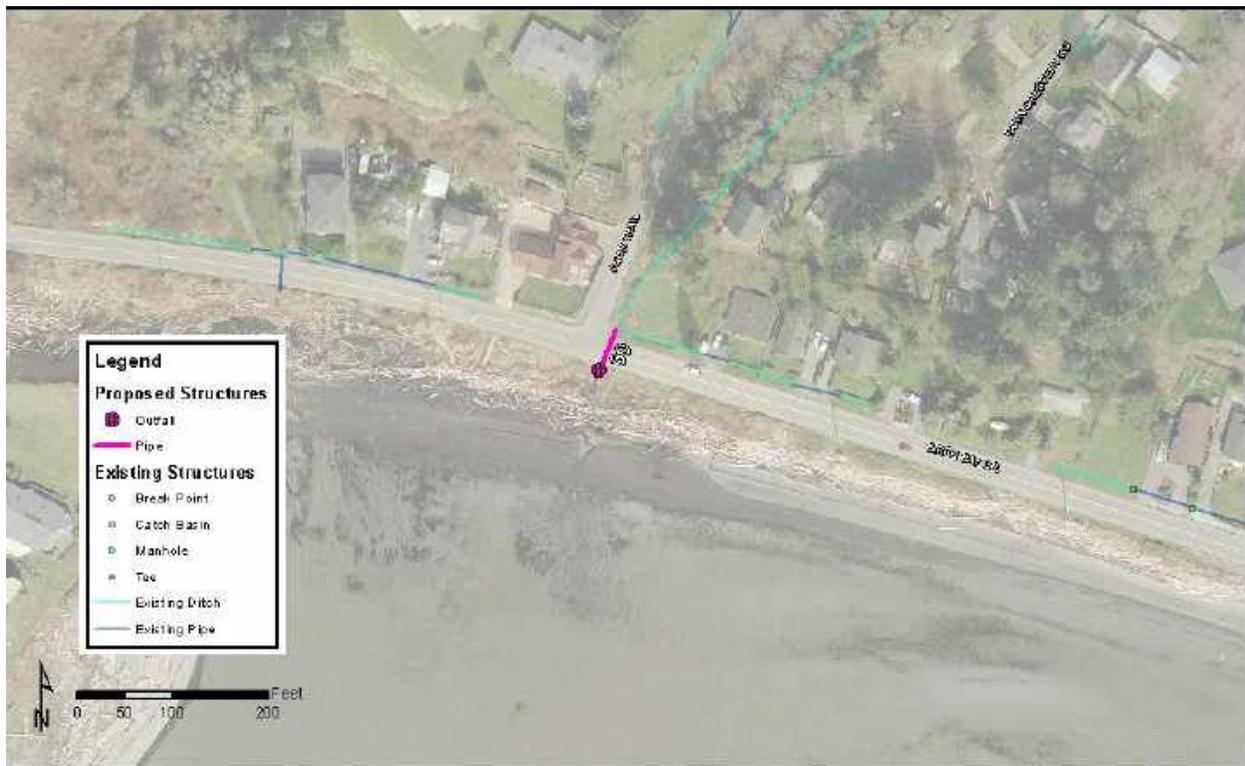
PROJECT: SH-3 (Problem SH-3)
DESCRIPTION: Birch Bay Deer Trail Outfall Replacement
SUBBASIN: Shintaffer

Description: Undersized outfall pipeline causes flooding along Birch Bay Drive for 100-year event under existing and future conditions.

- Install 45 lineal feet 30-inch diameter pipe under Birch Bay Drive.
- Install new 30-inch outfall with tide valve to Birch Bay.

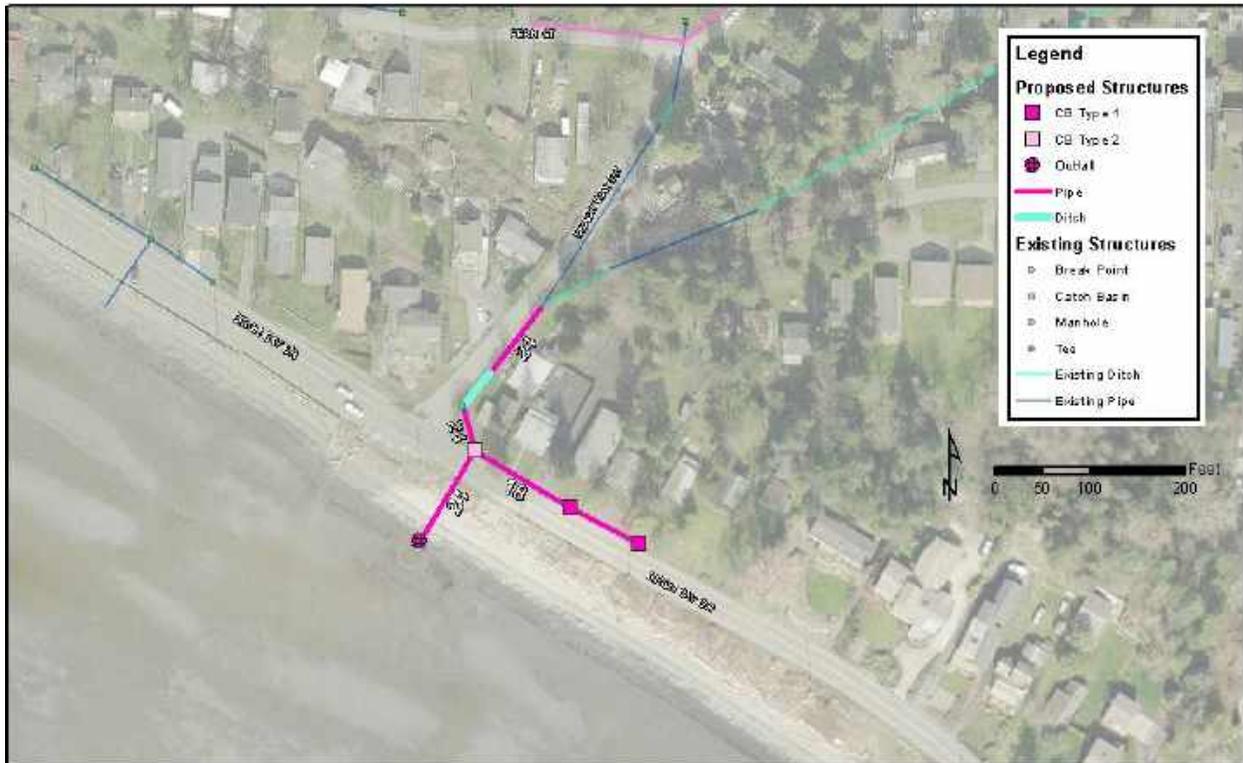
PROJECT: <u>CS-2 (Problem CS-2)</u>	BY: <u>GMS</u>
DESCRIPTION: <u>Beachway Drive and Birch Bay Drive Storm Drain Impr</u>	CHECKED BY: _____
SUBBASIN: <u>Cottonwood Beach South</u>	DATE: <u>May 8, 2012</u>

- Replace 200 lineal feet of 12-inch diameter storm drain with 18-inch diameter HDPE on north side of Birch bay Road
- Replace 18-inch diameter driveway culvert and 18-inch diameter storm drain and outfall with 240 lineal feet of 24-inch diameter HDPE pipe.
- Regrade 45 lineal feet of roadside ditch
- Construct 24-inch diameter outfall with tide valve.

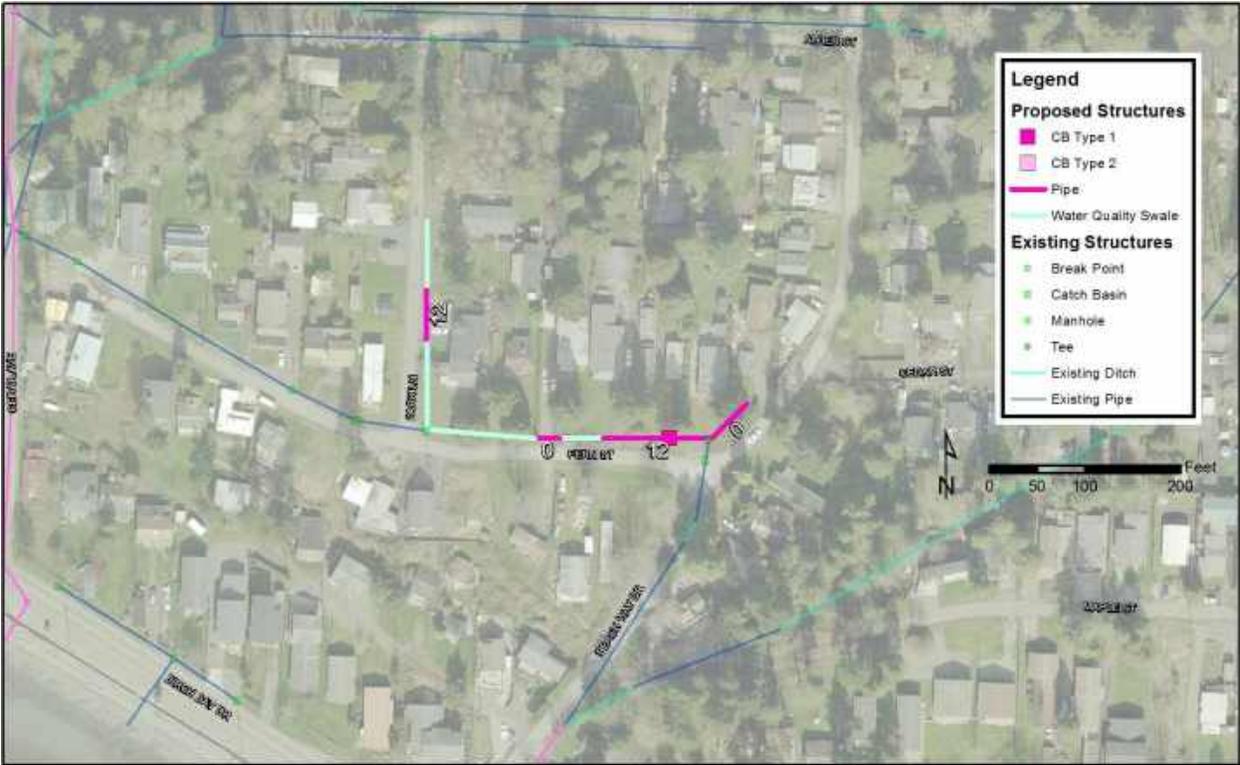
PROJECT: CS-3 (Problem CS-9)
DESCRIPTION: Fern Street Storm Drain System
SUBBASIN: Cottonwood Beach South

- Install 290 lineal feet of new 12-inch diameter HDPE
- Install 330 lineal feet of water quality swale
- Install 1 CB Type 1.

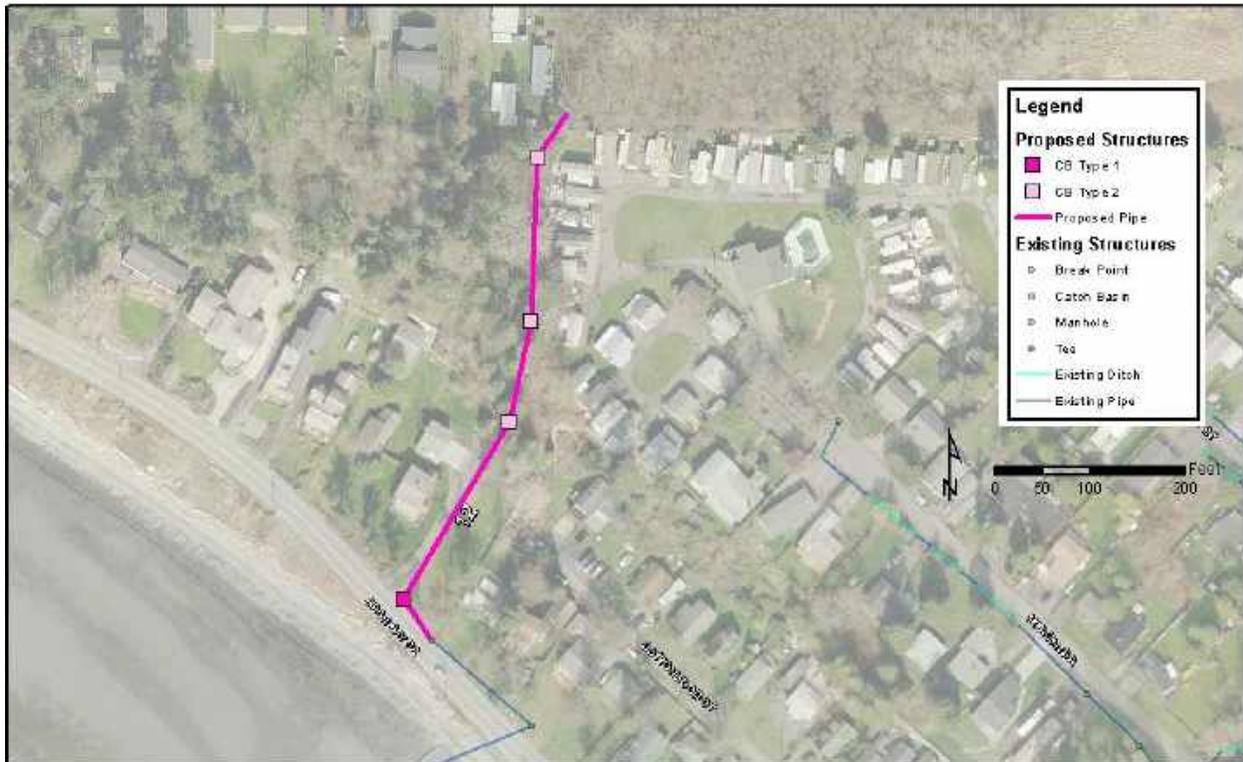
PROJECT: CS-4 (Problem CS-11) **BY:** GMS
DESCRIPTION: Tightline and Storm Drain between North Bay Trailer **CHECKED BY:** _____
SUBBASIN: Cottonwood Beach South **DATE:** May 8, 2012

- Install 600 lineal feet of 12-inch diameter HDPE pipe.
- Install 1 new Type 1 CB, 2 new Type 2 CBs and 1 new Type 2 CB as energy dissipater.

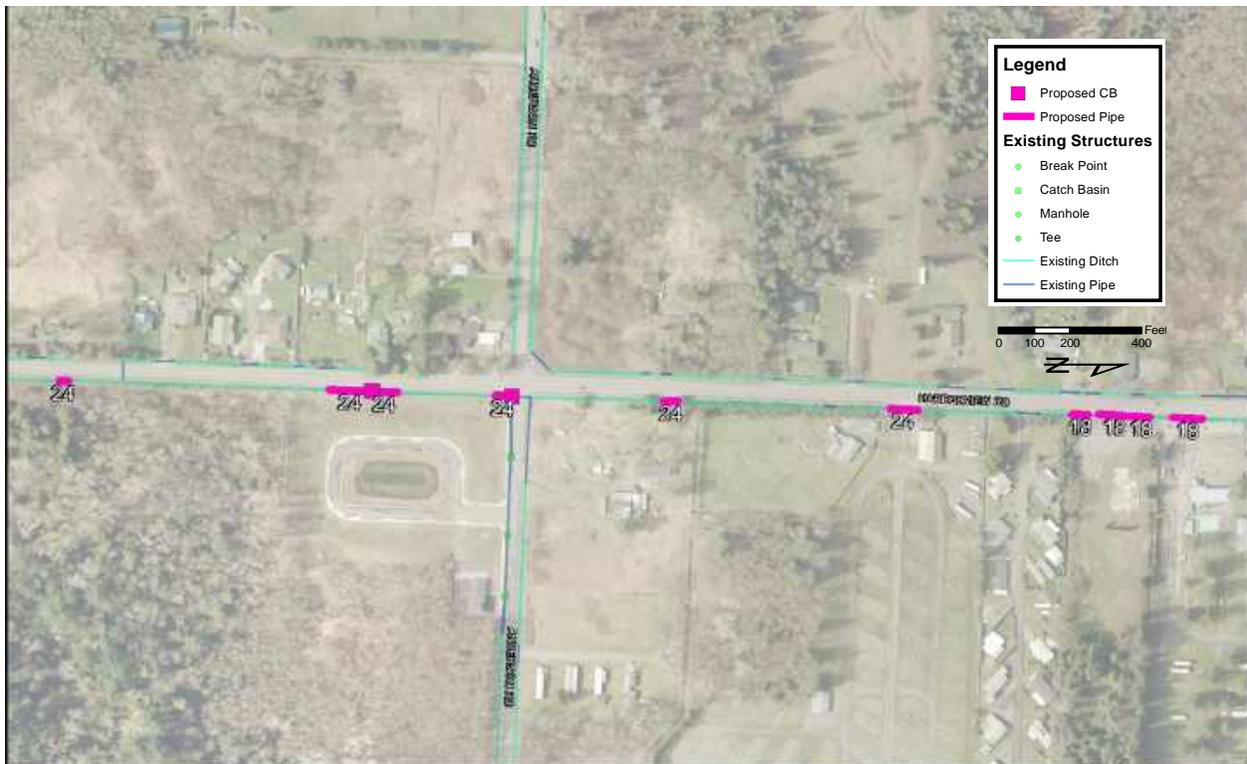
PROJECT: HL-1 (Problem HL-5)
DESCRIPTION: Replace 10 culverts, east side Harborview Rd.
SUBBASIN: Hillsdale

- Replace six 12- and 18-inch diameter road and driveway culverts (280 lineal feet) with 24-diameter HDPE pipes. Total replacement culvert pipe length is 280 feet.
- Replace four 12- inch diameter road and driveway culverts (200 lineal feet) with 18-diameter HDPE pipes.
- Replace two catch basins with Type 2 CBs.
- A local peak flow increase of about 9 percent would occur in the reach downstream of Harborview Drive. The average channel velocity is also predicted to increase slightly by 3 percent in this reach also. Flow and velocity increase are attenuated and not transferred downstream.

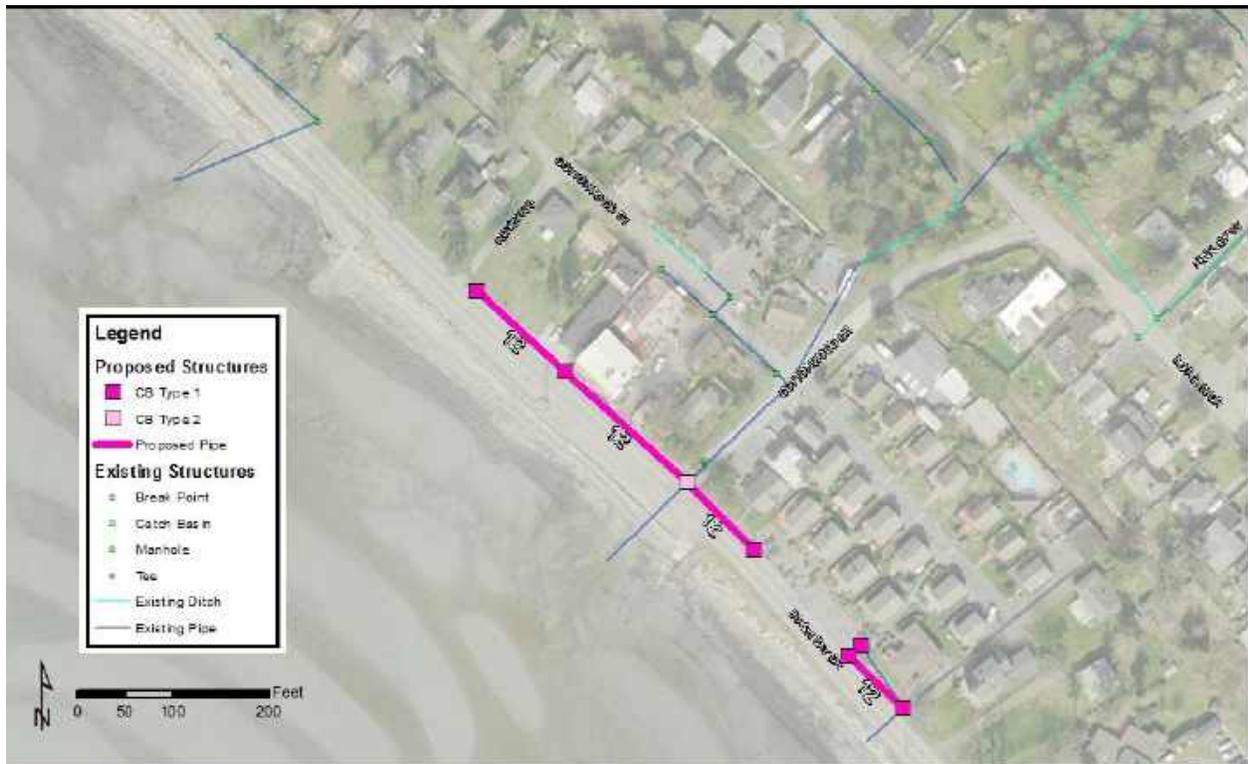
PROJECT: HL-2 (Problem HL-1 and HL-8) **BY:** GMS
DESCRIPTION: Replace storm drain, Birch Bay Dr. at Cottonwood Dr. **CHECKED BY:** _____
SUBBASIN: Hillsdale **DATE:** May 8, 2012

- Replace 325 lineal feet of 6- and 8-inch diameter storm drain with 12- diameter HDPE pipe.
- Install 175 lineal feet of 12- inch diameter HDPE pipe.
- Replace 4 catch basins with Type 1 CBs.
- Install 2 new Type 1 CBs
- Install 1 new Type 2, 72-inch diameter CB to connect new storm drain to existing 30-inch diameter pipeline outfall.

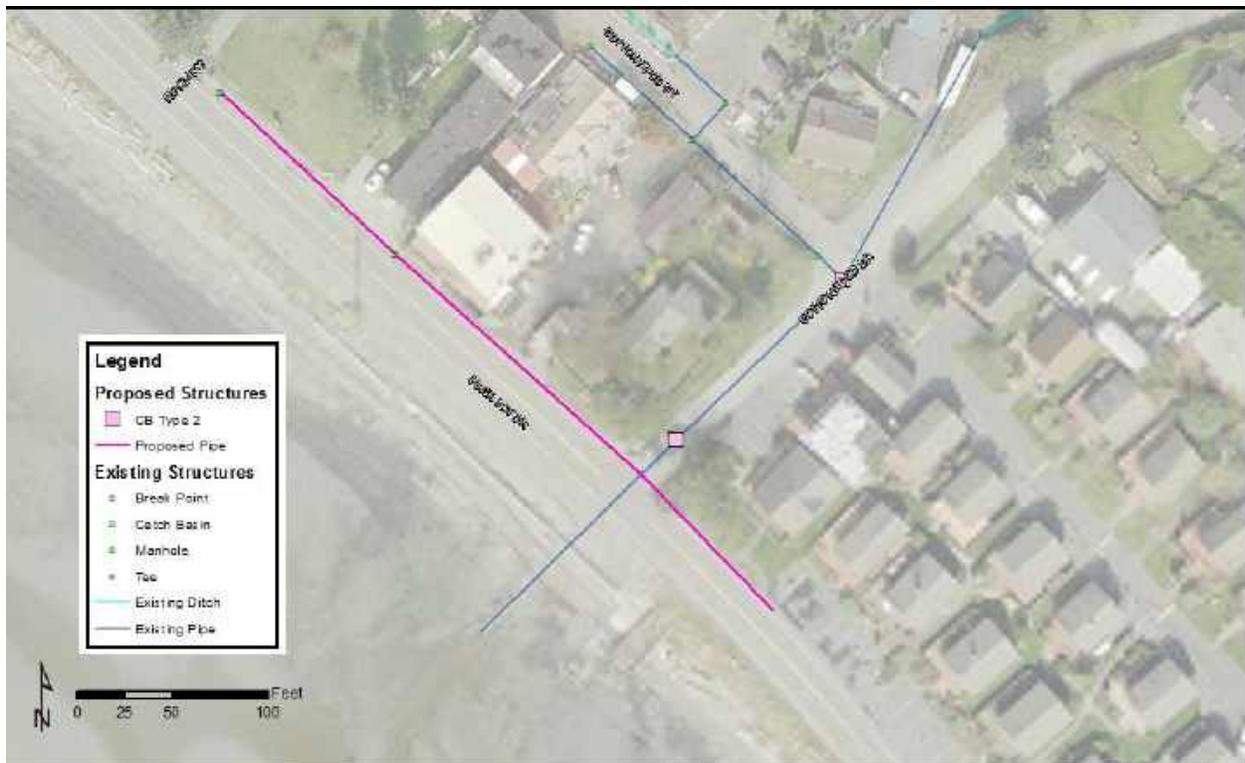
PROJECT: HL-3 (Problem HL-13 and HL-14)
DESCRIPTION: Cottonwood Drive Maintenance Improvements
SUBBASIN: Hillsdale

- Replace two blind tee connections with type 2 CBs.
- Connect existing pipe to CBs.
