**AMENDING THE 2006 BIRCH BAY COMPREHENSIVE STORMWATER PLAN TO
INCLUDE FOUR SUBWATERSHED MASTER PLANS**

BIRCH BAY

COMPREHENSIVE STORMWATER PLAN

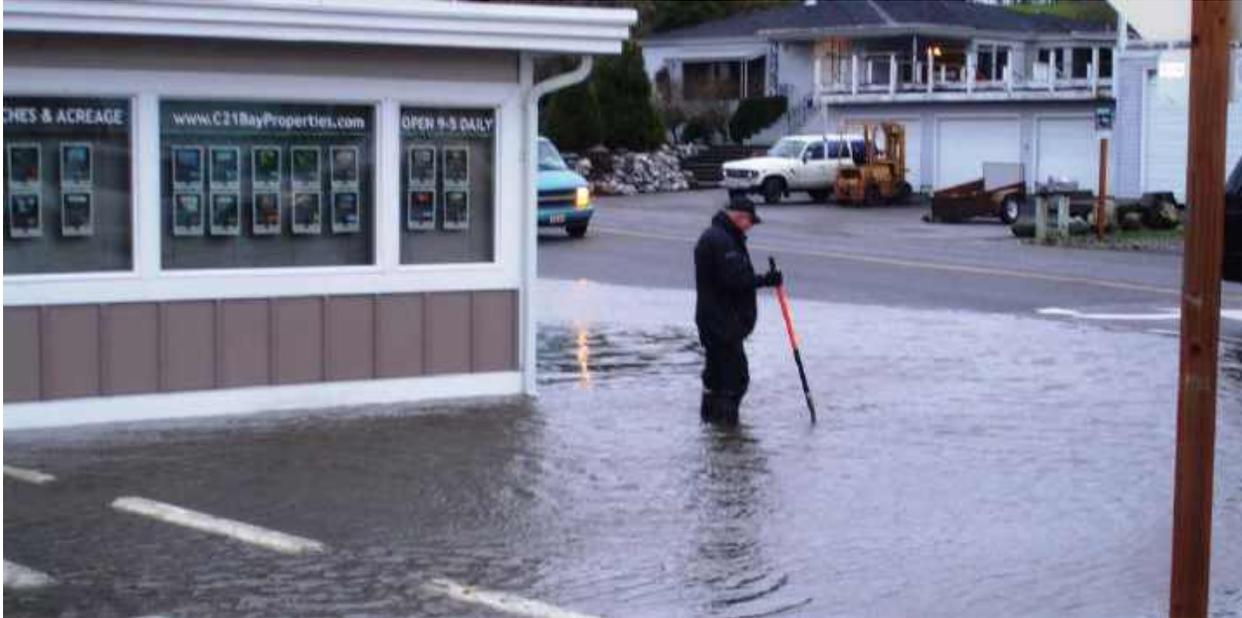
Naturally occurring ponding in an undisturbed system is beneficial because it slows the rate of runoff, thus reducing the likelihood of conveyance and erosion problems downstream. However, if ponding poses a safety concern or property damage risk (see Figure 4-1), then correction is required. Most ponding in the Central South Subwatershed occurs because of high tide during storm events, lack of drainage infrastructure and low ground slopes.

Figure 4-1. Street Ponding on Birch Bay Drive Near Harborview Road (Photo by Whatcom County)

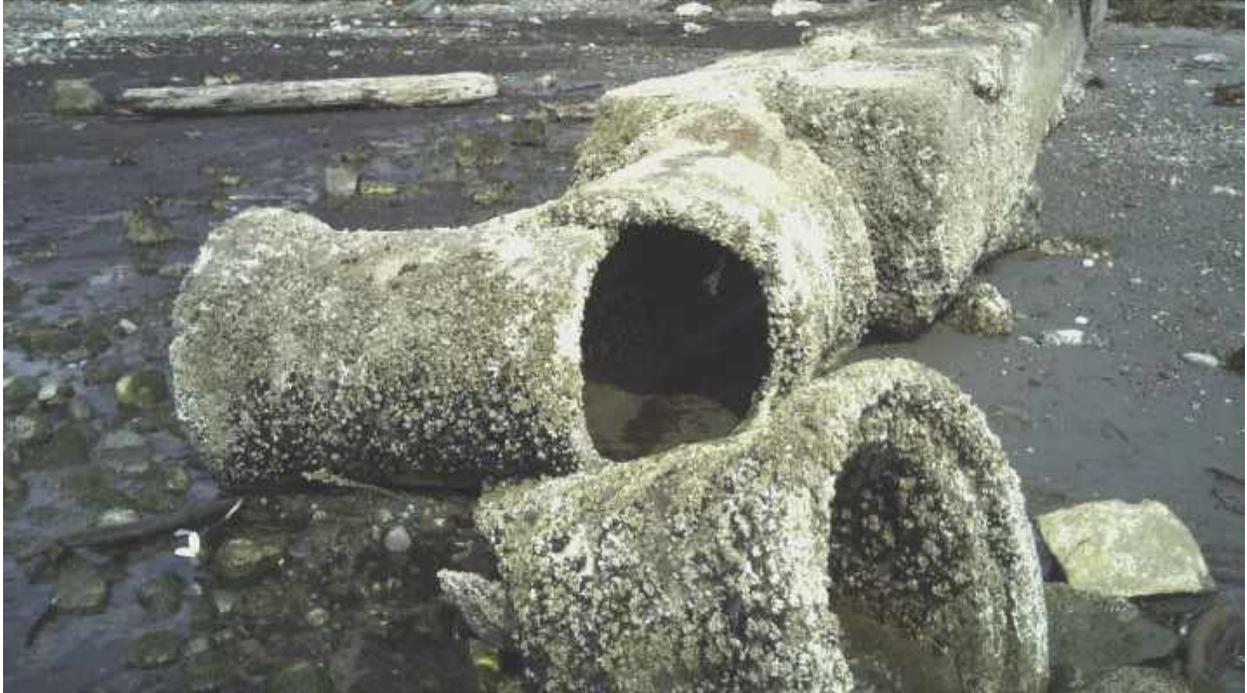
Drainage structures are considered inadequate when they are too small to accommodate stormwater flows, whether by original design or because land use changes increase flows to levels beyond the system's capacity. It is not economical to design systems with capacity for every possible storm, but systems that are inadequate for a reasonable design storm must be improved by performing a hydraulic analysis of the system and designing improvements to meet local design criteria. Within the study area, many of the existing drainage structures were installed fairly recently and are of adequate size. More significant is the lack of any drainage infrastructure in several of the older neighborhoods. Inadequate infrastructure also includes structures in poor condition and in need of replacement, as shown in Figure 4-2.

Figure 4-2. Harborview Road Outfall Near Birch Bay Drive (photo by Wilson Engineering)

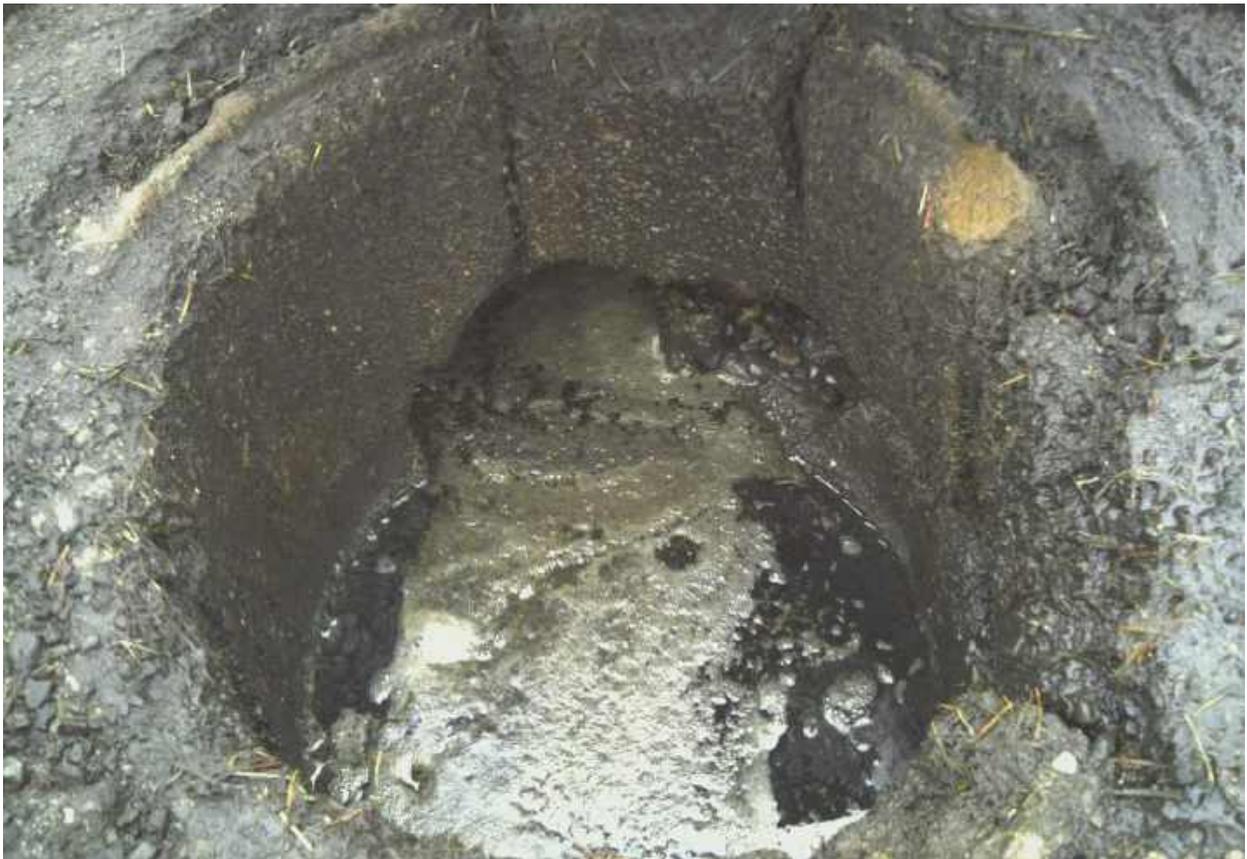
Urban stormwater quality is highly variable, depending on factors such as land use, the level of development, the age of the developed area, and the density of construction. The quality of stormwater runoff has historically been degraded by changes from natural to urbanized conditions (Figure 4-3). Fecal coliform and trash have been identified as water quality problems in the Central South Subwatershed.

Figure 4-3. Catch Basin with Oil Sheen and Odors (photo by Wilson Engineering)

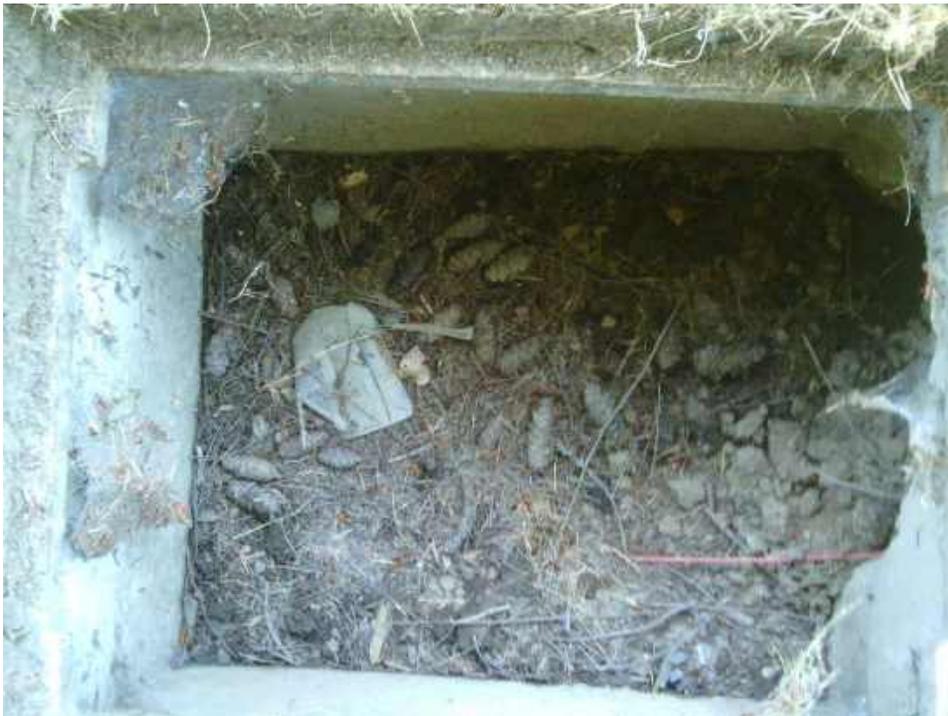
Drainage structures fill with sediment over time in the absence of regular cleaning (see Figure 4-4). When structures become blocked, stormwater may overflow during rainfall events, causing damage to surrounding public and private property. Drainage structures in the Central South Subwatershed are especially prone to siltation and blockage due to backwater in low-gradient drainage systems which allows sediment to settle into the pipe and ditch systems. Sediments from developed areas have been shown to contain high levels of pollutants. Also, stormwater outfalls to Birch Bay are susceptible to blockage due to tidal fluctuation that washes sand and mud into outfall pipes and offshore currents that float debris over the opening.

Figure 4-4. Catch Basin with Sediment and Debris Accumulation (photo by Wilson Engineering)

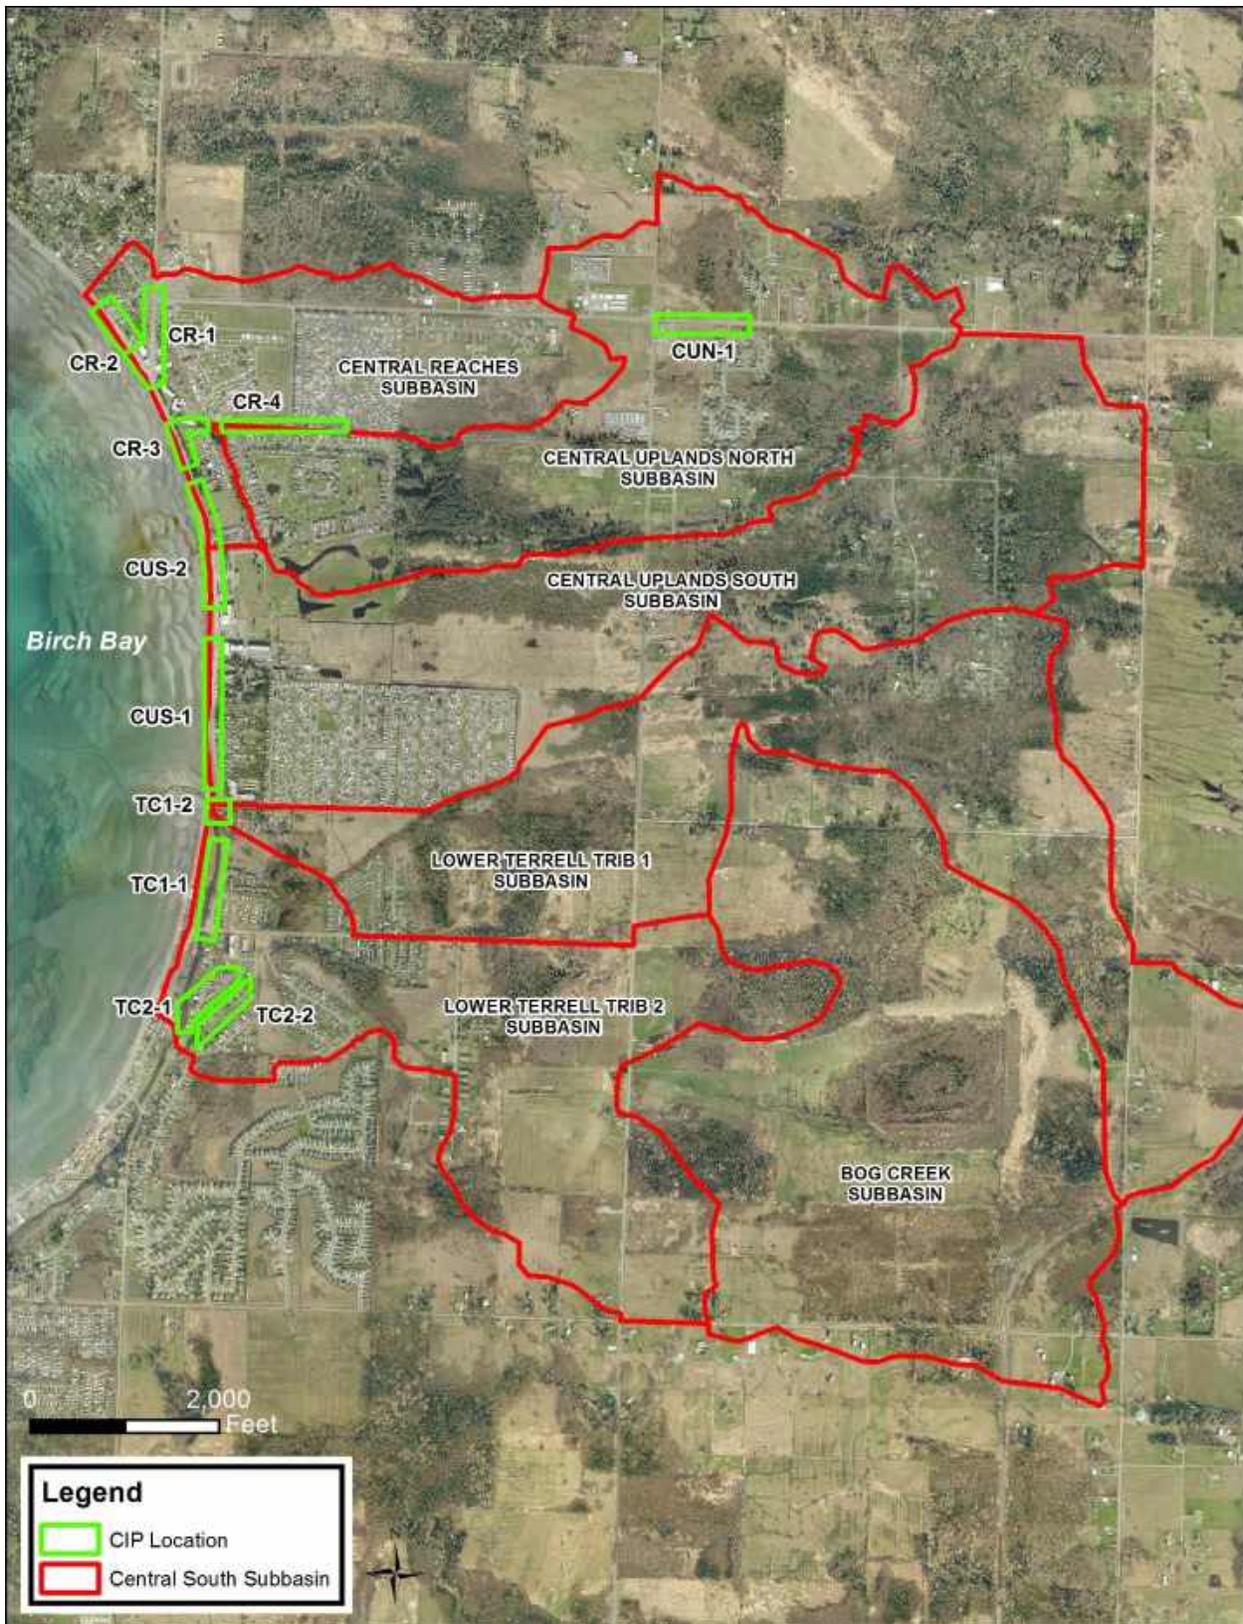
Twelve capital projects were developed to address 33 drainage problems, as listed in Table 5-5. In some locations, a single project addresses more than one problem. The proposed projects include a total of over 11,300 feet of new or replacement storm drain pipeline, 265 feet of roadside ditch, 115 new or replacement catch basins, 290 feet of water quality swale, two new tide valves, and 6 new or replaced outfalls. Figure 5-2 shows the project locations. Detailed project descriptions are provided in Appendix C. Table 5-6 shows a breakdown of estimated project costs.

Figure 5-2. Capital Projects

a. See Figure 5-2.

a. See Figure 5-2 for project location.

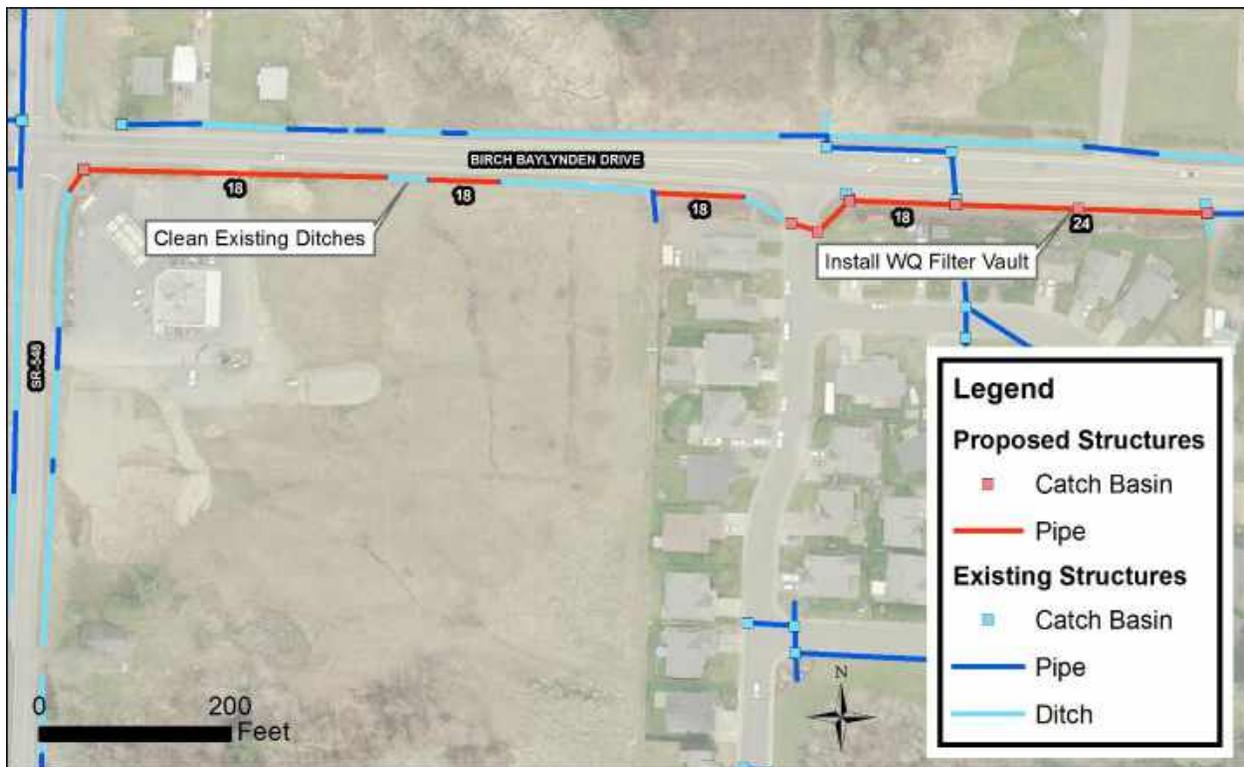
- Clean 265 lineal feet of roadside ditch.
- Replace 582 lineal feet of 12-inch diameter pipe with 18-inch diameter CPE.
- Replace 264 lineal feet of 24-inch diameter smooth plastic pipe with 24-inch diameter CPE.
- Replace 3 CB Type 1 structures with CB Type 2 structures.
- Replace 3 CB Type 2 structures.
- Install 1 water quality filter vault.

PROJECT: CUN-1
DESCRIPTION: Birch Bay – Lynden Road Roadside Storm Drainage Improvements
SUBBASIN: Central Uplands North

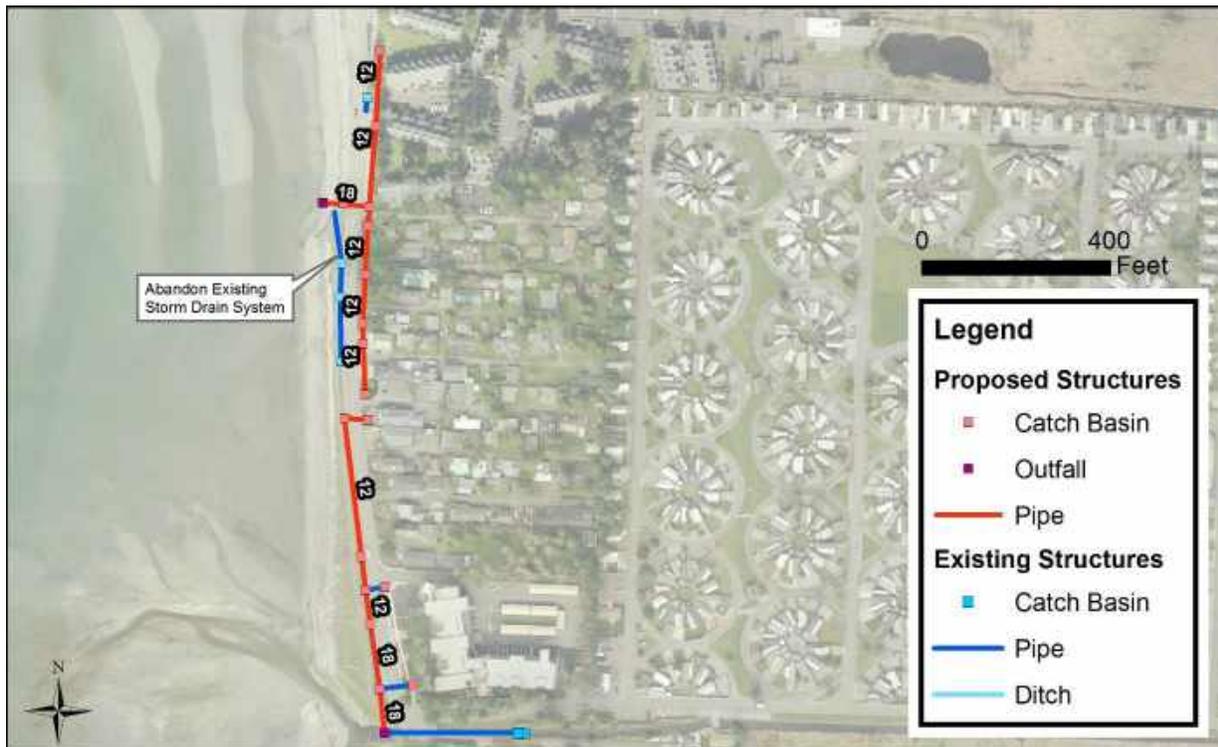
- Abandon existing storm drain line.
- Replace 679 lineal feet of 8-inch diameter storm drain with 445 lineal feet of 12-inch CPE and 234 lineal feet of 18-inch CPE.
- Replace 2 CB Type 1 structures with CB Type 2 Structures
- Replace 5 CB Type 1 structures.
- Install 788 lineal feet of 12-inch diameter CPE pipe and 55 lineal feet of 18-inch diameter CPE pipe
- Install 9 CB Type 1 structures and 2 CB Type 2 structures.
- Install one 18-inch HDPE outfall to Birch Bay (30 lineal feet).

PROJECT: CUS--1
DESCRIPTION: Birch Bay Drive Storm Drain Improvements North of Lora Lane
SUBBASIN: Central Uplands South

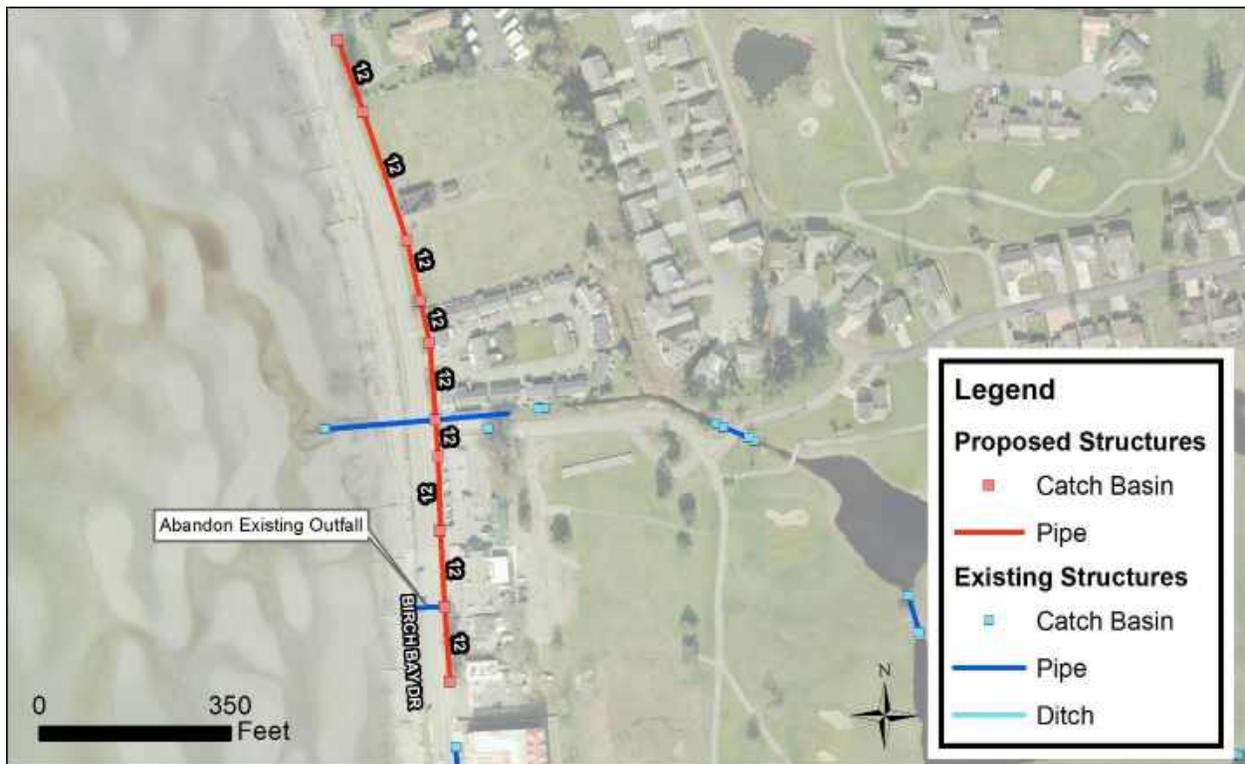
- Install 1,200 linear feet of 12-inch CPE pipe.
- Install 9 CB Type 1 structures.
- Replace 1 CB Type 2 structure.

PROJECT: CUS-2
 DESCRIPTION: Birch Bay Drive at Club House Drive Storm Drain Improvements
 SUBBASIN: Central Reaches / Central Uplands South

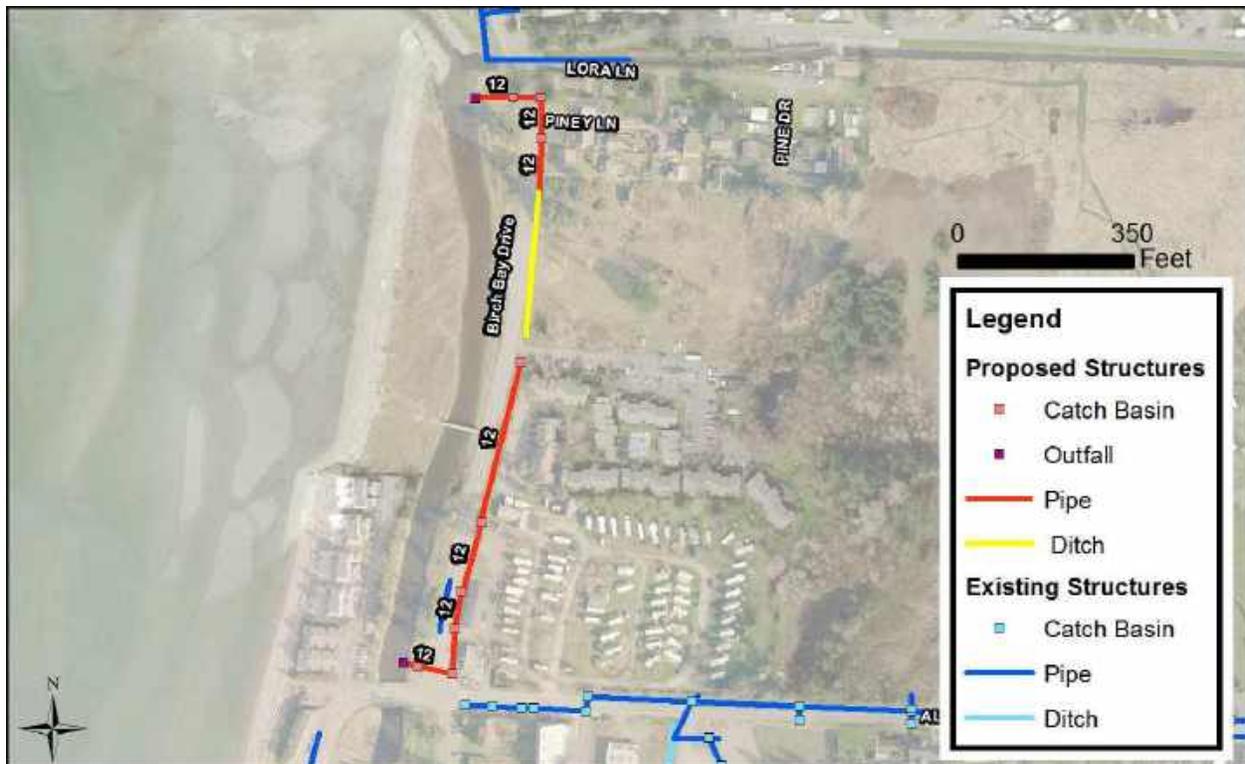
- Replace 194 lineal feet of 8- and 10-inch diameter storm drain with 12-inch diameter CPE.
- Install 719 lineal feet of 12-inch diameter CPE pipe.
- Construct 294 lineal feet of water quality swale.
- Replace 3 CB Type 1 structures and install 6 CB Type 1 structures.
- Install two 12-inch diameter HDPE pipe outfalls (145 total lineal feet).

PROJECT: TC1-1
DESCRIPTION: Birch Bay Dr. Storm Drain Improvements North of Alderson Rd.
SUBBASIN: Terrell Creek Tributary 1

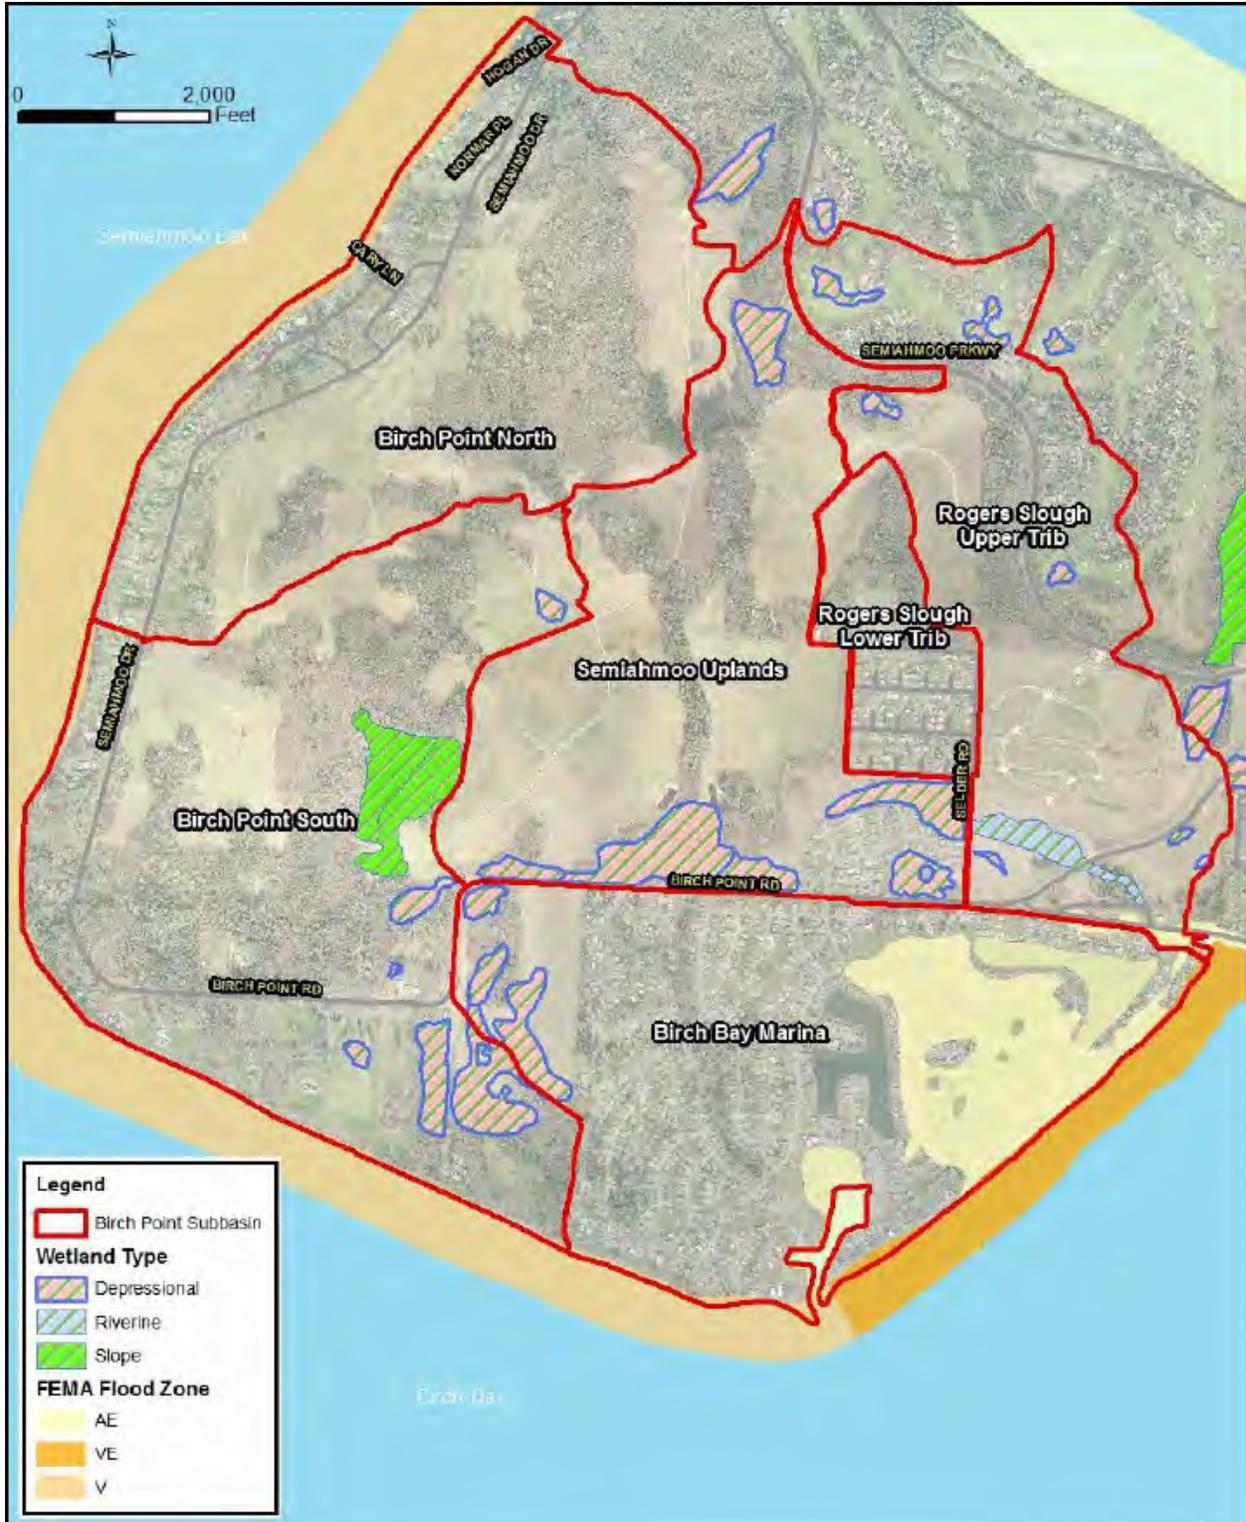
Wetlands are located in lowland areas of the subwatershed near Birch Point Road (see Figure 2-4) due to the flat topography, potentially high groundwater and relatively pervious surface soils. Table 2-1 summarizes the wetland area in each subbasin. Wetland locations were generated using approximate methods based on information from county sources; they may not represent actual wetland areas in the subwatershed.

Figure 2-4. Wetlands and FEMA Flood Zones within the Birch Point Subwatershed

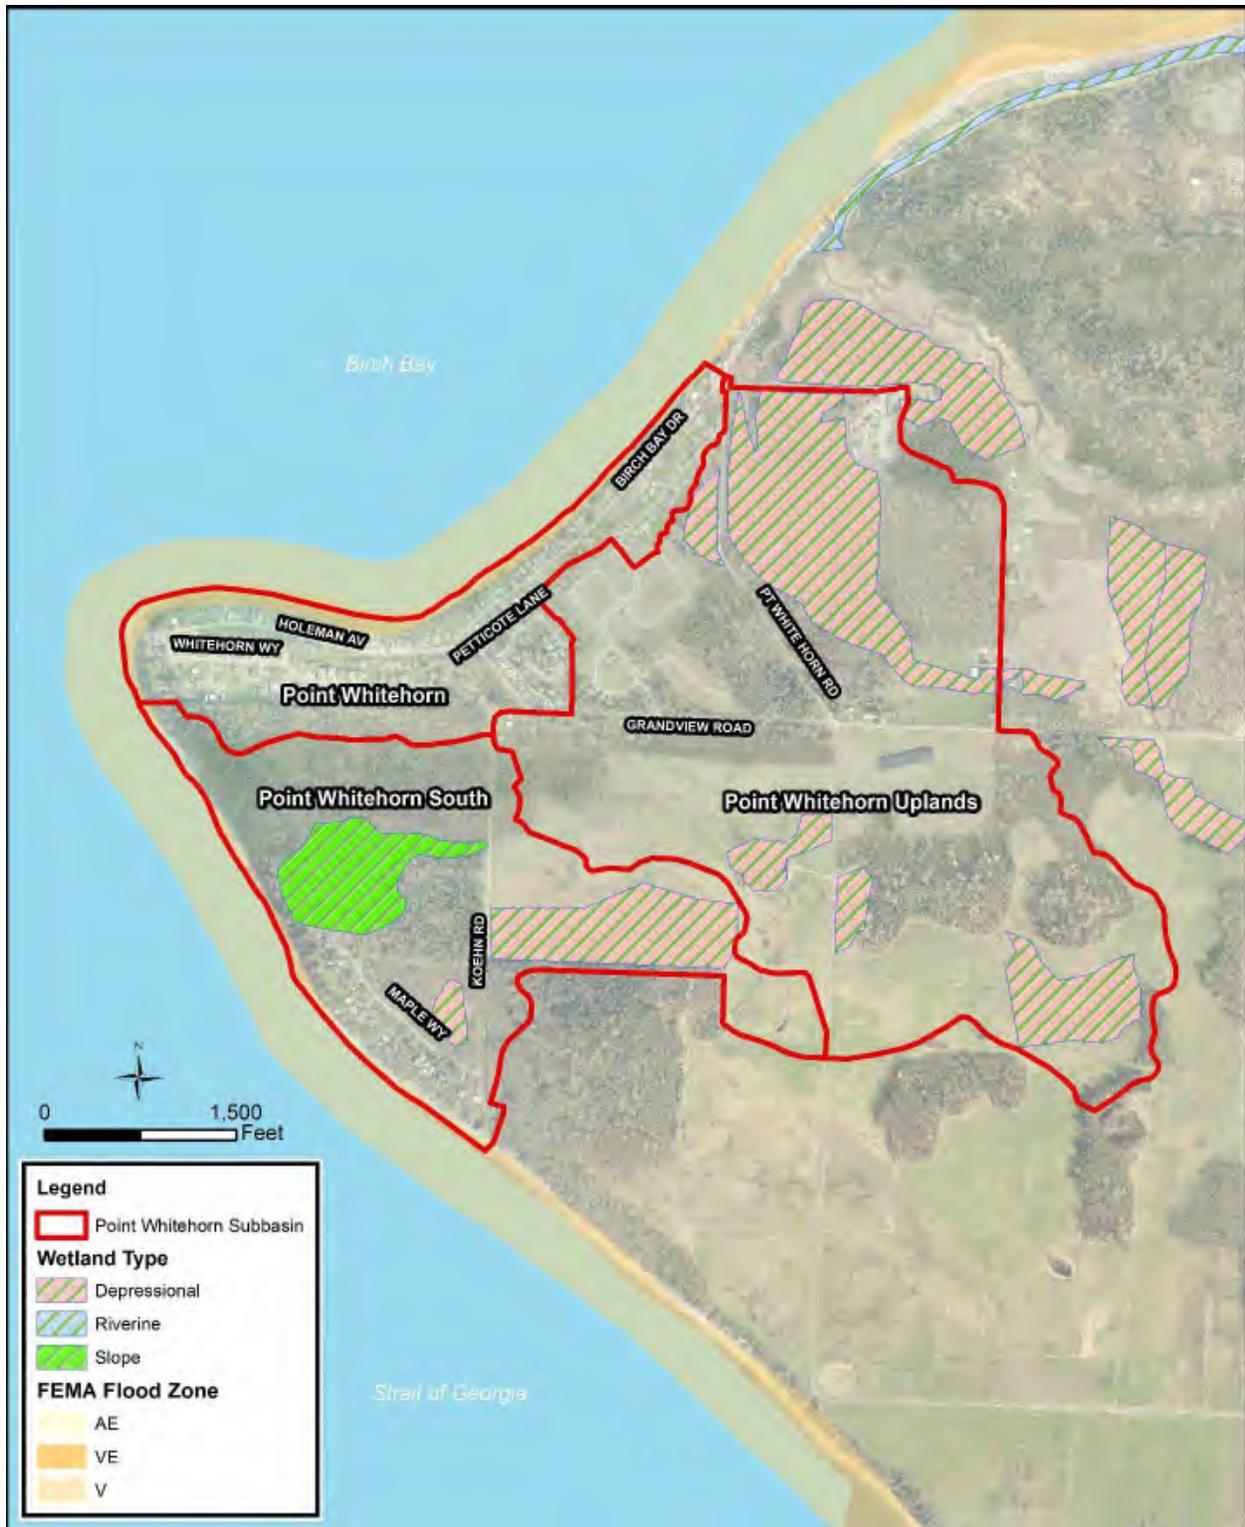
Wetlands in the Point Whitehorn Subwatershed are shown in Figure 2-12 and cover approximately 20 percent of the subwatershed. The most extensive coverage is in the Point Whitehorn Uplands Subbasin, where wetlands cover 30 percent of the subbasin. Depressional wetland are found throughout the subwatershed and a slope wetland is located at the western edge. Table 2-9 summarizes wetland coverage in the Point Whitehorn Subwatershed. Wetland types are described on page 12.

Figure 2-12. Wetlands and FEMA Flood Zones within the Point Whitehorn Subwatershed

A Type V flood zone is located along the shoreline through the entire length of the Point Whitehorn Subwatershed (Figure 2-12). No other flood zones were identified within the subwatershed. Flood zones are described on page 12.

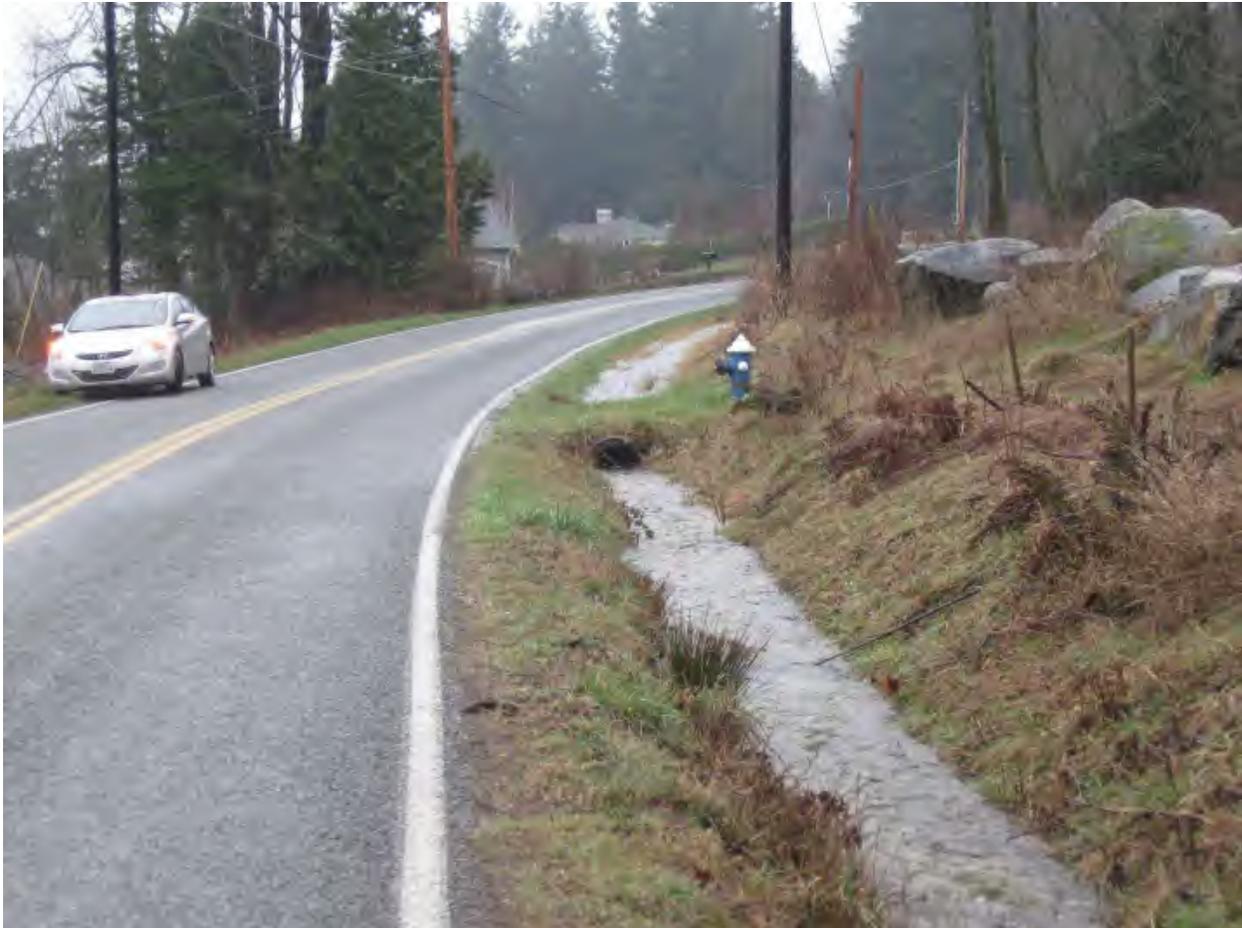
Figure 4-1. Roadside Ditches on Semiahmoo Drive, Undersized for Large Storms

Drainage structures are considered inadequate when they are too small to accommodate stormwater flows, whether by original design or because land use changes increased flows to levels beyond the system's capacity. It is not economical to design systems with capacity for every possible storm, but systems that are inadequate for a reasonable design storm (see Figure 4-1) must be improved by performing a hydraulic analysis and designing improvements to meet local design criteria. Within the study area, many of the existing drainage structures were installed fairly recently and are of adequate size. Inadequate infrastructure also includes structures in poor condition and in need of replacement, as shown in Figure 4-2.

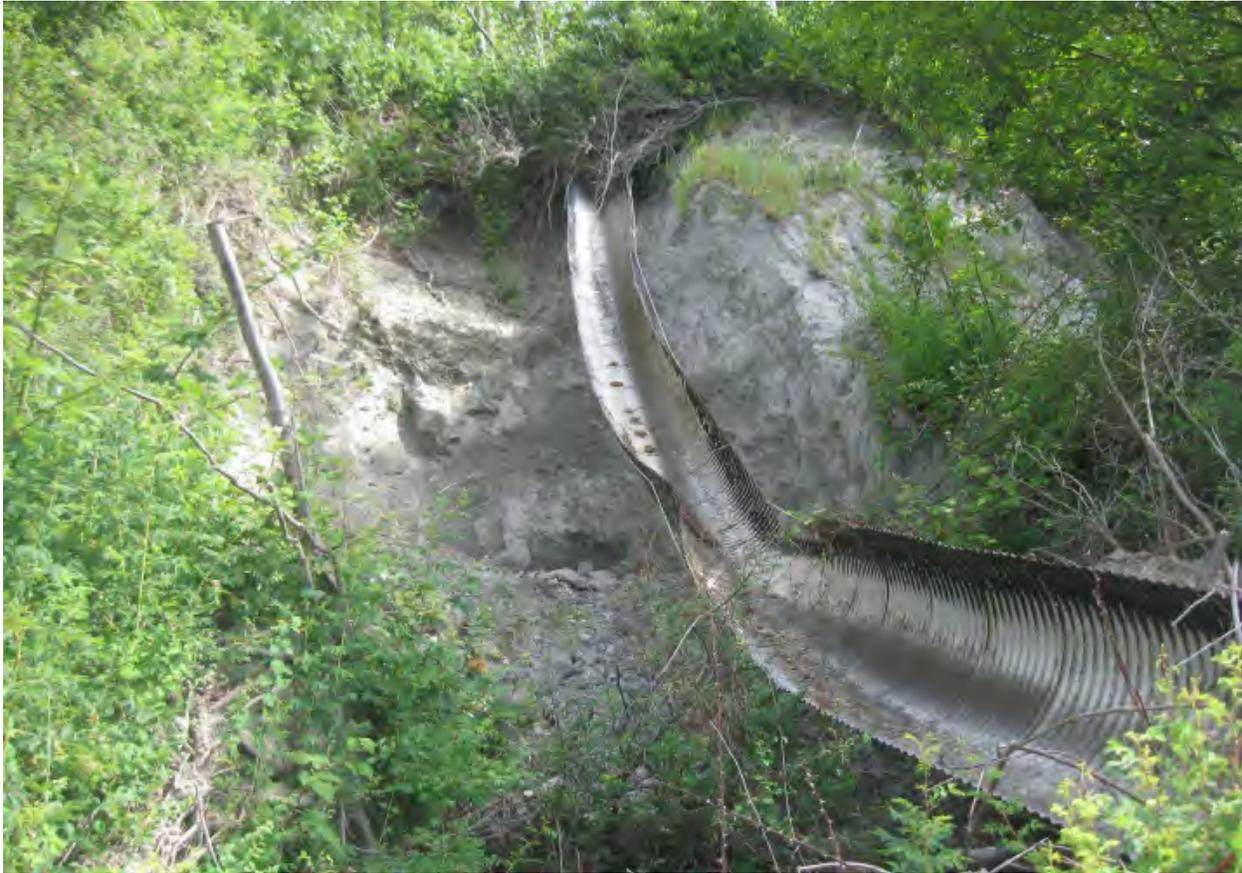
Figure 4-2. Erosion-Undermined Storm Drain Outfall to Birch Bay

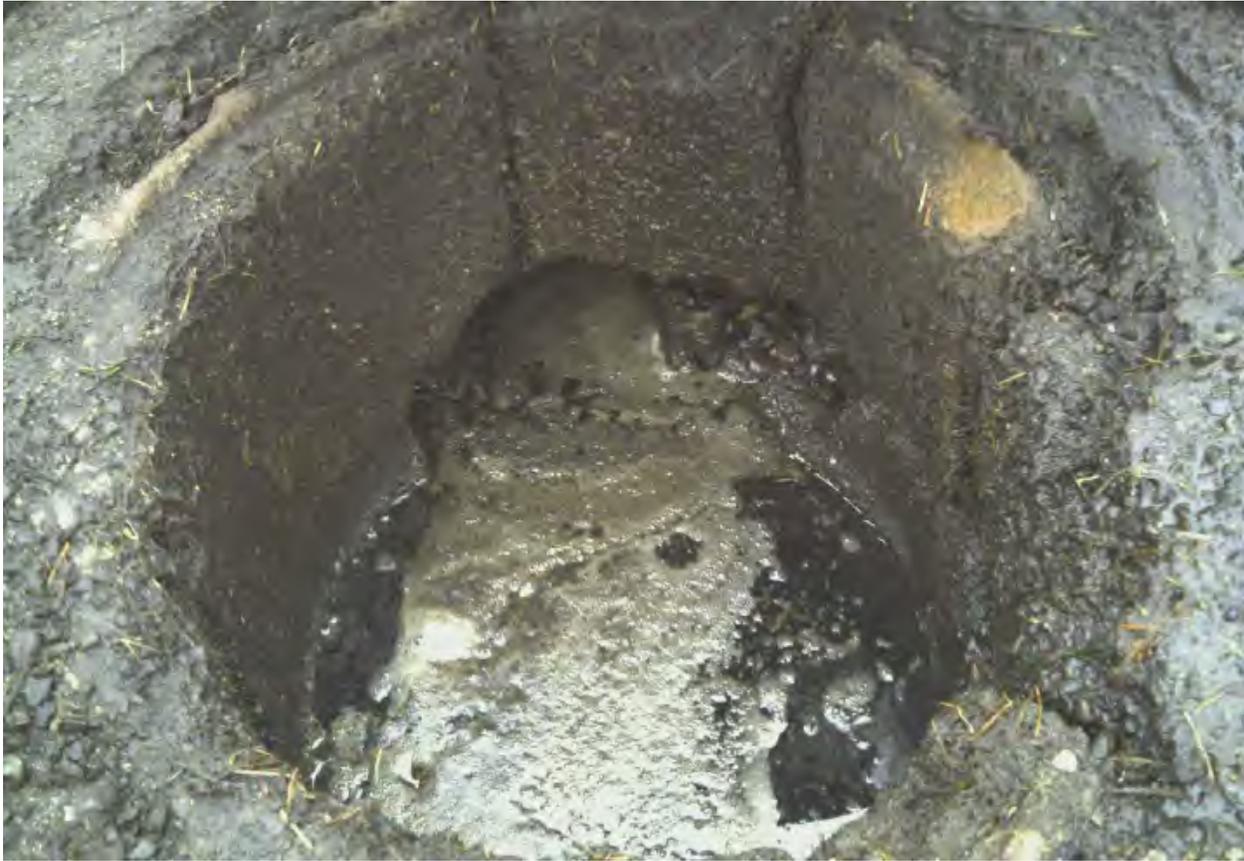
Figure 4-3. Catch Basin with Oil Sheen and Odors

The type and amount of pollutants depend on land uses in the drainage area, pollutant source controls, and drainage system maintenance programs. Primary contaminants in stormwater from developed areas are eroded sediment and debris from deteriorating roadways and buildings. Other pollutants associated with runoff are heavy metals, inorganic chemicals, nutrients (nitrogen and phosphorus), petroleum products, and fecal coliform bacteria (Figure 4-3). Older, poorly maintained urban neighborhoods generally have higher levels of pollutants than newer developments, due to higher levels of traffic, accumulation of debris, and deteriorating housing stock.

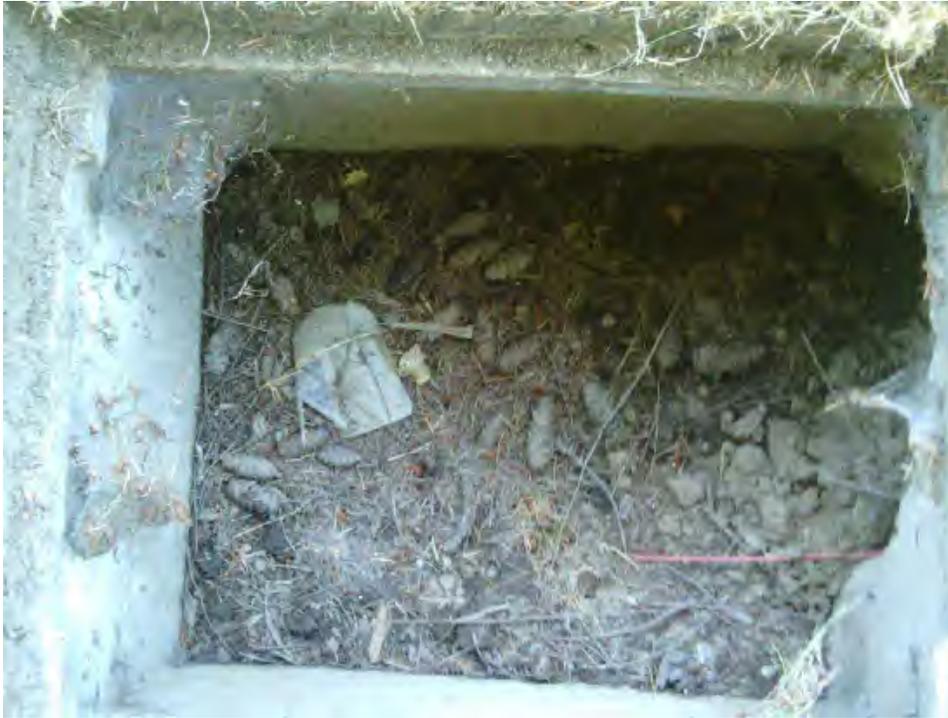
Drainage structures fill with sediment over time in the absence of regular cleaning (see Figure 4-4). When structures become blocked, stormwater may overflow during rainfall events, causing damage to surrounding public and private property. Drainage structures in the BP-TC-PW Subwatersheds are especially prone to siltation and blockage due to backwater in low-gradient systems, which allows sediment to settle into pipes and ditches. Sediments from developed areas have been shown to contain high levels of pollutants. Also, stormwater outfalls near sea level are susceptible to blockage due to tidal fluctuation that washes sand and mud into outfall pipes and offshore currents that float debris over the opening. Lack of access may also prevent adequate maintenance of the storm drain system. Proper storm drain design requires an access structure, usually a catch basin or manhole, at each point where a pipeline changes grade or alignment direction. Without this access, pipeline inspection and cleaning is difficult or impossible.

Figure 4-4. Catch Basin with Sediment and Debris Accumulation (photo by Wilson Engineering)

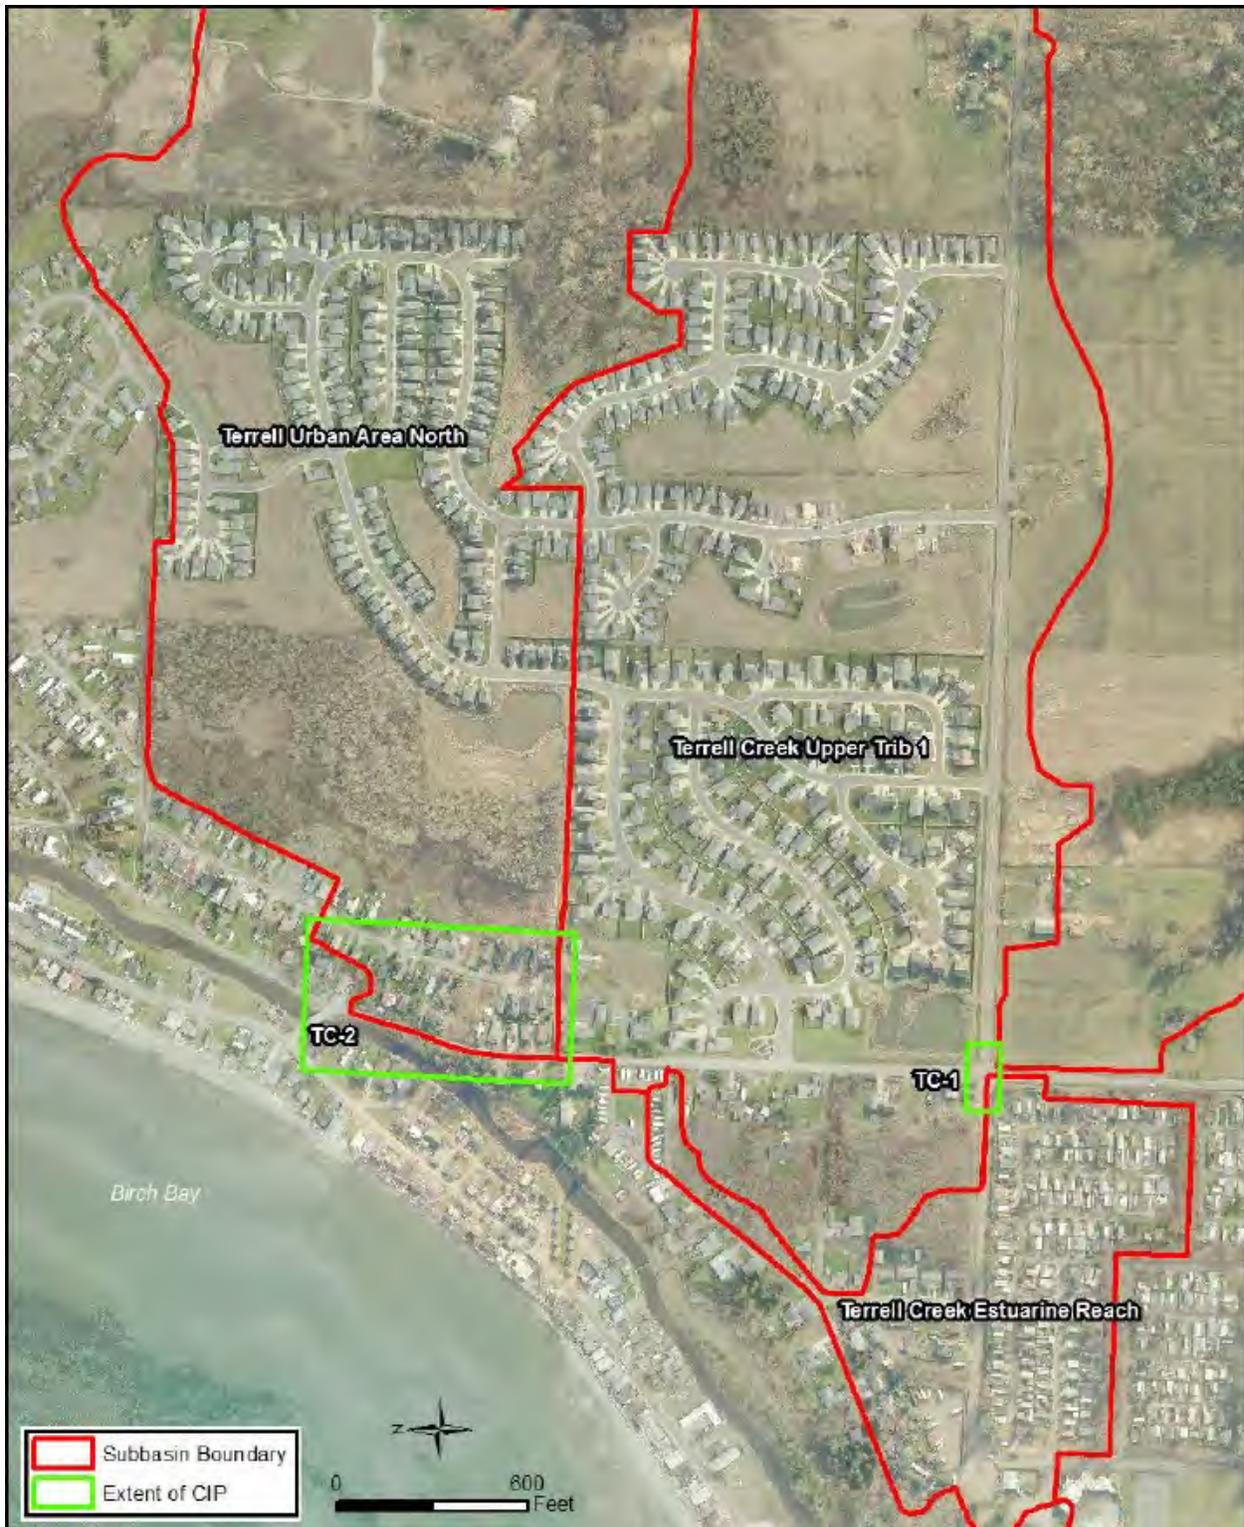
Figure 5-2B. Capital Projects within the Terrell Creek Urban Area Subwatershed

a. See Figures 5-2 for locations.
b. See Figures 4-5, 4-6, and 4-7 for locations.
c. All projects consist of installation of new/replaced storm drainage pipeline, connection to existing drainage infrastructure, and associated outfall and ditch improvements. See Appendix C for project descriptions.

a.	See Figure 5-2 for project location.
