**AMENDING THE 2006 BIRCH BAY COMPREHENSIVE STORMWATER PLAN TO
INCLUDE FOUR SUBWATERSHED MASTER PLANS**

BIRCH BAY

COMPREHENSIVE STORMWATER PLAN

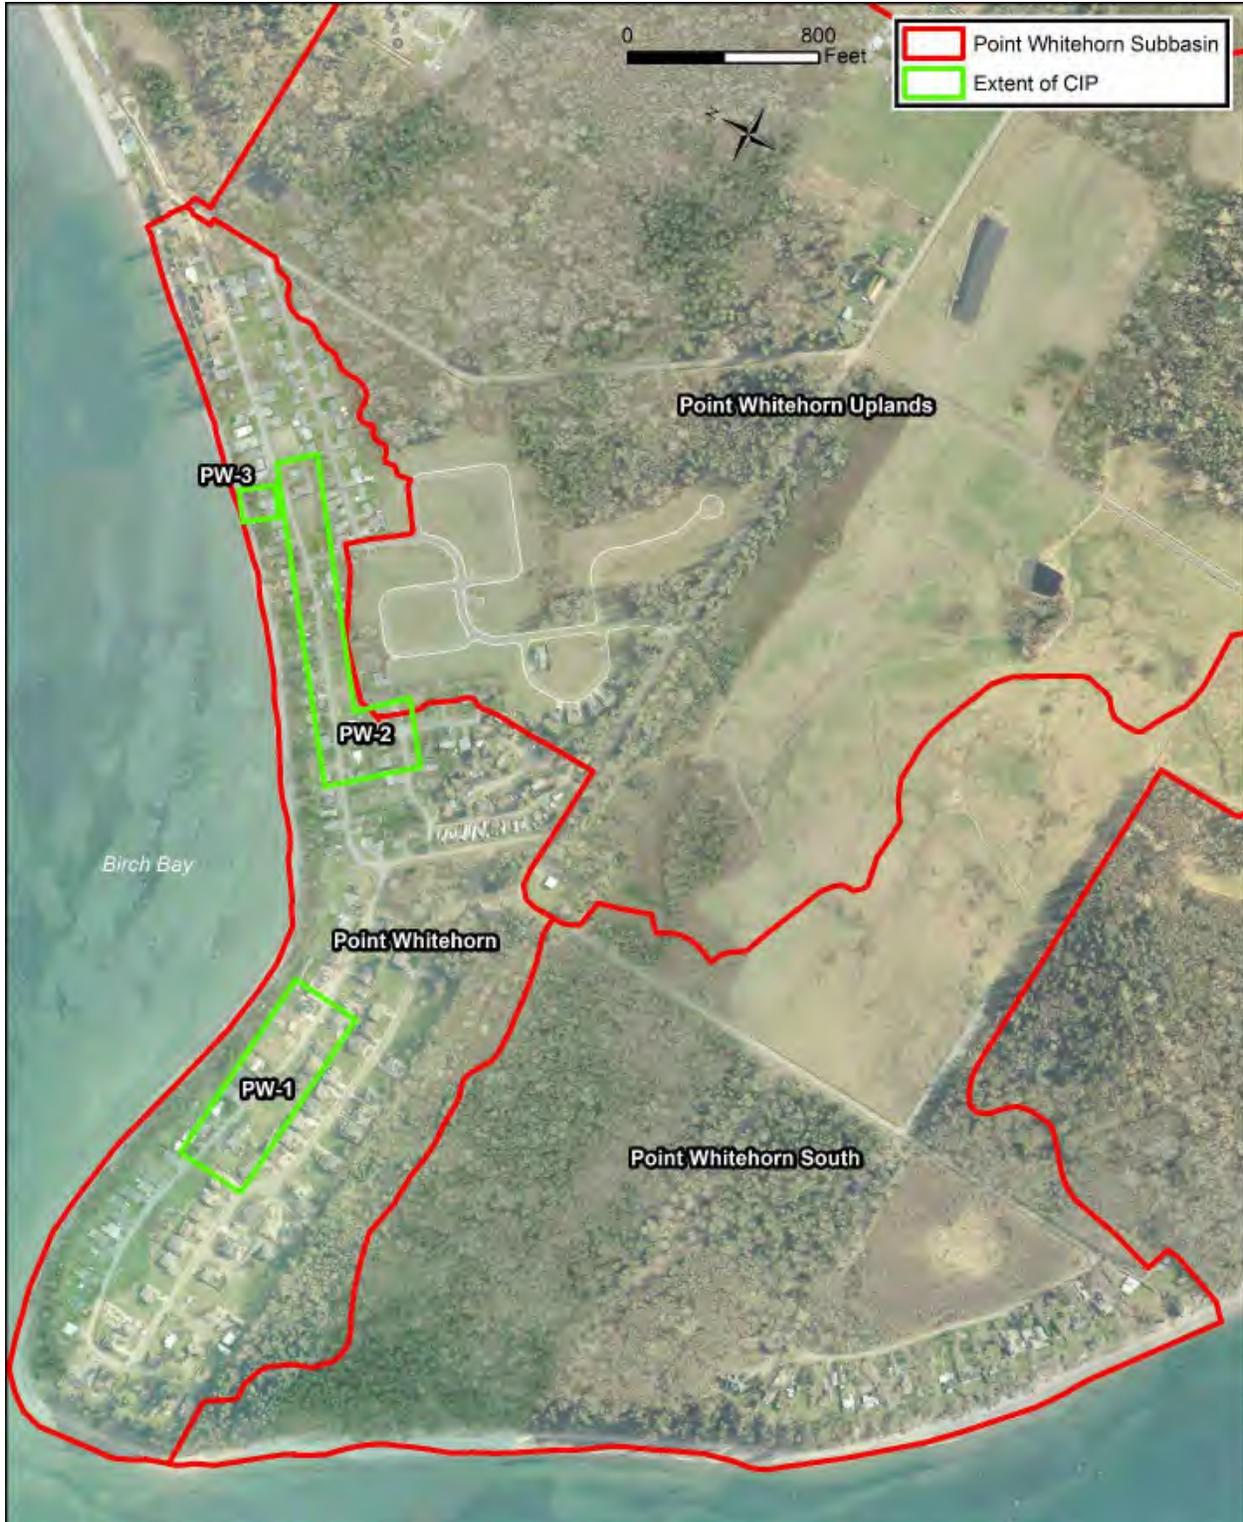
Figure 5-2C. Capital Projects within the Point Whitehorn Subwatershed

a. See Figures 5-2 for locations.
b. See Figures 4-5, 4-6, and 4-7 for locations.
c. All projects consist of installation of new/replaced storm drainage pipeline, connection to existing drainage infrastructure, and associated outfall and ditch improvements. See Appendix C for project descriptions.

a.	See Figure 5-2 for project location.

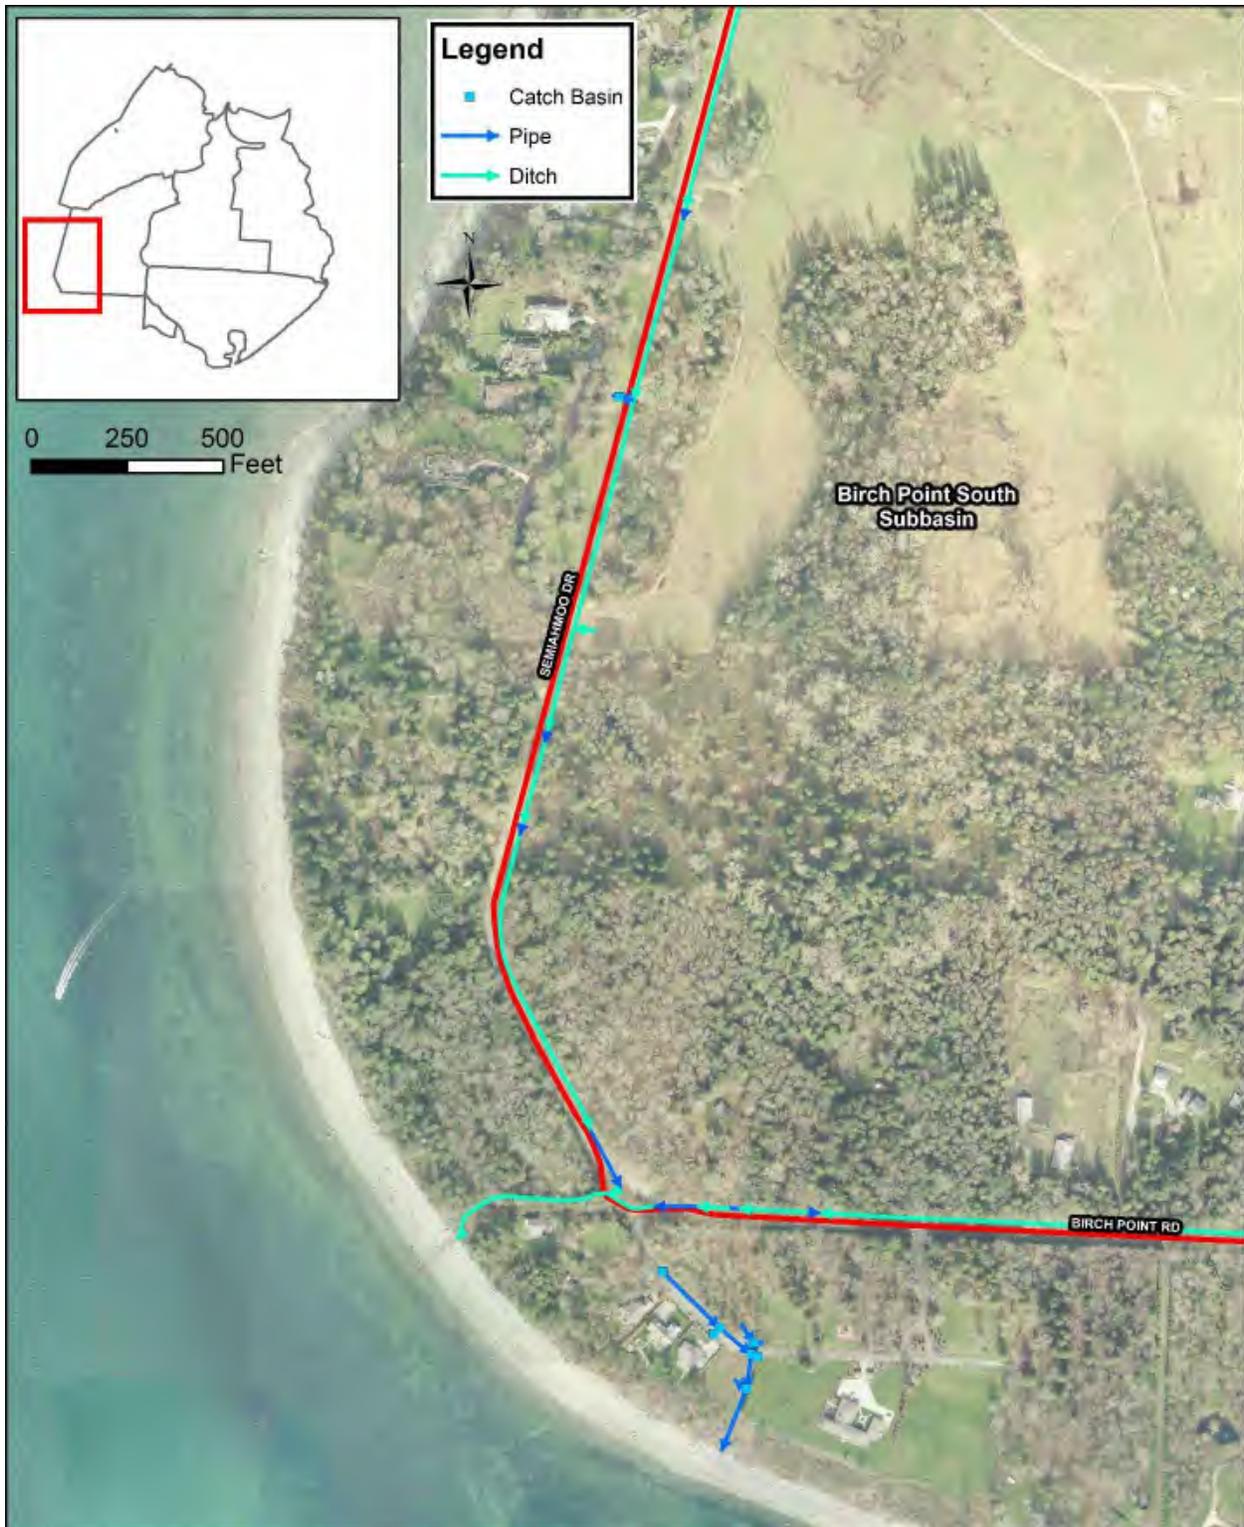
Figure A-4. Stormwater Inventory – Birch Point South Subbasin

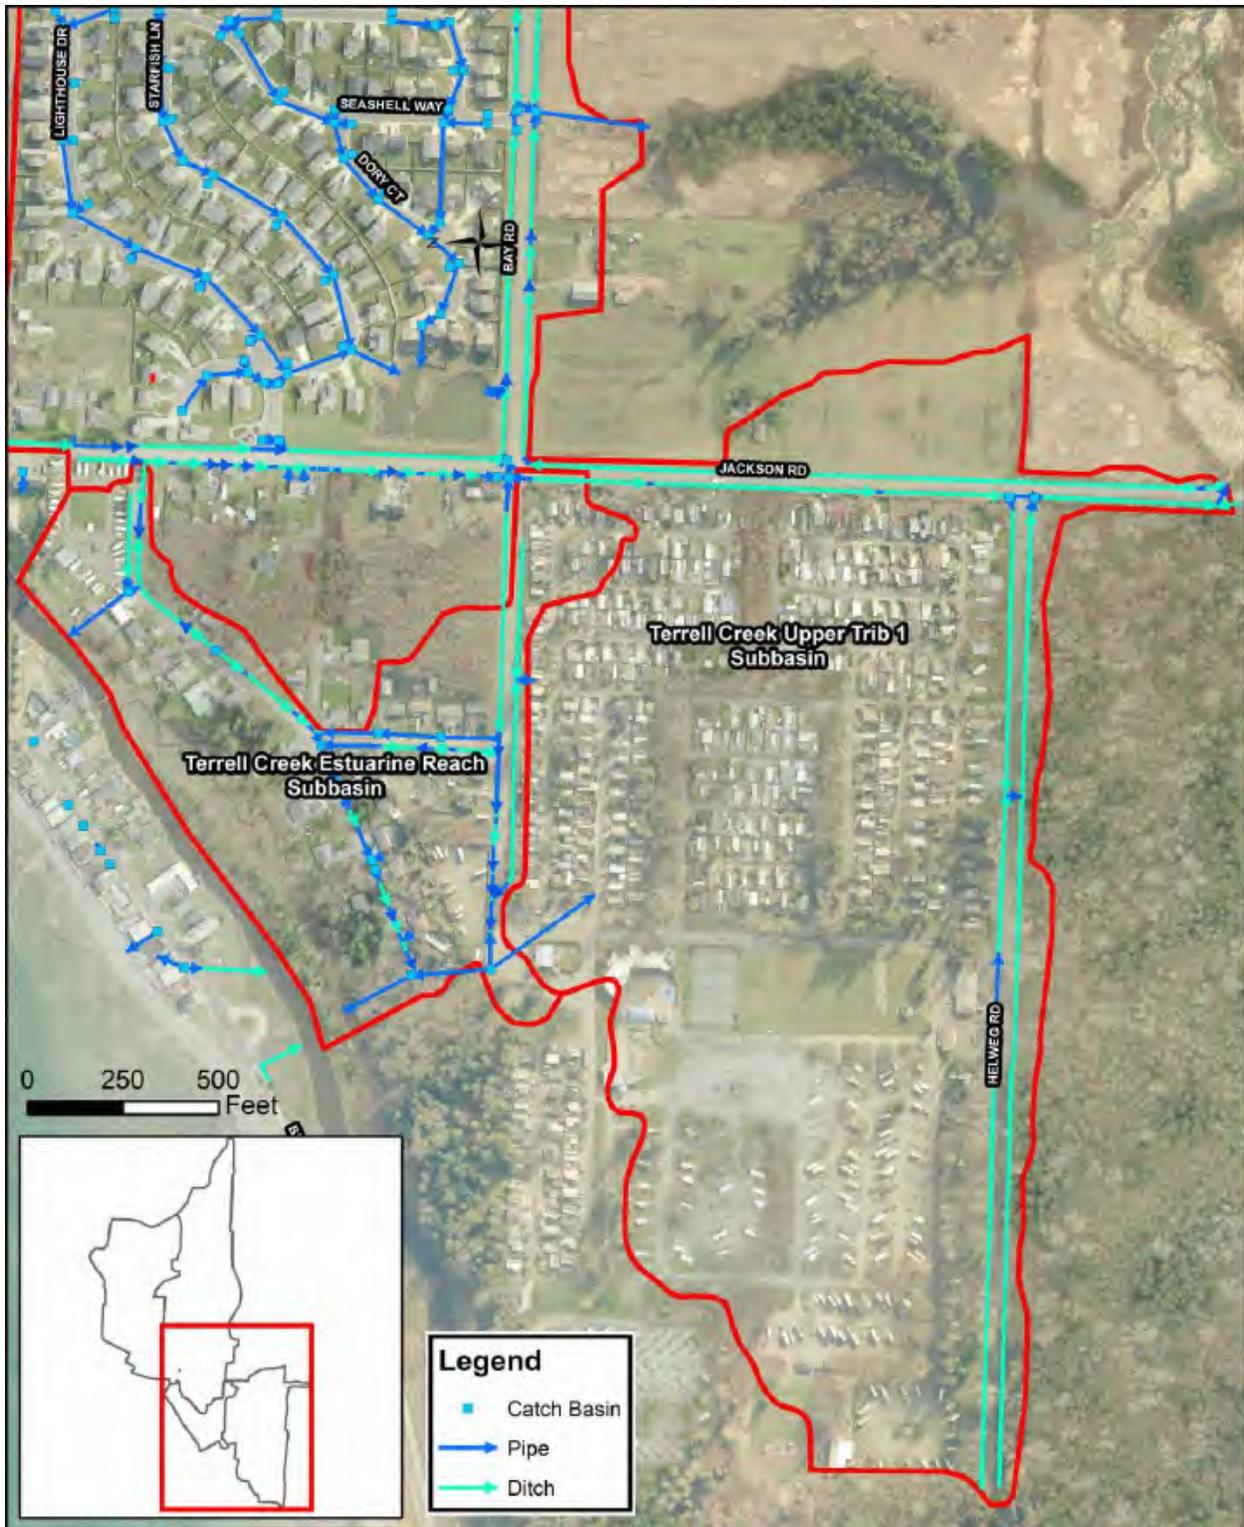
Figure A-9. Stormwater Inventory – Terrell Creek Upper Tributary 1 and Estuarine Reach Subbasins

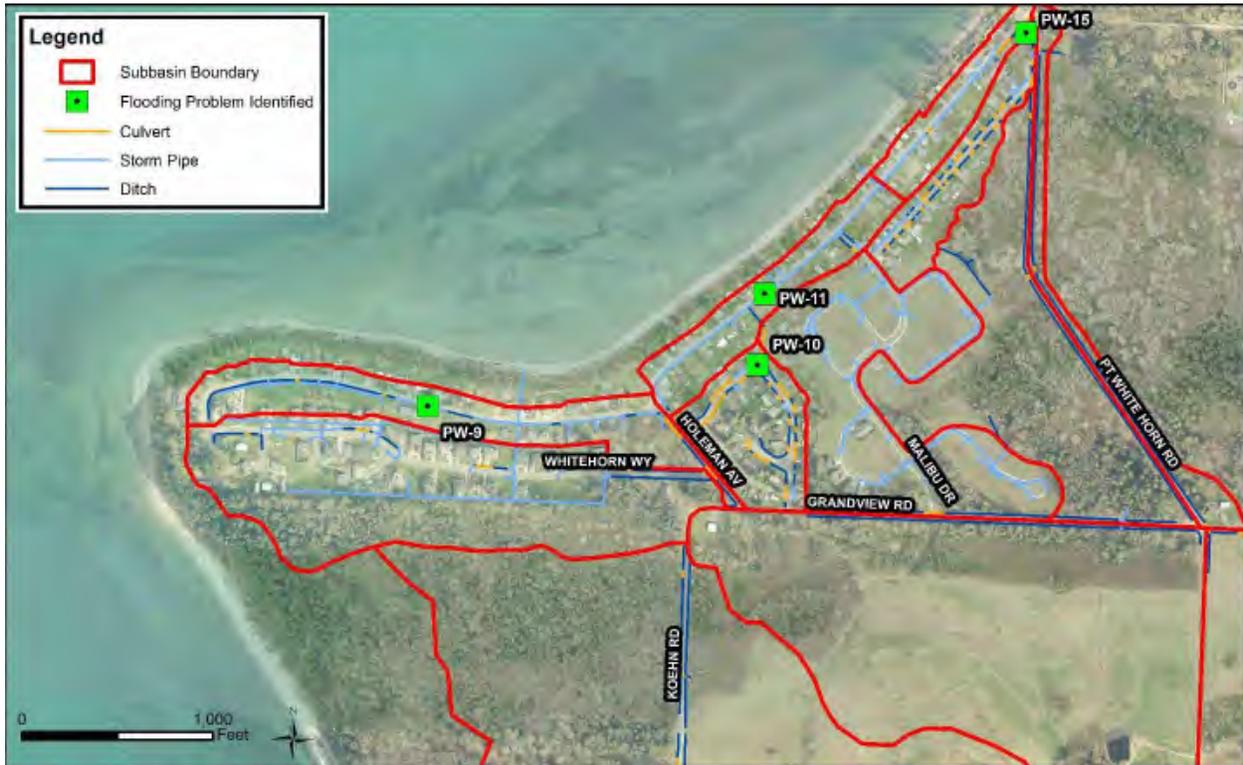
Figure 6-C. Flooding problems identified for the Point Whitehorn subwatershed

Point Whitehorn Subbasin					
PW-9	Holeman Avenue	Holeman Ave. west of Birch Bay Dr.	25-Year	N/A	Undersized 12-inch culverts on Holeman Ave.
PW-10	Petticote Lane	Petticote Lane near Holeman Ave.	25-year	N/A	Undersized 12-inch culverts draining Petticote Lane
PW-11	Birch Bay Drive	Birch Bay Dr. between Holeman Ave and Jill Street	25-year	N/A	Undersized 12-inch storm drain along Birch Bay Road
PW-15	Birch Bay Drive	Birch Bay Dr. between Jill St. and Point Whitehorn Way	25-Year	N/A	Undersized 12-inch storm drain along Birch Bay Road

See Figure 6-A, 6-B, and 6-C

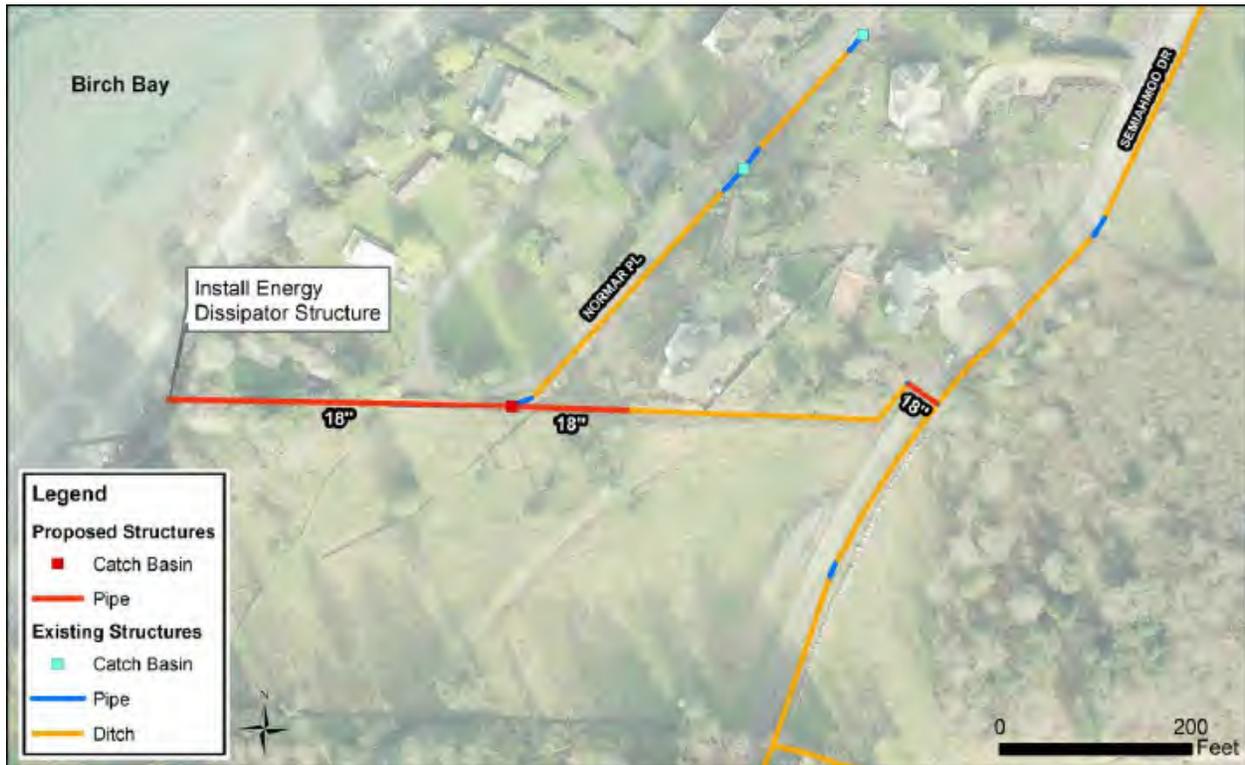
PROJECT: BP-1
DESCRIPTION: Normar Place Storm Drain Improvements
SUBBASIN: Birch Point North

Description: Culvert crossing under Semiahmoo Drive is undersized and causing roadway flooding during the 2-year and larger storm event under existing and future conditions. A flume conveys stormwater from Semiahmoo Drive to Normar Place (private) and overflows during the 25-year and larger storm event for existing and future conditions. High flow velocity in the roadside ditches is causing scour, sediment is transported to the downstream catch basin and obstructs flow.

- Replace 415 lineal feet of 12-inch diameter pipe with 18-inch diameter CPE.
- Replace 30 lineal feet of 12-inch diameter concrete culvert with 18-inch CPE.
- Replace 1 CB Type 1 structure with 1 CB Type 2 structure.
- Install energy dissipater at pipe outfall.

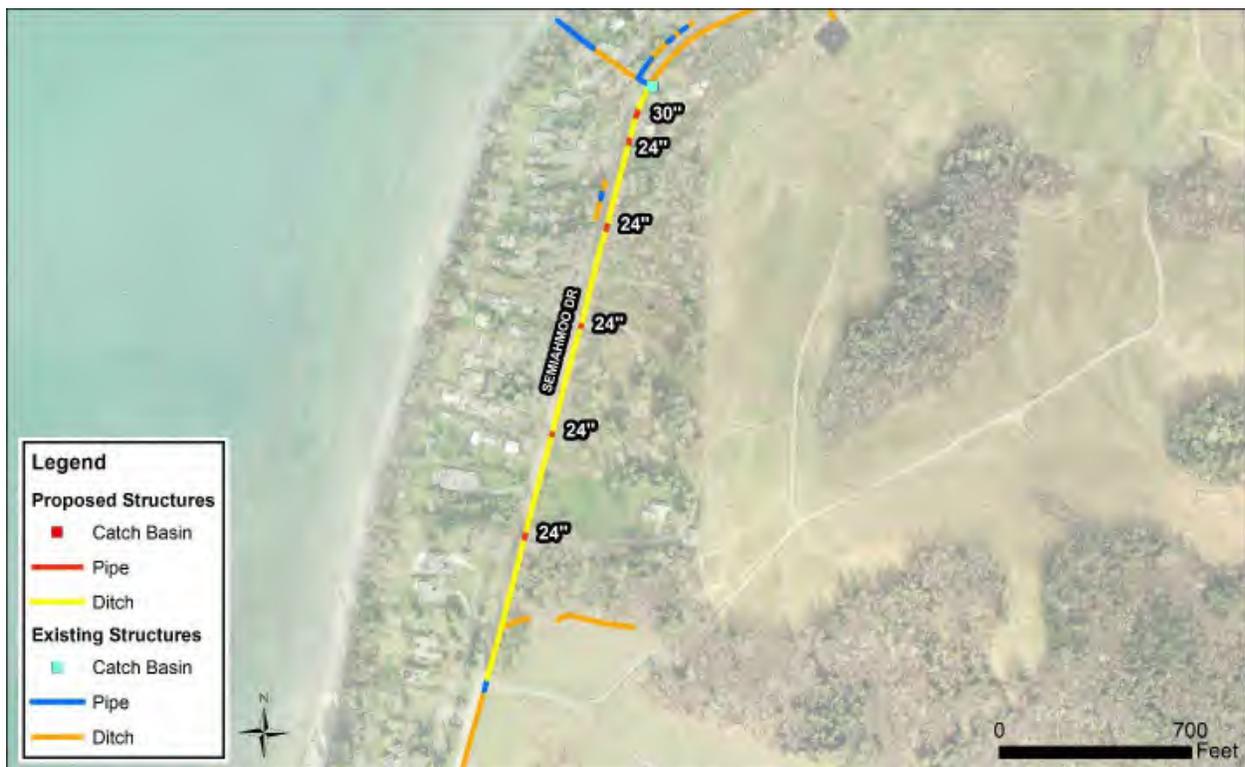
PROJECT: <u>BP-2</u>	BY: <u>GW</u>
DESCRIPTION: <u>Semiahmo Drive Drainage Improvements (North)</u>	CHECKED BY: <u>GMS</u>
SUBBASIN: <u>Birch Point North</u>	DATE: <u>11/1/2016</u>

Description: Driveway culverts and roadside ditches on the east side of Semiahmoo Drive have insufficient capacity and overflow during the 25-year and larger future conditions storm event.

- Replace 165-linear feet of 15-, 18-, & 24- inch diameter pipe with 30-inch & 24-inch diameter CPE pipe.
- Re-establish 2,090 linear feet of roadside ditch.

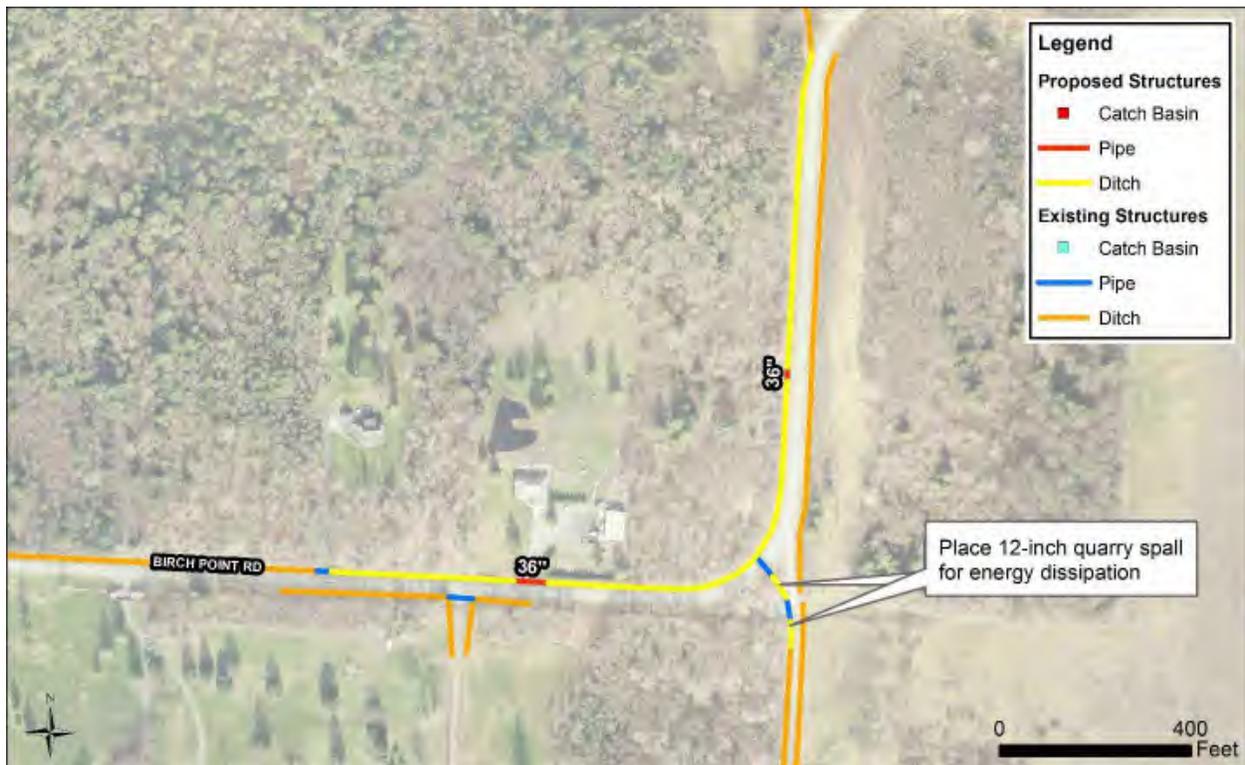
PROJECT: BP-3
DESCRIPTION: Birch Point Road Storm Drain Improvement
SUBBASIN: Birch Point South

Description: Driveway culverts and roadside ditches along Birch Point Road are undersized and flooding for the 25-year and larger storm existing conditions storm event and 25-year and larger future conditions storm event. High flow velocity is causing erosion at the outlet of both driveway culverts on the south side of Birch Point Road adjacent to the private driveway.

- Replace 70 lineal feet of 18-inch diameter PE culvert with 36-inch CPE.
- Replace 30 lineal feet of 24-inch diameter PE culvert with 36-inch CPE.
- Re-establish 2,000 lineal feet of roadside ditch.
- Place 12-inch quarry spall at culvert outlets adjacent to private driveway.

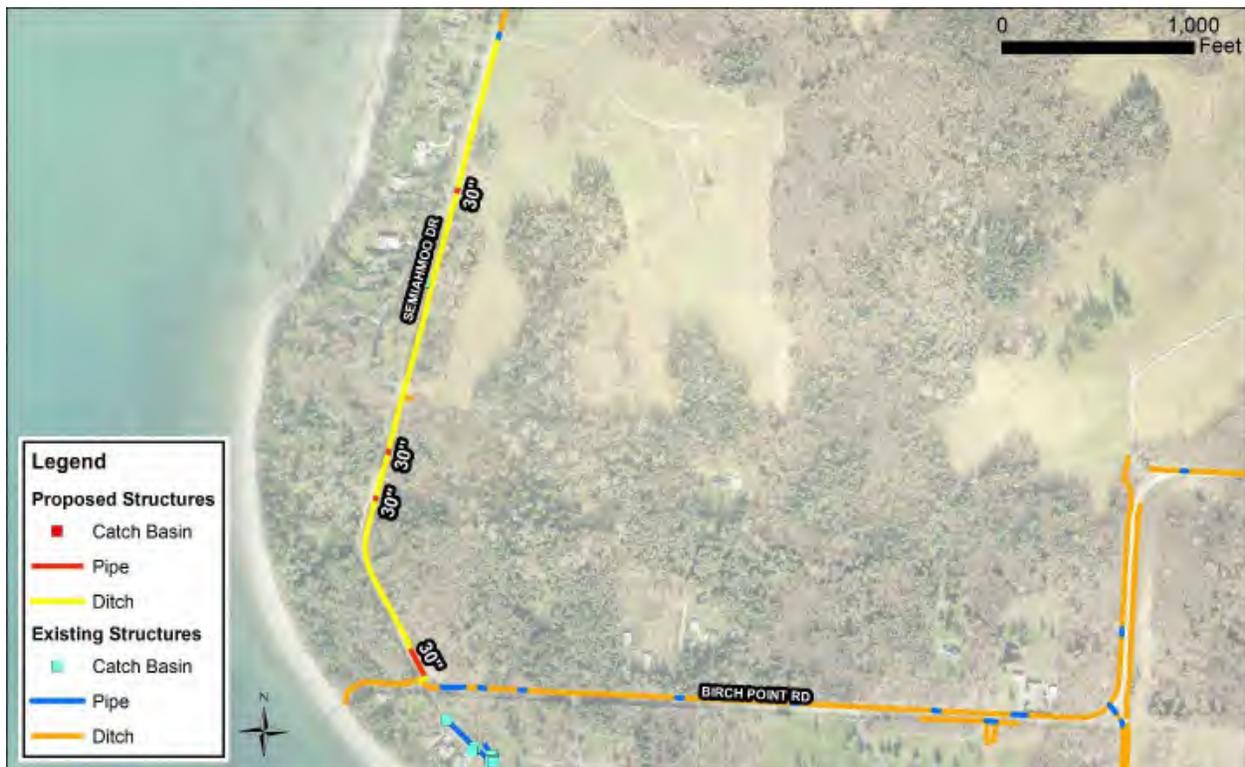
PROJECT: BP-5
DESCRIPTION: Semiahmoo Drive Drainage Improvements (South)
SUBBASIN: Birch Point South

Description: Ditches and driveway culverts on the east side of Semiahmoo Drive overflow during the 25-year and larger existing conditions storm event and the 2-year and larger future conditions storm event.

- Replace 265 lineal feet of 12-inch diameter concrete pipe with 30-inch CPE.
- Deepen 3,260 feet of existing ditches

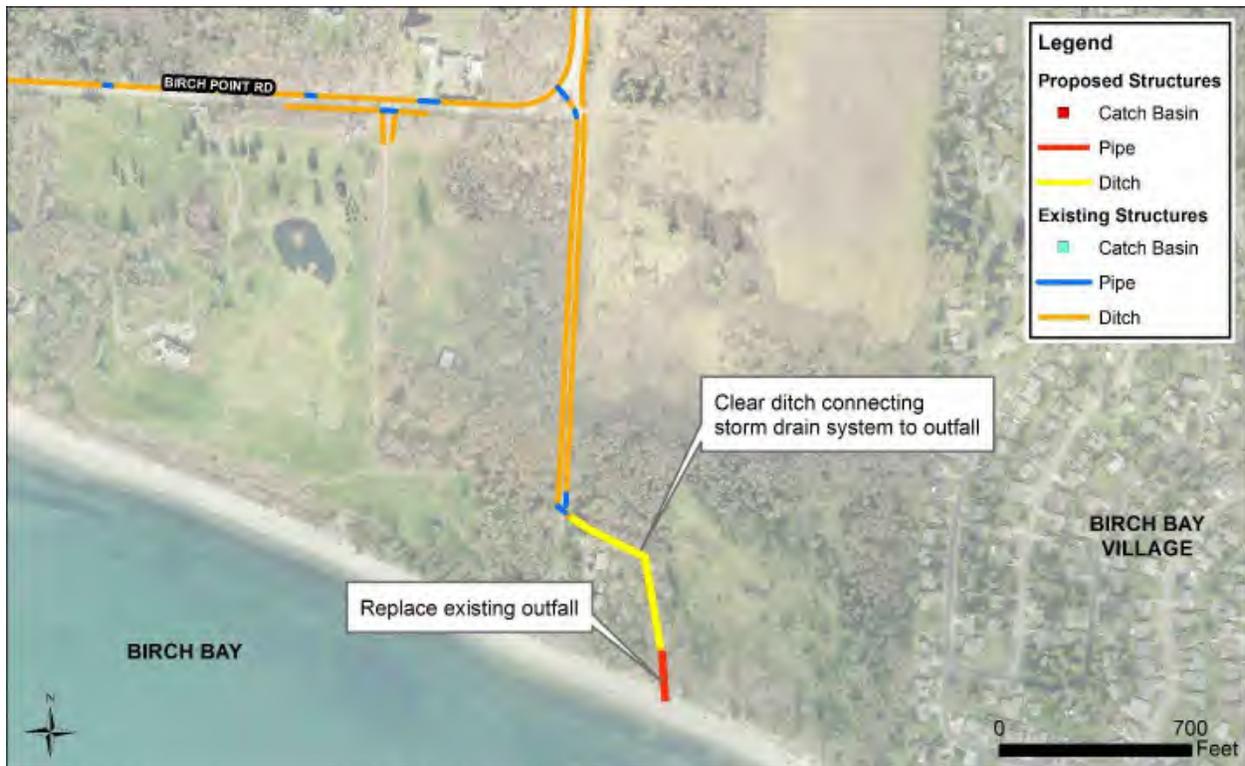
PROJECT: BP-6
 DESCRIPTION: Birch Point Road Outfall Improvement
 SUBBASIN: Birch Point South

- Replace approximately 100 lineal feet of 48" diameter CMP half-pipe with 48-inch diameter HDPE tightline and anchor.
- Inspect and repair ditch connecting outfall and upstream storm drain system.
- Install energy dissipater.

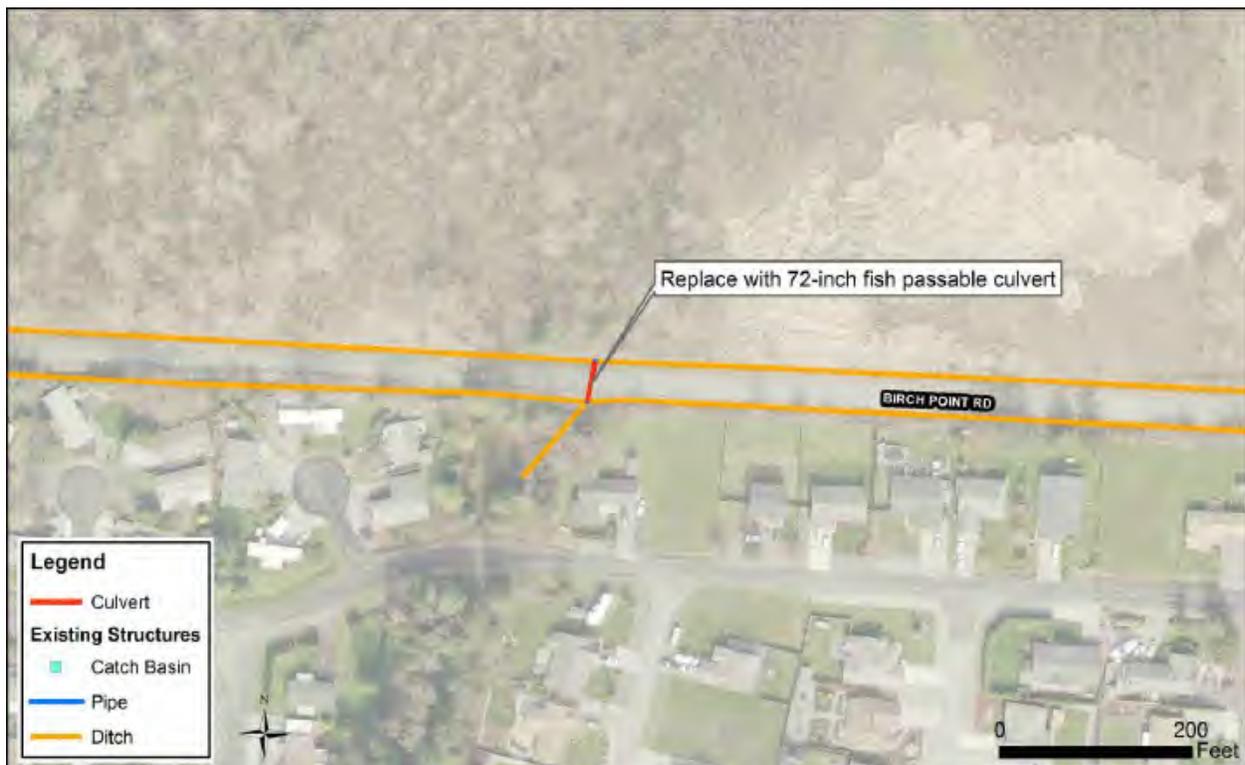
PROJECT: BP-7
DESCRIPTION: Birch Point Road Culvert Improvement
SUBBASIN: Semiahmoo Uplands

- Replace existing 24-inch diameter concrete culvert with 72-inch diameter fish passage culvert structure (50 lineal feet).

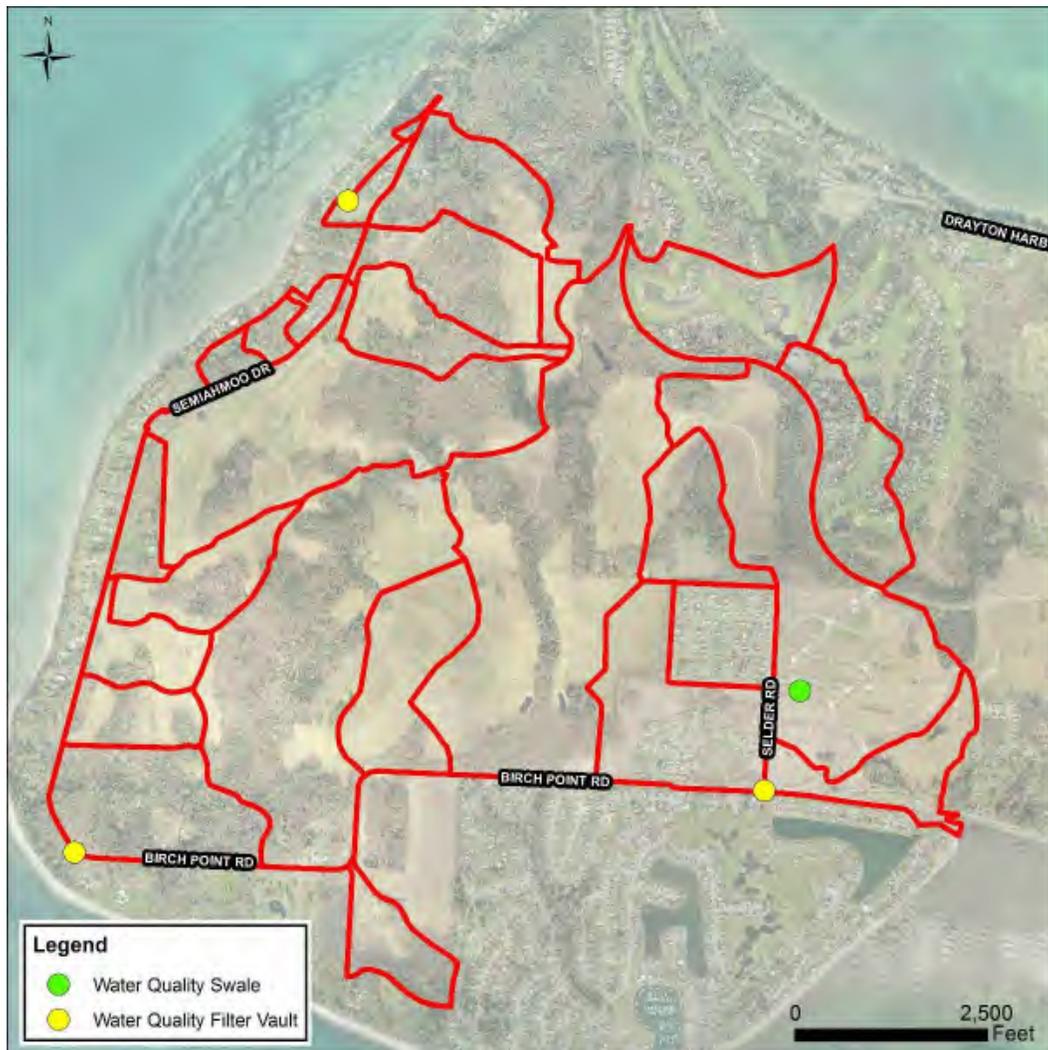
PROJECT: BP-8
DESCRIPTION: Subwatershed Water Quality Retrofit
Subwatershed Birch Point Subwatershed

- 4 locations have been identified for water quality facility installations. Facility types will be evaluated and selected based on individual opportunity and may include water quality filter vaults and swales

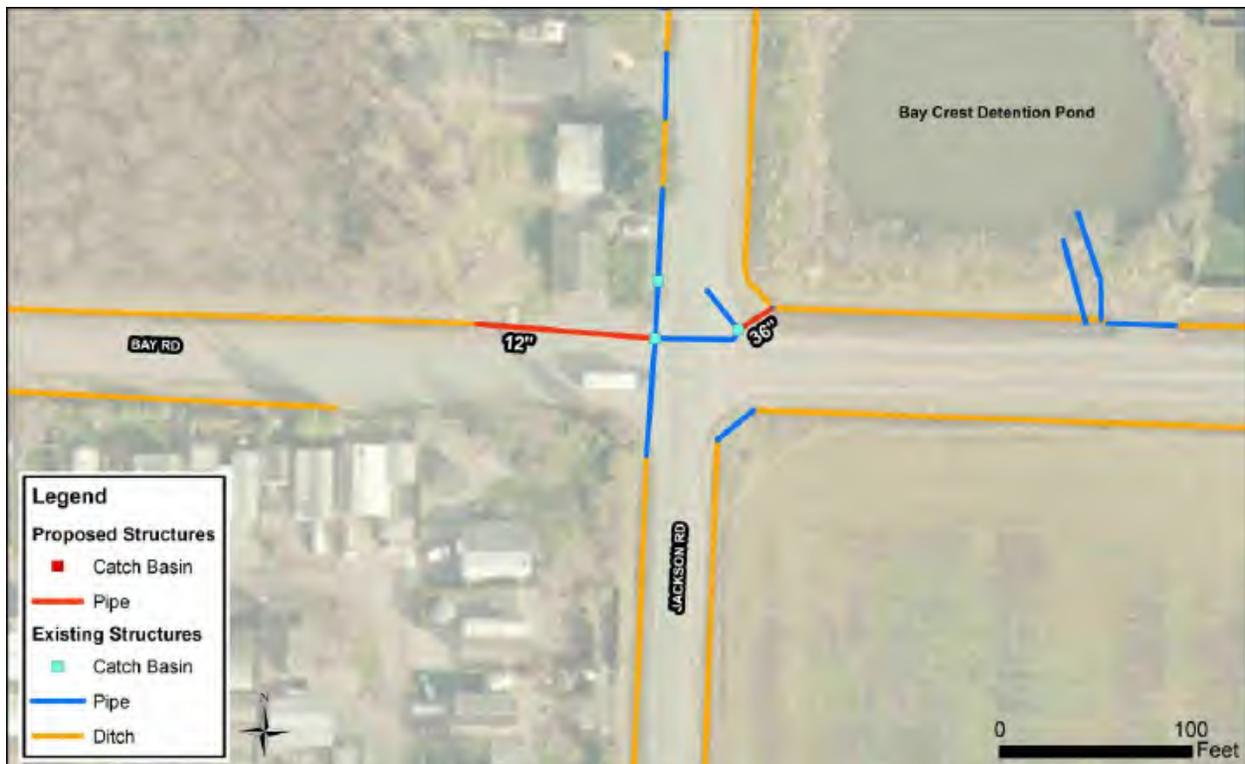
PROJECT: TC-1
DESCRIPTION: Bay Road Storm Drain Improvments
SUBBASIN: Terrell Creek Upper Tributary 1

Description: Roadside storm drainage at the intersection of Bay Road and Jackson road is undersized and causing roadway flooding for the 25-year and larger storm event. High flow depth along Birch Bay Road causes a backwater condition at the culvert outlet and contributes to reduced pipe capacity.

- Replace 90 lineal feet of 8-inch diameter pipe with 12-inch CPE.
- Replace 25 lineal feet of 24-inch diameter pipe with 36-inch CPE.

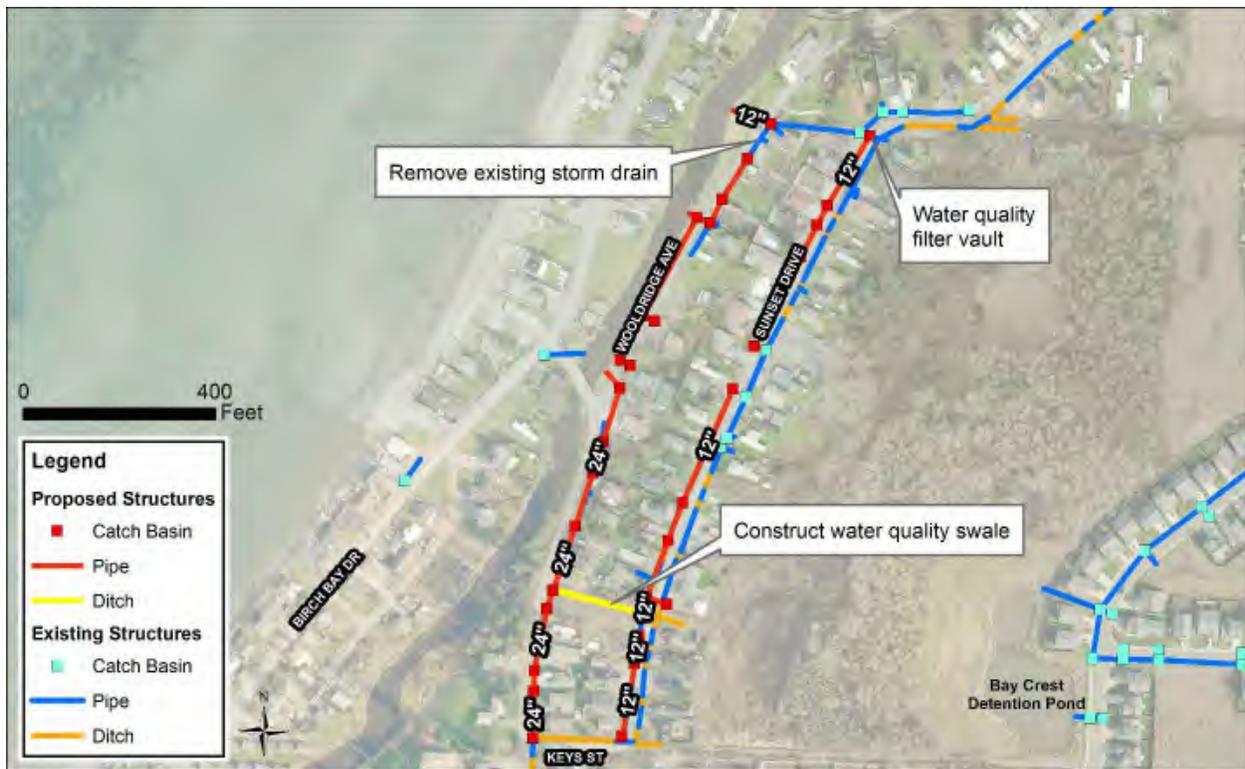
PROJECT: <u>TC-2</u>	BY: <u>GW</u>
DESCRIPTION: <u>Wooldridge Avenue Stormwater Improvements</u>	CHECKED BY: <u>GMS</u>
SUBBASIN: <u>Terrell Creek Urban Area North</u>	DATE: <u>11/1/2016</u>

- Replace roadside ditches and culvert and install 1,750 lineal feet of 12-inch diameter CPE.
- Replace roadside ditches and culvert and install 865 lineal feet of 12-inch diameter CPE.
- Install 25 Type 1 CB structures and 9 Type 2 CB structures.
- Install 72-inch water quality filter vault.
- Install 100 lineal feet of water quality treatment swale.
- Remove 1,300 lineal feet of existing storm pipe.

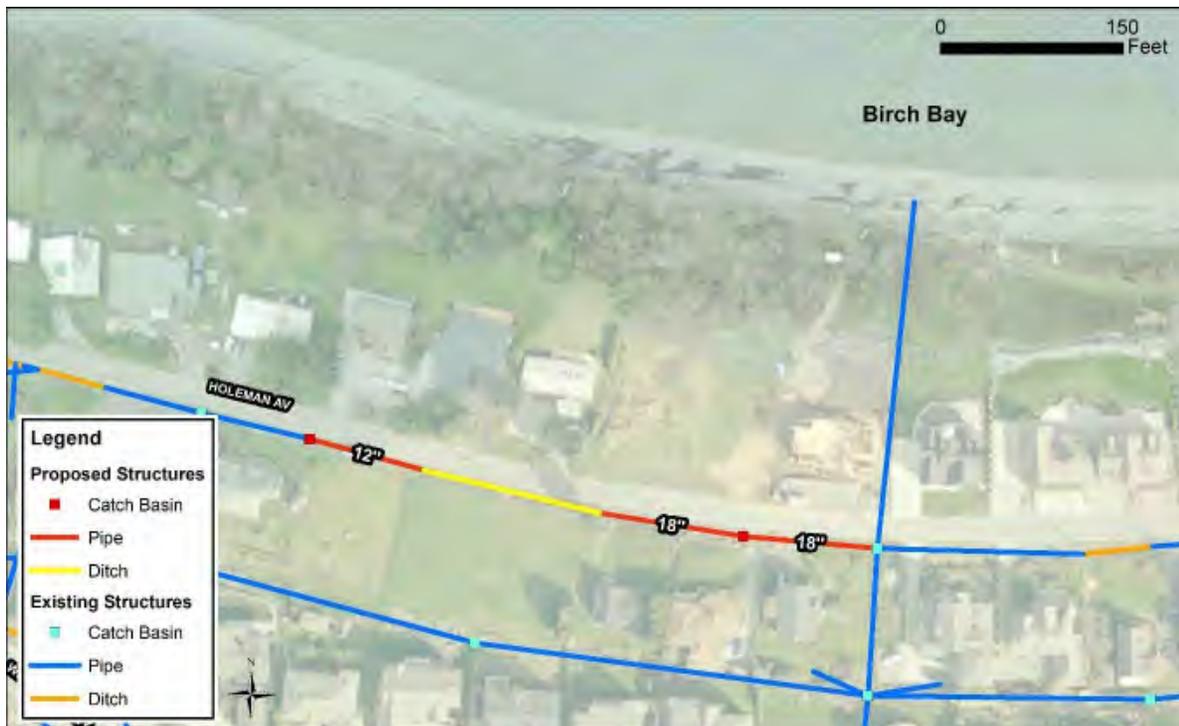
PROJECT: PW-1
DESCRIPTION: Holeman Avenue Storm Drain Improvements
SUBBASIN: Point Whitehorn

- Replace 235 lineal feet of 12-inch diameter pipe with 18-inch CPE.
- Replace 100 lineal feet of 12-inch diameter pipe with 12-inch CPE.
- Replace 1 CB Type 1 structure.
- Replace 1 CB Type 1 structure with 1 CB Type 2 structure.
- Re-establish 160 lineal feet of existing ditch to match pipe invert elevations.

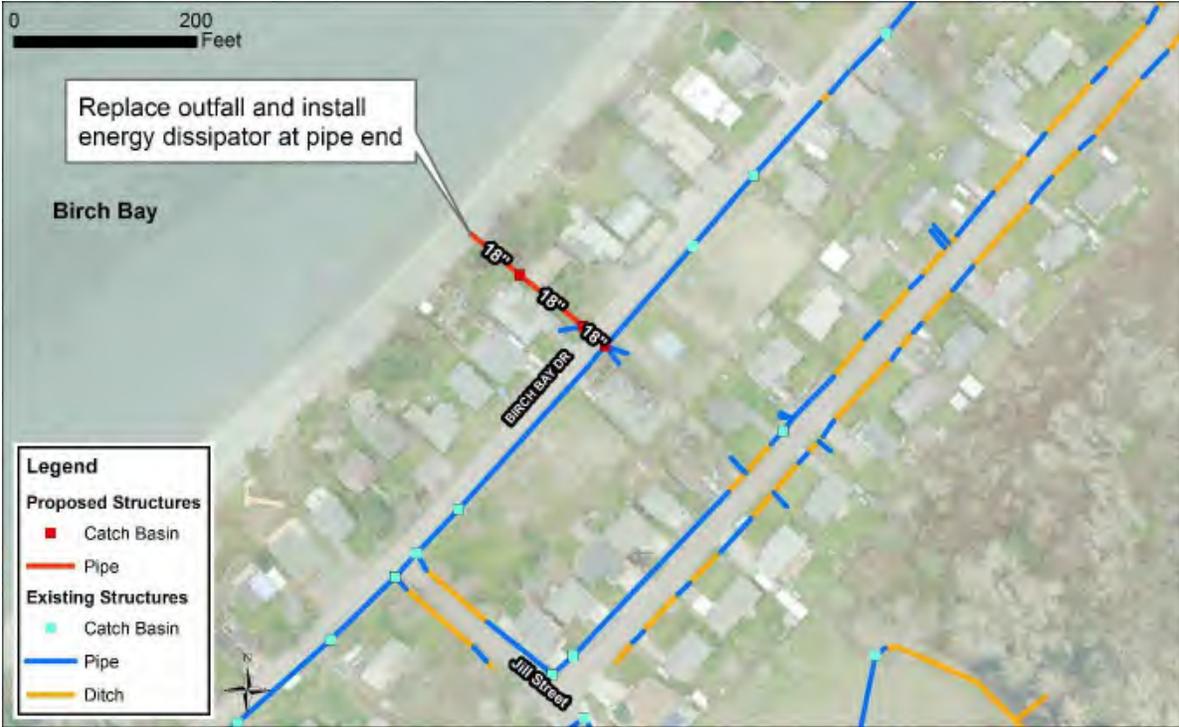
PROJECT: PW-3
DESCRIPTION: Birch Bay Drive Outfall Improvement
SUBBASIN: Point Whitehorn

- Replace 1 Type 2 CB structure and install 1 Type 2 CB structure.
- Replace 18-inch diameter outfall with 18-inch diameter HDPE pipe (80 lineal feet).
- Replace 35 feet of 18-inch diameter concrete pipe with 18-inch CPE.
- Replace 55 feet of 12-inch diameter concrete pipe with 18-inch CPE.
- Install energy dissipater.

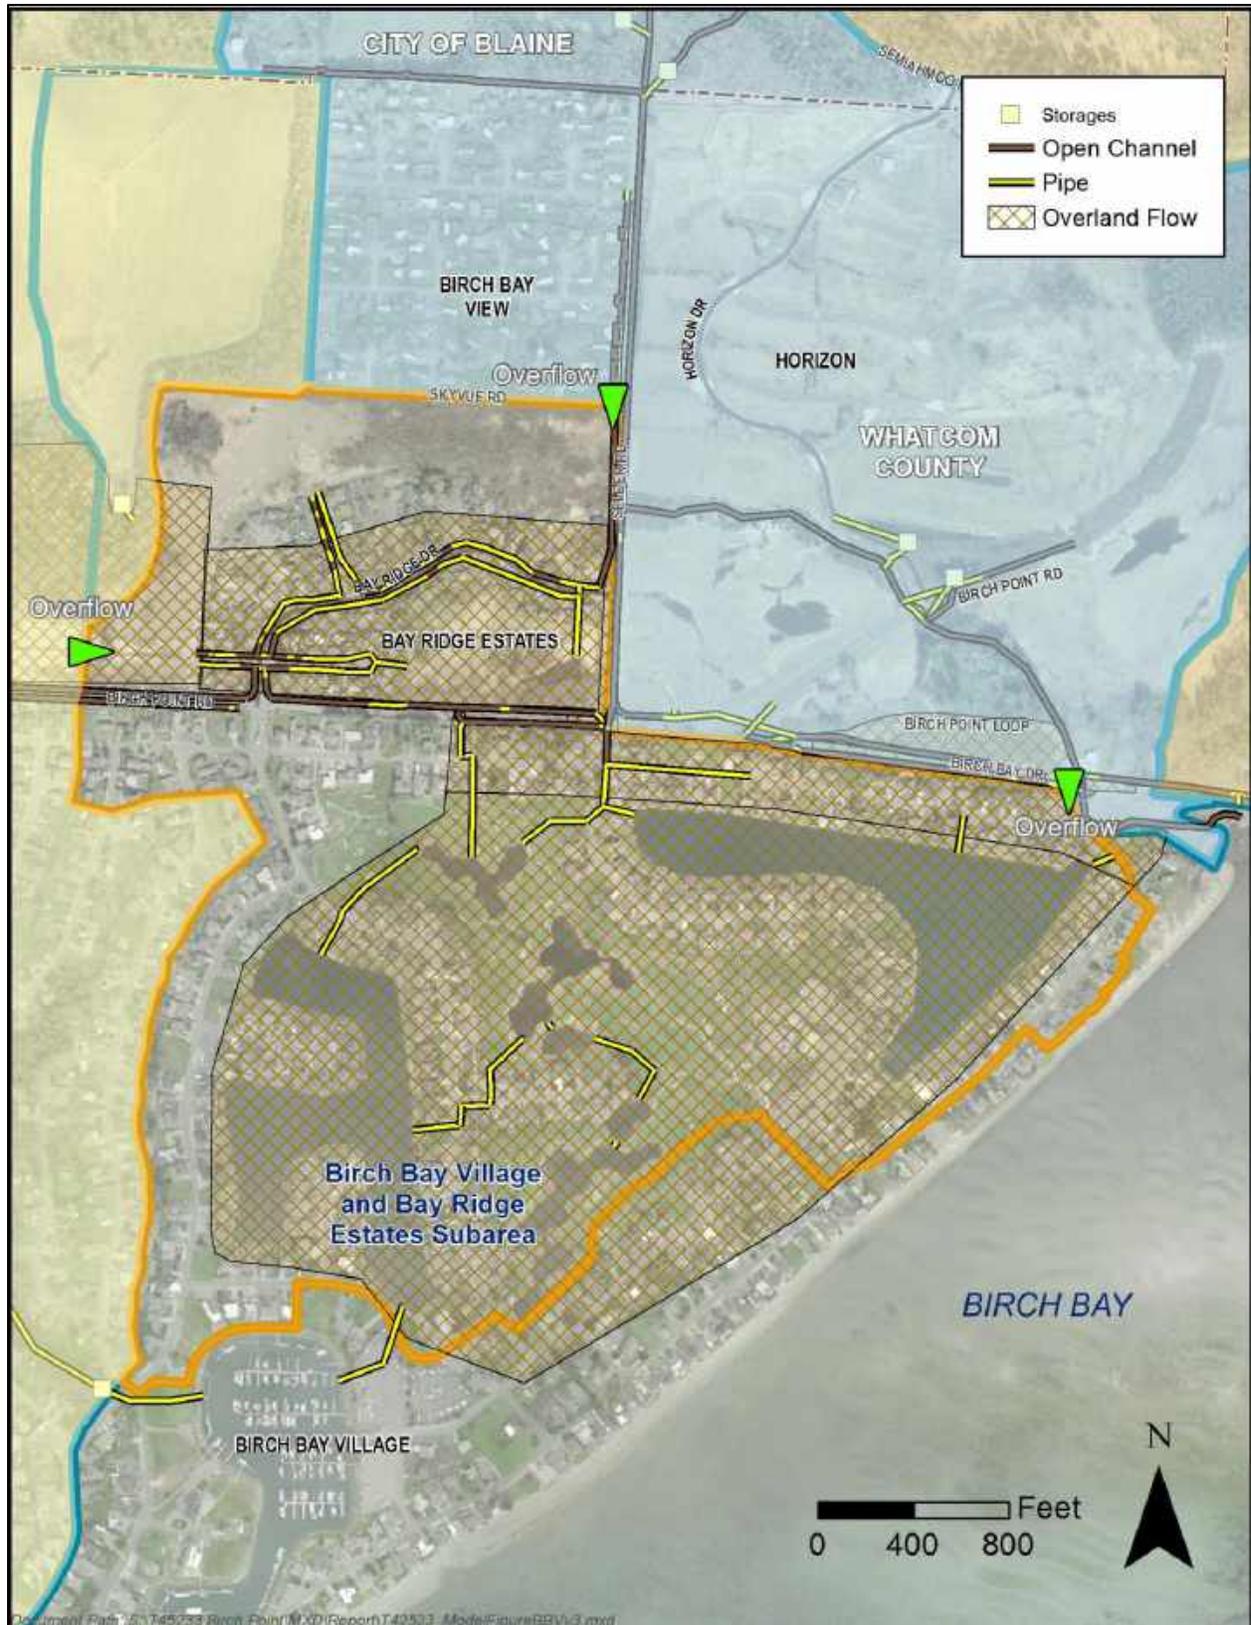
Figure 3. Birch Bay Village and Bay Ridge Estates Subarea

The Birch Bay Village and Bay Ridge Estates Subarea covers 246 acres and generally includes the Bay Ridge Estates neighborhood and is bounded by Skyvue Road on the north, Chehalis Road on the west side, and Selder Road and Birch Bay to the south and east (see Figure 3). The subarea is mostly medium-density residential in Birch Bay Village and Bay Ridge Estates neighborhoods. The remaining area is undeveloped vacant land (north of Bay Ridge Estates) and open space/golf course in Birch Bay Village.

Bay Ridge Estates is served by a piped storm drain system within the development and discharges to a pond at the northwest corner of Selder Road and Birch Point Road. The Bay Ridge Estates system combines with the Birch Point Road and Selder Road drainage system and crosses under Birch Point Road at two locations: at the entrance to Birch Bay Village and at Selder Road. From this point, the drainageway enters the Birch Bay Village drainage system and is combined with the golf course ponds and is conveyed to Thunderbird Lake and then to the Birch Bay Marina.

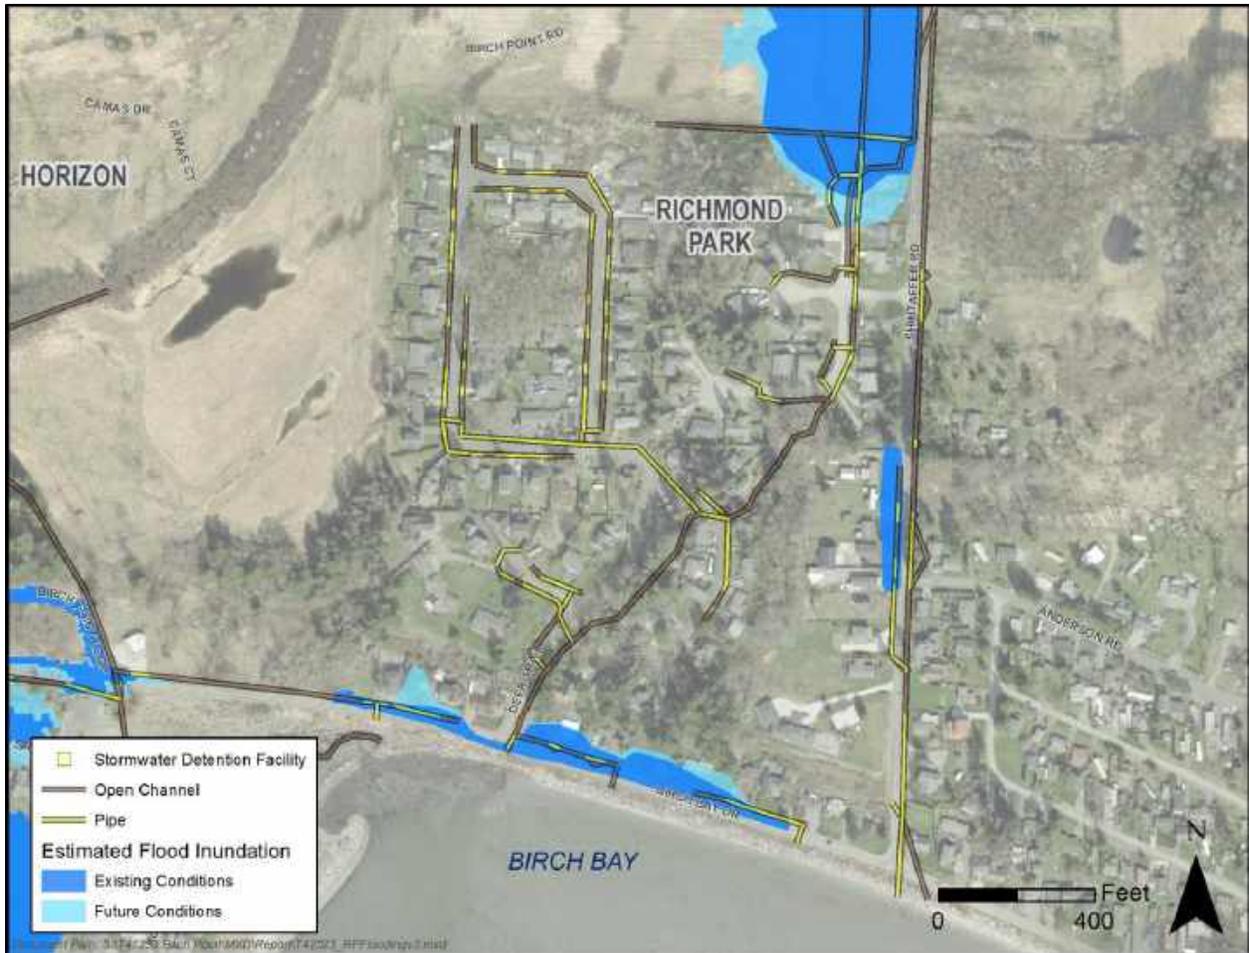
Figure 15. Simulated Flooding in Shintaffer Sub Area - Existing and Future Conditions, 100-year Event

The hydraulic analysis predicted flooding at three locations under existing conditions in the Shintaffer subarea. Table 11 and Table 12 show predicted peak stage and flow at selected locations in this sub area. Figure 15 and Figure 16 show the estimated flood inundation extents for the 100-year and November 2021 events.

The hydraulic analysis of future conditions showed that flood depth will increase up to 0.5 feet in the Richmond Park area (S-B) if flow control is not provided with upstream development. Peak flow rates would increase for all events along Shintaffer Road, but the increase would be mitigated with the depression storage on the farm field north of Richmond Park. The peak flow attenuation of this storage is demonstrated by the peak flow reduction that occurs between the farm field (S-1) and Richmond Park (S-2) for all events analyzed. For example, Table 12 shows peak flow for the 100-year event is about 34 cfs in the roadside ditch west of Shintaffer Road (S-1) but is reduced to about 18 cfs downstream of Richmond Park (S-2).
