**AMENDING THE 2006 BIRCH BAY COMPREHENSIVE STORMWATER PLAN TO
INCLUDE FOUR SUBWATERSHED MASTER PLANS**

BIRCH BAY

COMPREHENSIVE STORMWATER PLAN

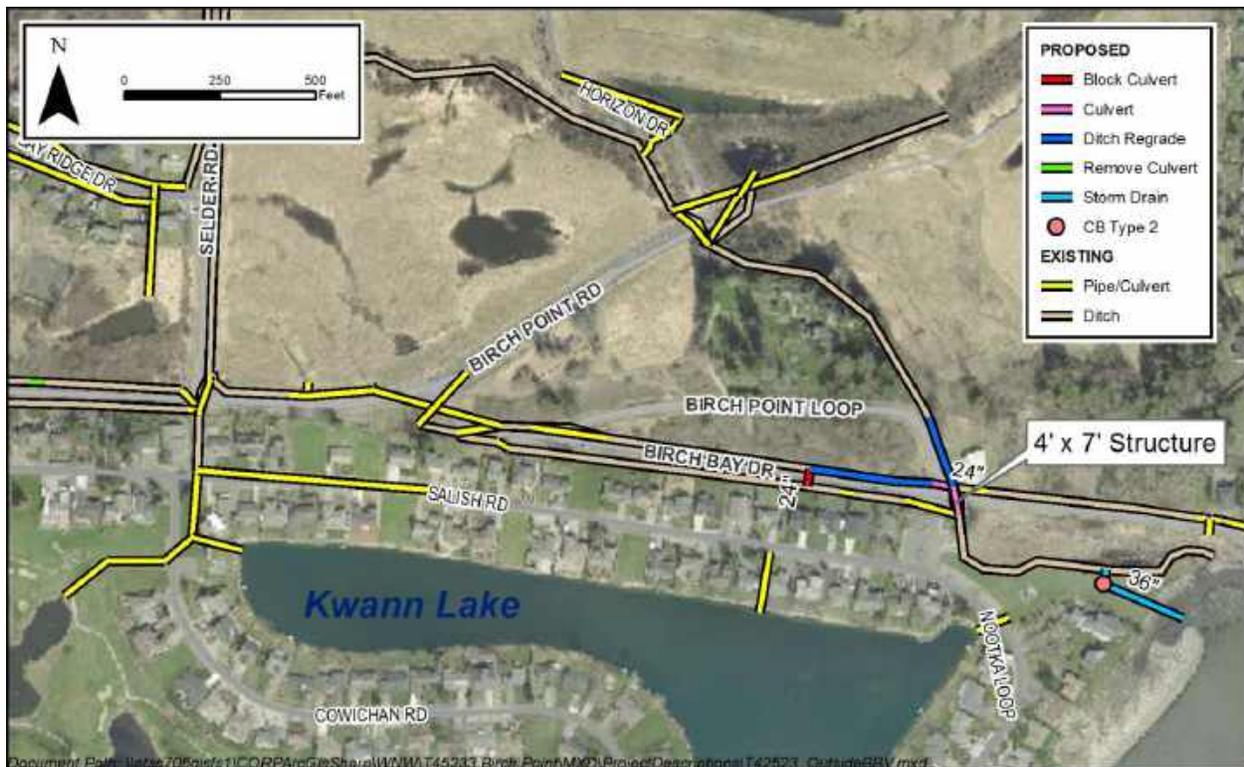
- Block an existing 24-inch diameter culvert with CDF.
- Install 55 lineal feet of 24-inch diameter PVC pipe under Birch Point Loop.
- Replace 144 lineal feet of existing twin 30-inch diameter culvert with a 4-foot by 7-foot rectangular concrete culvert.
- Remove existing 18-inch culvert under Birch Bay Drive between east and west intersection of Birch Point Loop.
- Regrade 319 feet of existing roadside ditch along Birch Point Road.
- Regrade 185 feet of channel along Birch Point Loop to establish positive drainage over entire length roadside ditch along north side of Birch Bay Drive.
- Install one new Type 2 CB near Nootka Loop.
- Install 230 lineal feet of new 36-inch diameter PVC pipe.

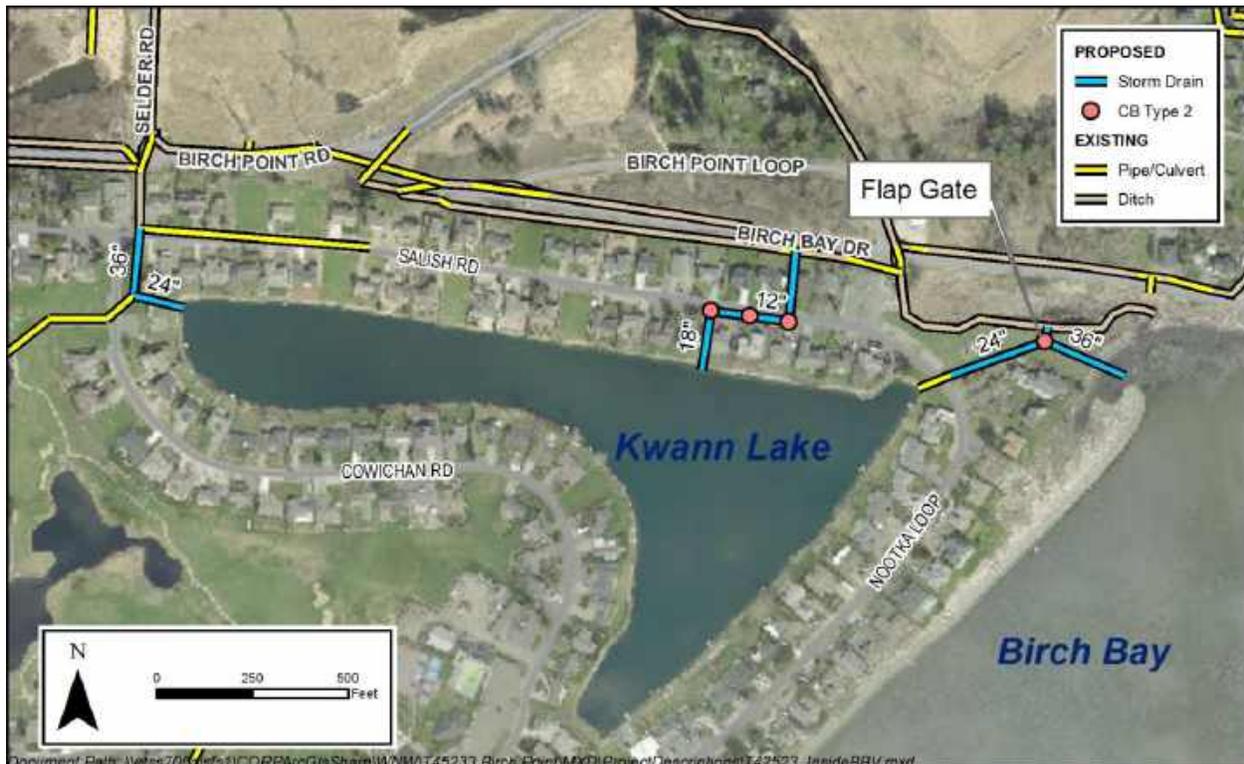
- Replace 140 lineal feet of 12-inch diameter pipe with 24-inch diameter corrugated polyethylene pipe from Cowichan Road to Kwann Lake.
- Replace 160 lineal feet of 12-inch diameter pipe with 18-inch diameter PVC pipe from Salish Road to Kwann Lake.
- Replace 176 lineal feet of 24-inch diameter pipe with 36-inch diameter PVC pipe along Cowichan Road.
- Install 390 lineal feet of new 12-inch diameter PVC pipe along Salish Road.
- Install 3 new CB Type 2, 48-inch diameter structures along Salish Road.
- Install one new CB Type 2, 54-inch diameter structure near Nootka Loop.
- Install new 36-inch diameter flap gate near Nootka Loop
- Install 290 lineal feet of 24-inch diameter PVC pipe near Nootka Loop
- Install 230 lineal feet of new 36-inch diameter PVC pipe near Nootka Loop
