# 2023 Annual Bridge Report

Prepared by the Whatcom County Public  
Works Bridge and Hydraulic Group  
Submitted September 2023

## 2023 Bridge Report

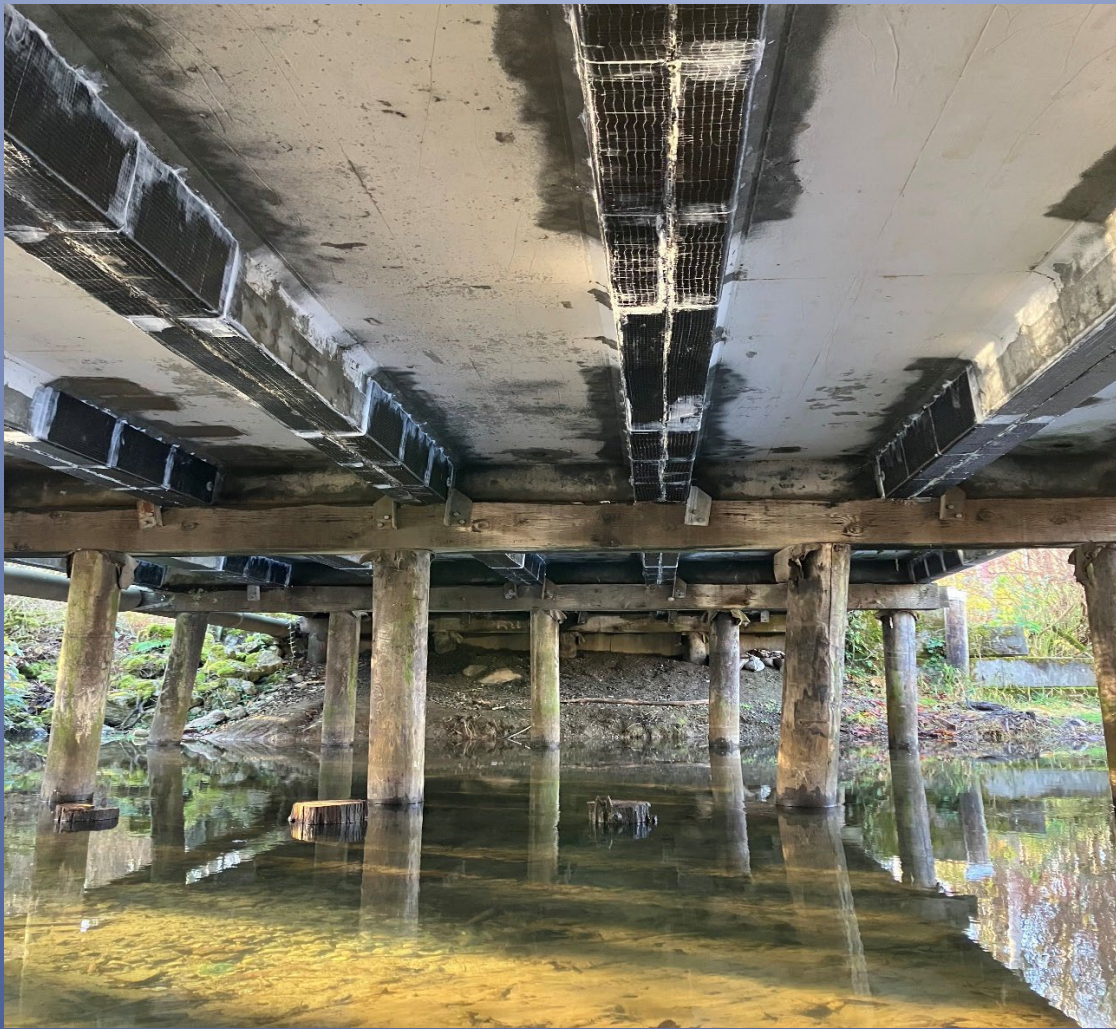
### Cover Photo:

The Nulle Road/Friday Creek Bridge No. 106 Structural Rehabilitation project was completed in the summer of 2023. This project added carbon fiber reinforced polymer strips to the existing girders along with other improvements. This work allowed for the existing load restrictions to be removed and the bridge opened to all legal loads.

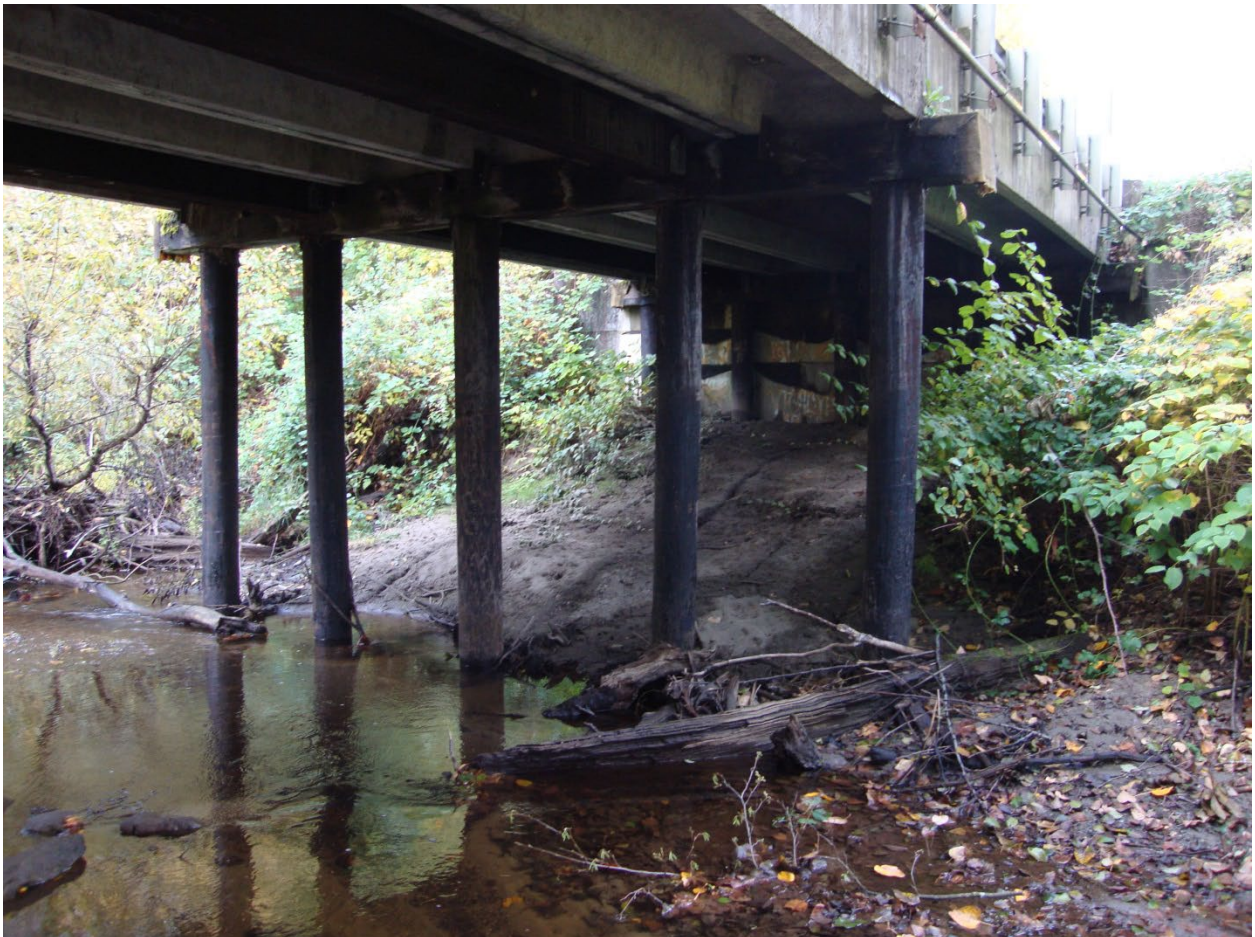
**Goshen Road/Anderson Creek Bridge No. 248 is typical of the concrete channel beam girder with timber pile and cap construction which is the most prevalent bridge type in the county inventory.**

3. Goshen Road/Anderson Creek Bridge No. 248 Replacement – approximately \$4 million in federal bridge replacement funds have been received for the design and construction phases of this project. Design work began in late 2020 with construction scheduled in 2026.

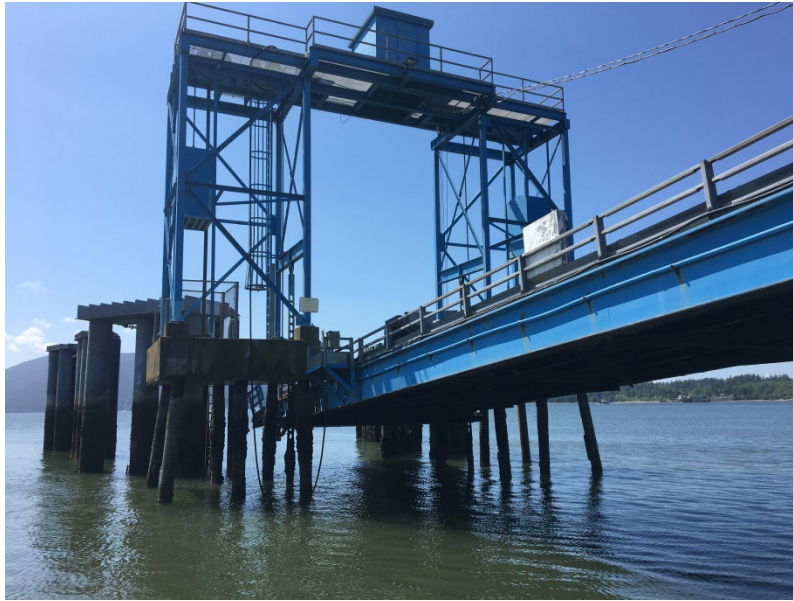
Gooseberry Point Terminal

The Gooseberry Point and Lummi Island Ferry Terminal approach and transfer spans are considered bridge structures and are inspected and maintained just like the other bridges in the county inventory. These consist of a steel transfer span and a timber approach span at the Gooseberry Point terminal and a steel transfer span and a reinforced concreted girder approach span at the Lummi Island terminal.

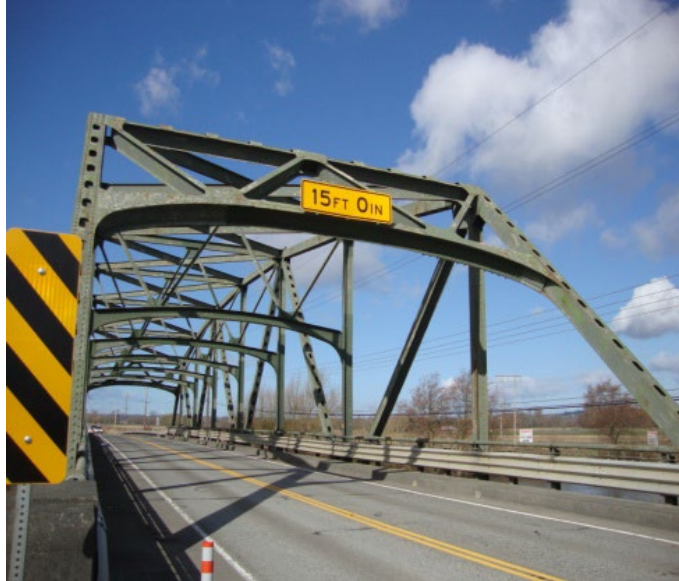
Height restriction sign posted on the Slater Road/Nooksack River Bridge No. 512

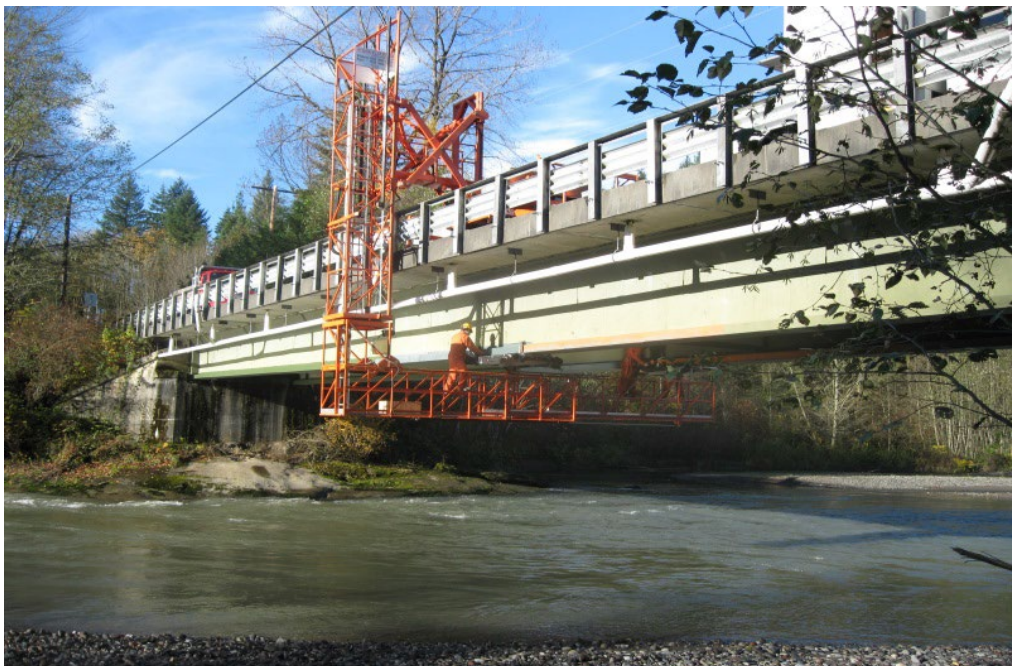
**Photo of M&O's bridge inspection platform in use on Mosquito Lake Road/NF Nooksack River Bridge No. 332**

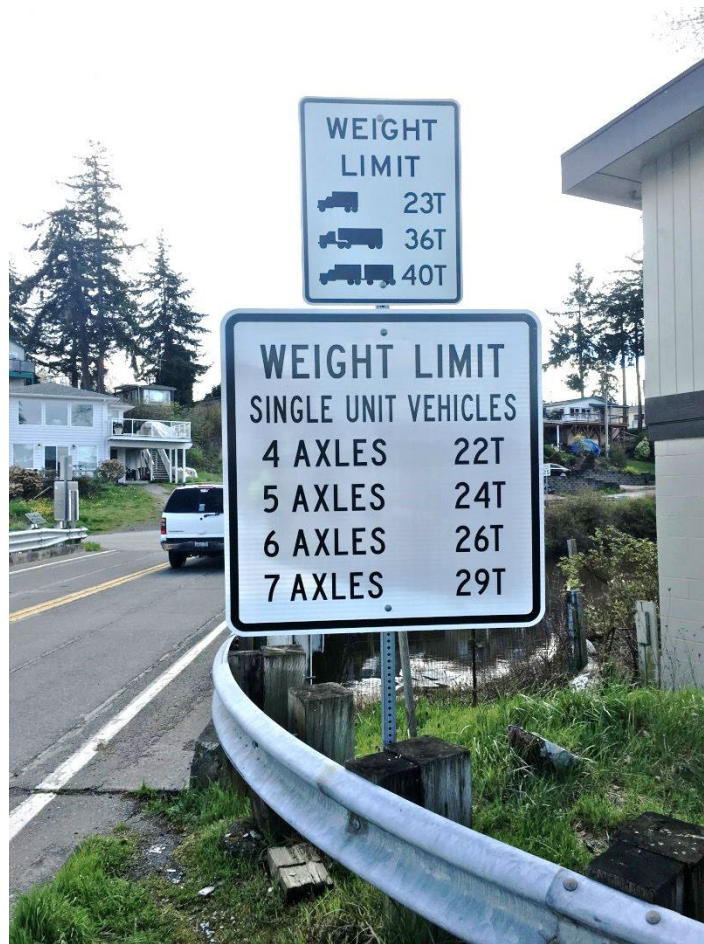
Posted weight restrictions for Jackson Road/Terrell Creek Bridge No. 81 showing AASHTO 1, 2 & 3 and single unit vehicles 4-axles through 7-axles restrictions.

2. Jackson Road/Terrell Creek Bridge No. 81 Replacement – TS&L initiated in 2020 including community engagement and preliminary engineering work. Whatcom County was awarded approximately \$4 million in federal bridge replacement funds for this project in 2022. Work on this project was delayed in 2022 due to reallocation of resources to address November 2021 emergency flood response. Construction year is yet to be determined for this project.

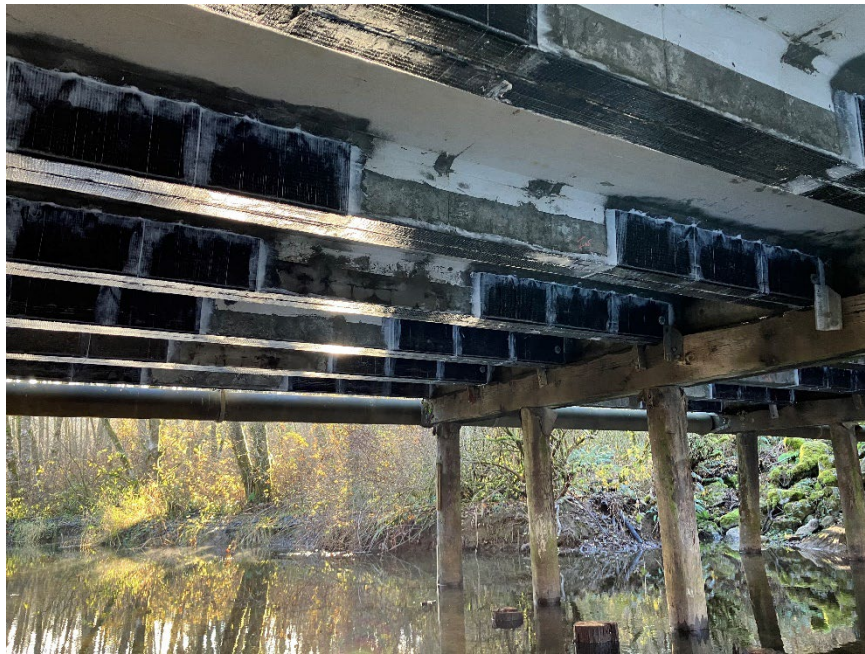
**Picture of newly completed carbon fiber reinforced polymer strips to the existing girders on the Nulle Road/Friday Creek Bridge No. 106.**

This project included the installation of carbon fiber reinforced polymer wraps to the existing girders as well as the repair of concrete spalls and cracks. Work also included removing the asphalt overlay from the bridge deck to reduce dead load. This rehabilitation work allowed the existing load restrictions to be removed better position this structure to handle the increased traffic it will likely see during the upcoming North Lake Samish Bridge No. 107 replacement project. This project was funded with local road funds.

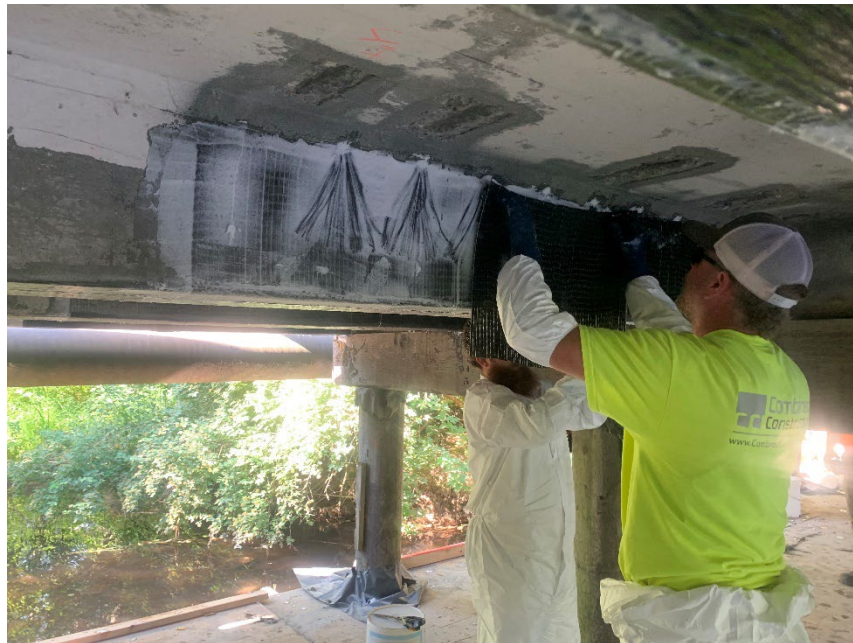
**Installation of carbon fiber reinforced polymer strips to the existing girders on the Nulle Road/Friday Creek Bridge No. 106.**

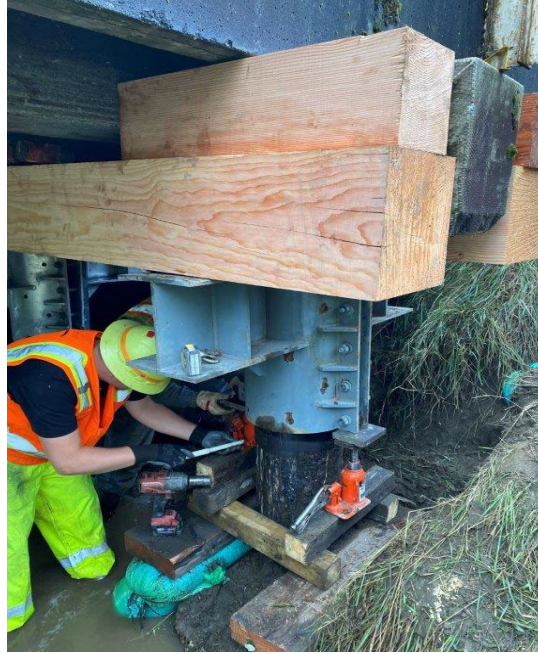
**Installation of steel collar brackets on Gillies Road/Sumas River Bridge No. 309.**

This project, which was completed by the M&O Bridge Crew in the fall of 2023, included the installation of new helper timber caps at the north abutment of the existing bridge. Work included installation of steel collar brackets, new timber caps and other ancillary work to address deterioration in the existing timber cap. This project was funded with local road funds.

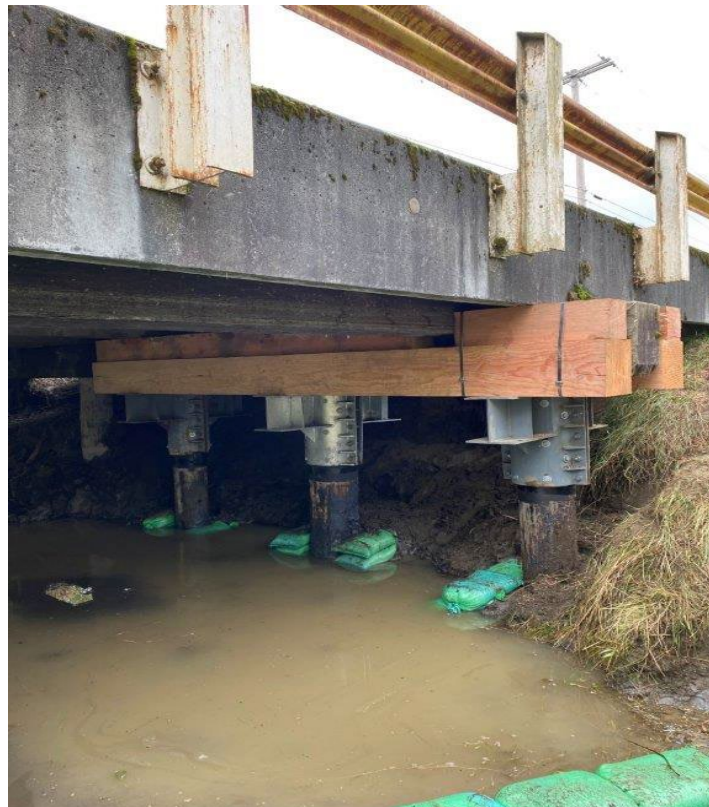
**Completed helper timber cap installation at north abutment of Gillies Road/Sumas River Bridge No. 309**
