ENGINEERING SERVICES JAMES P. KARCHER, P.E. County Engineer 322 N Commercial St Bellingham, WA 98225 Phone: (360) 778-6200 Fax: (360) 778-6201

Woodland Rd/Harksell Rd Intersection Traffic Study

10/24/2022

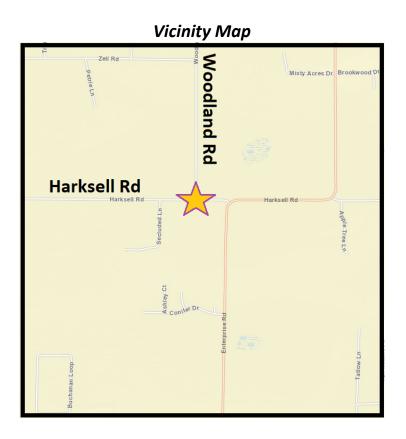
Woodland Rd/Harksell Rd Intersection Map

Two requests from the public that we examine this intersection are the basis for this study. This study will cover the intersection of Woodland Road (MP 2.02) and Harksell Road (MP 1.39).

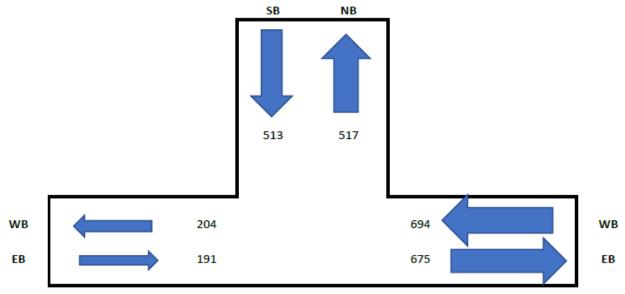
Traffic Direction and Volume:

Traffic counts were conducted from May 24th through May 30th, 2022 on all 3-legs of the intersection and are shown below. The counts consist of vehicle volumes, speeds, and percent of truck traffic.

1029 ADT (North of intersection) 395 ADT (West of intersection) 1369 ADT (East of intersection)
